UNITED STATES COAST GUARD

REPORT OF INVESTIGATION INTO
THE
TOWING VESSEL CSS ATLANTA (O.N. 647194)
CREWMEMBER LOSS OF LIFE ON THE LOWER
MISSISSIPPI RIVER, MILE MARKER 166 ON
NOVEMBER 10, 2020

MISLE ACTIVITY NUMBER: 7679092

**FALL OVERBOARD AND SUBSEQUENT LOSS OF ONE LIFE INVOLVING
THE INSPECTED TOWING VESSEL CSS ATLANTA (O.N. 647194) IN THE
VICINITY OF MILE MARKER 166 ON THE LOWER MISSISSIPPI RIVER
NEAR ST. JAMES, LOUISIANA ON NOVEMBER 10, 2020**

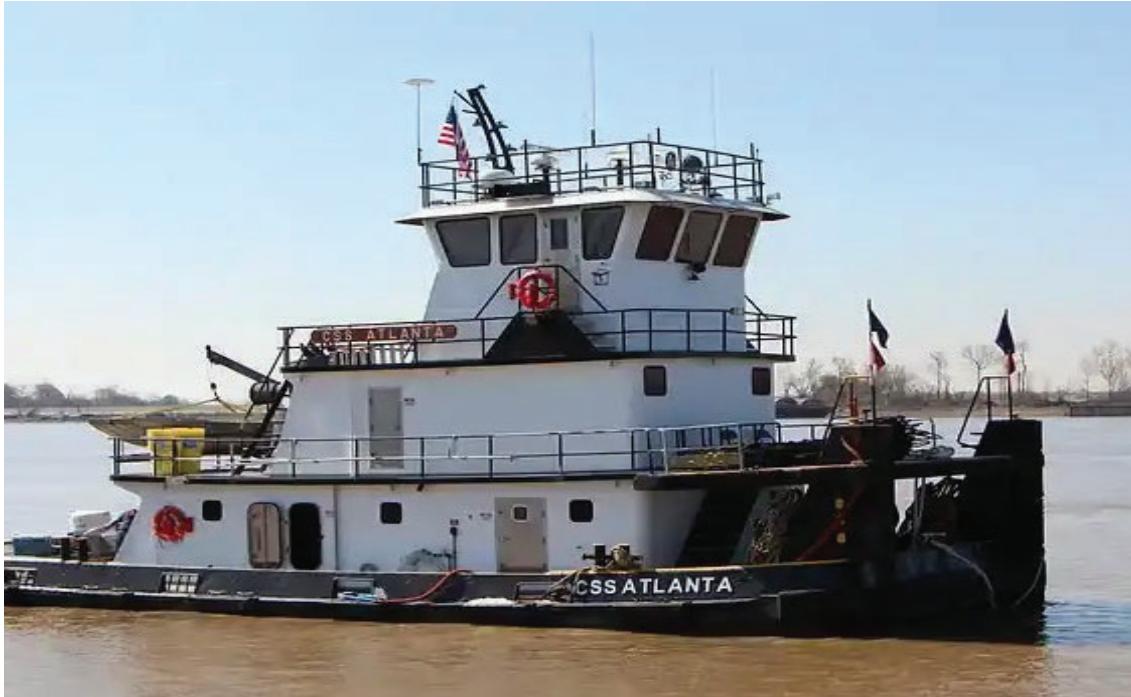
Figure 1. Undated photograph of *CSS ATLANTA*. Photograph obtained from <https://www.carlinecompanies.com/css-atlanta>.

- 4.6. *Inadequate vessel movement.* Once the Master was notified that Deckhand 1 had fallen overboard between the two barges, the Master put the engines of the CSS ATLANTA in reverse and the flanking rudders to starboard to attempt to keep a gap between the two barges. However, the maneuvering was not enough to keep the barges apart and Deckhand 1 was pinned between the two barges. Had the maneuvering of the CSS ATLANTA been substantial enough to keep the two barges separated, it was possible that Deckhand 1 would not have sustained severe injuries.

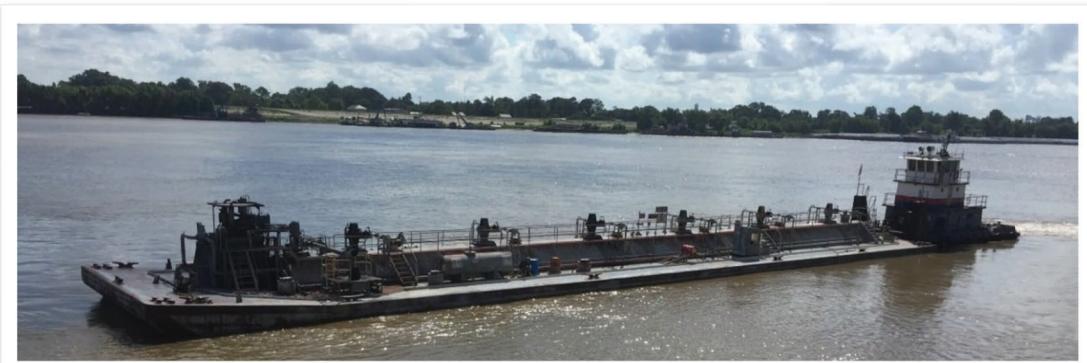
Figure 2. Undated photograph of CY-11. Photograph from <https://www.vtbarge.com/vtbourfleet>.

4.2.8. Non-skid coating at the location where Deckhand 1 fell overboard was partially worn.

4.2.9. There was multiple inherent tripping hazards present along the deck of the CY-11, which included buttons, cleats, mooring lines, and various metal structures.

4.2.10. Neither the CY-11 nor the FC 2 was equipped with a fendering system.

- 4.3. *Partially worn non-skid coating on deck.* The non-skid coating on the deck of the CY-11 was partially worn in the vicinity where Deckhand 1 fell overboard. Non-skid is a type of epoxy/paint which, once dry, offers an abrasive texture to reduce the chance of boots/shoes slipping while transiting the deck of a vessel. The Carline Companies incident report specified that there may have been dew on the deck of the CY-11 at the time, which was not unusual and would not render the barge unfit for use. It was also misting rain at the time of the incident. It was possible that the dew/moisture on the deck, coupled with the partially worn non-skid coating on the deck, led to Deckhand 1 slipping while walking and falling overboard. Had the non-skid coating on the deck of the CY-11 not been partially worn, it was possible that Deckhand 1 may have retained his footing and not fallen overboard.

- 4.4. *Inherent tripping hazards.* There were multiple inherent tripping hazards along the deck of the CY-11, which included buttons, cleats, mooring lines, and various metal structures. Considering Deckhand 1 walked toward the stern of the CY-11 to assist with final mooring operations, it was reasonable to assume that he would have stepped over various tripping hazards while walking. Additionally, Carline Companies safety rules warned crewmembers to "avoid an unsafe situation by paying close attention to what is happening around you". Had there been no tripping hazards on the deck of the CY-11, it was possible that Deckhand 1 may not have fallen into the water.

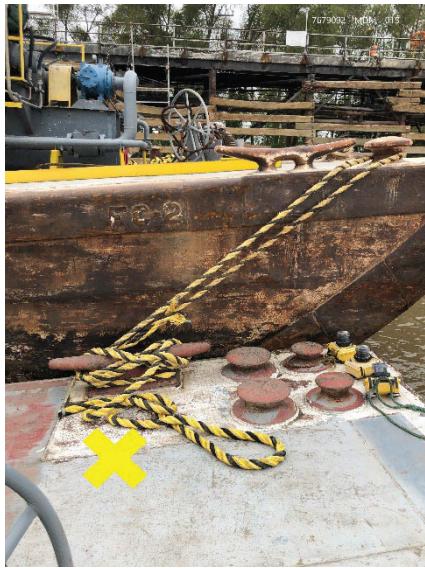
4.1.5. At 0609, Deckhand 1 tied off the CY-11 port bow line to the FC 2 and then walked toward the stern of the vessel to assist with final mooring operations.

Figure 4. Tow configuration of CY-11 and FC-2 and last known location of deckhand 1. Photo taken by Coast Guard Sector New Orleans.

4.1.6. The Master checked the gap between the stern of the two barges, which was approximately five feet. The Master maneuvered the stern of the CY-11 inward to allow for the stern line to be secured.

4.1.7. At 0610, Deckhand 1 fell overboard, between CY-11 and FC 2.

4.1.10. Despite the Master's efforts, Deckhand 1 was pinned between CY-11 and FC 2 and sustained serious injuries.
