**REPORT OF THE INVESTIGATION
INTO THE
CUMBERLAND II (O.N. 1244371) AND MOTOR
VEHICLE (PLATE #1PD5341) ROLL OFF WITH
LOSS OF LIFE NEAR CUMBERLAND RIVER
MILE 104
ON APRIL 25, 2025**

MISLE ACTIVITY NUMBER: 8126294

**MOTOR VEHICLE ROLL OFF FROM THE BARGE FERRY CUMBERLAND II
(O.N. 1244371) WHILE CONDUCTING BOARDING OPERATIONS RESULTING
IN THE LOSS OF ONE LIFE ON THE CUMBERLAND RIVER NEAR
CUMBERLAND CITY, TENNESSEE ON APRIL 25, 2025**

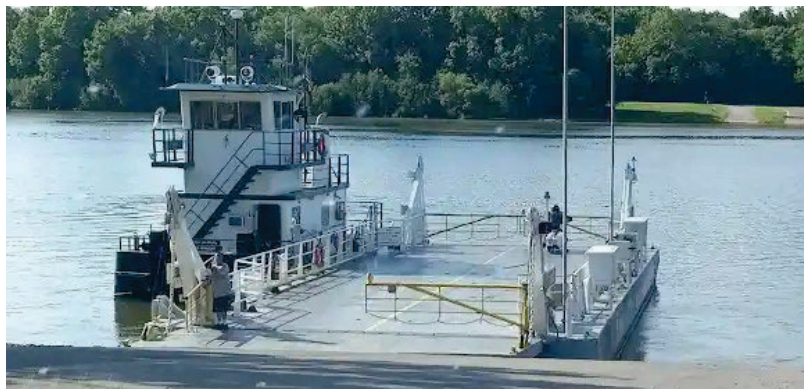
Figure 1. ITV PATIENCE and CUMBERLAND II (Google) (March 18,2026/USCG)

5.2. *Insufficient Barrier Strength for Run-A-Way Vehicles.* The *CUMBERLAND II* is a ferry barge inspected under Subchapter T and per 46CFR177.940 is required to have suitable chains, cables, or other barriers installed at the end of each vehicle runway. The gate, rails, and latching mechanism met the intent of the regulation before and after the incident. Following the event, the operator proactively upgraded the latching hardware to increase the physical strength of the barrier system. Specifically, the original hollow steel latch pin was replaced with a solid steel pin of increased length.

6.1.1.2. The ferry barge retention gate and latch mechanism did not support the force of a run-a-way vehicle.

7.1. On April 26, 2025, one-day after the incident, the Vice President of Marine Operations stated that the metal pin, as a part of the latching mechanism on the loading gates, were replaced with a solid steel versus hollow steel pin and lengthened.

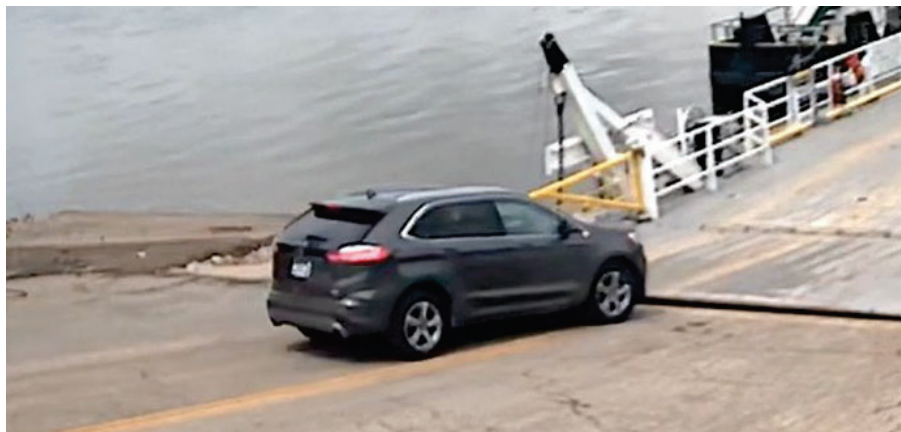
Figure 2. 2020 Gray Ford Edge (PLATE #1PD5341) (River Marine Services, Inc.) (April 25, 2025)

5.1. *Loss of Situational Awareness.* After driving onto the *CUMBERLAND II*, the owner/operator of the 2020 Ford Edge briefly tapped the breaks but failed to come to a full stop. The vehicle maintained enough momentum to break through the closed and latched gates and entered the water. Had the operator come to a full stop the vehicle would not have breached the barrier. The medical examiner's report listed the suspected cause of death (COD) as Asphyxia-Drowning. The medical examiner attributed the death to drowning, though the driver's medical history and medication use were noted as potential variables.

6.1.1.1. The owner/operator of the 2020 Ford Edge lost situational awareness and did not come to a complete stop before breaching the closed and latched gates.
