# UNITED STATES COAST GUARD

**REPORT OF INVESTIGATION  
INTO THE  
FIRE THAT OCCURRED ONBOARD  
*CUYAHOGA* (O.N. 243772)  
ON MARCH 15, 2024, WHILE MOORED AT KINDER  
MORGAN PINNEY DOCK IN ASHTABULA, OHIO**

**FIRE ON BOARD THE CANADIAN FLAGGED BULK CARRIER CUYAHOGA  
(IMO# 5166392) RESULTING IN THE TOTAL CONSTRUCTIVE LOSS OF THE  
VESSEL WHILE MOORED AT THE KINDER MORGAN PINNEY DOCK IN  
ASHTABULA, OHIO ON MARCH 15, 2024**

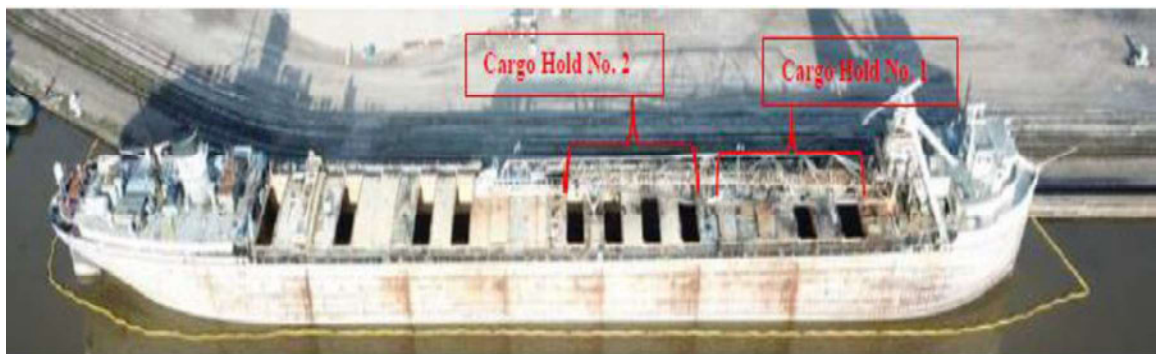
4.1.17. *Cuyahoga* was designed with multiple lift-away hatch covers for each of the ship's four cargo holds. *Cuyahoga* Cargo Hold No. 2's four hatch covers had been removed prior to March 15, 2024, by a hatch crane and stowed in the ship's bay. *Cuyahoga* Cargo Hold No. 1's forward hatch covers had also been removed prior to March 15, 2024; however, Cargo Hold No. 1's two aft hatch covers remained in their respective place as shown in Figure 3.

Figure 3. Photograph of *Cuyahoga*'s hatch covers taken post-fire. Source: Ashtabula Fire Department.

the spar deck (upper continuous deck), and hatch coamings and hatch covers. In addition, *Cuyahoga's* cargo boom's main structure buckled and distorted, and the boom's conveyor belt structure burnt and was distorted from the boom pivot up to frame 115, which included components such as the belt, rollers, frames, pulleys, hoisting cables, and electrical raceway. The port side and starboard side conveyor tunnels and their associated equipment were charred and sustained substantial damage.

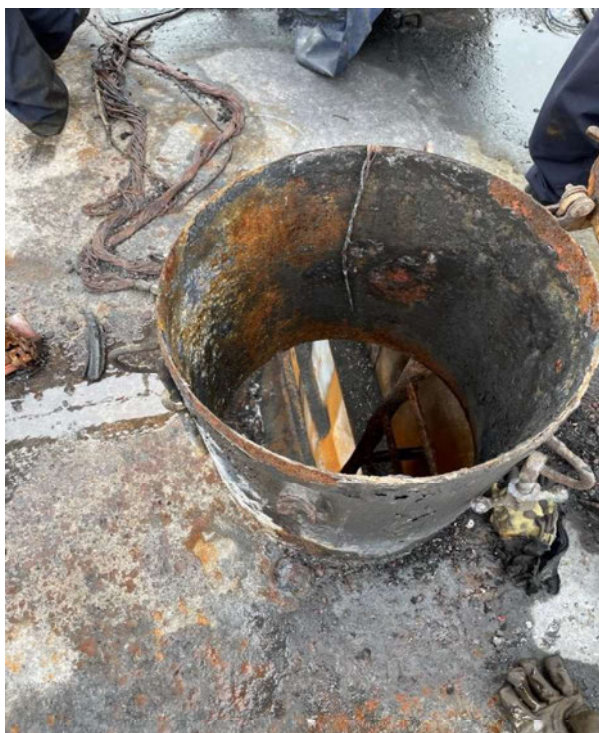
4.1.21. *Cuyahoga* was designed with a booby hatch at the forward and aft ends of Cargo Hold No. 2. Booby hatches are small hatches giving access to a ladder from the weather deck to the interior of a cargo hold. On March 15, 2024, Cargo Hold No. 2's forward and aft booby hatches were in the open position as seen in Figure 5.

Figure 5. *Cuyahoga's* Cargo Hold No. 2 forward booby hatch. Source: U.S. Coast Guard.

6.1.3 The fire on the forward bulkhead in *Cuyahoga's* Cargo Hold No. 2 resulted in a subsequent event, which was substantial damage to Cargo Hold No. 1, Cargo Hold No. 2, the spar deck (upper continuous deck), hatch coamings and hatch covers, the cargo boom and the boom's conveyor belt structure, and the port side and starboard side conveyor tunnels and their associated equipment. Causal factors that contributed to the event were: (1) a lack of firefighting equipment immediately available in the vicinity of hot work being conducted in *Cuyahoga's* Cargo Hold No. 2; and (2) the ineffective firefighting technique used by the fire watch when initially combatting the fire, which likely allowed the fire to spread.

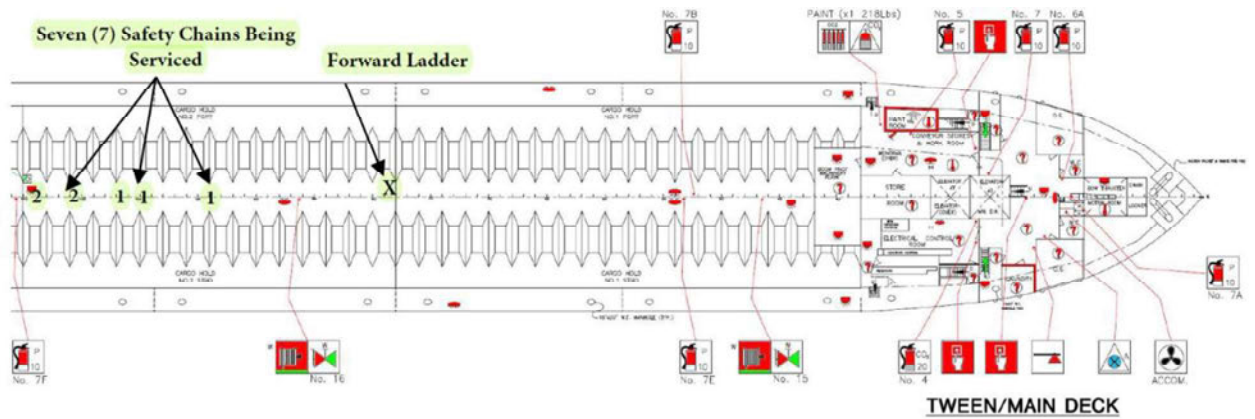
Figure 7. *Cuyahoga's* Cargo Hold No. 2 with location of safety chains and ladder replacement. Source: U.S. Coast Guard.

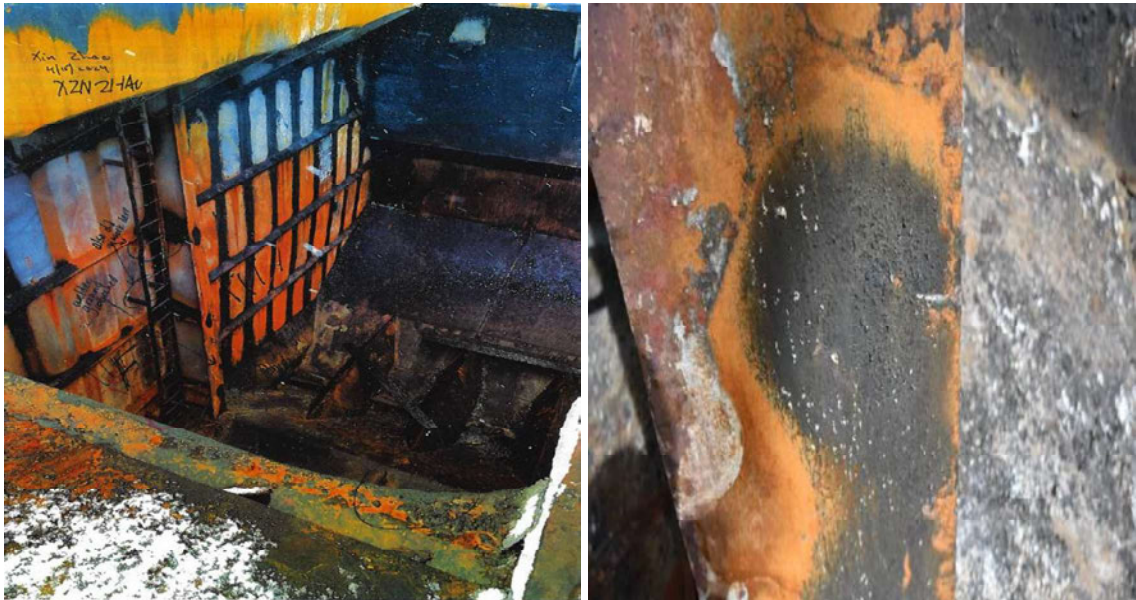
4.1.34. SMS' welder grinded and removed a three-to-four-inch radius of paint on Cargo Hold No. 2's forward bulkhead for each ladder bracket that was being welded to the bulkhead. Another spot, approximately two-hands width, was grinded and paint removed on a nearby I-beam for the grounding electrode cable as seen in Figure 8.

Figure 8. *Cuyahoga*'s Cargo Hold No. 2 with location of the forward ladder (left) and location of grounded electrode clamp on the I-beam (right). Source: U.S. Coast Guard. Diagram obtained during an interview on April 15, 2024, with SMS' welder..

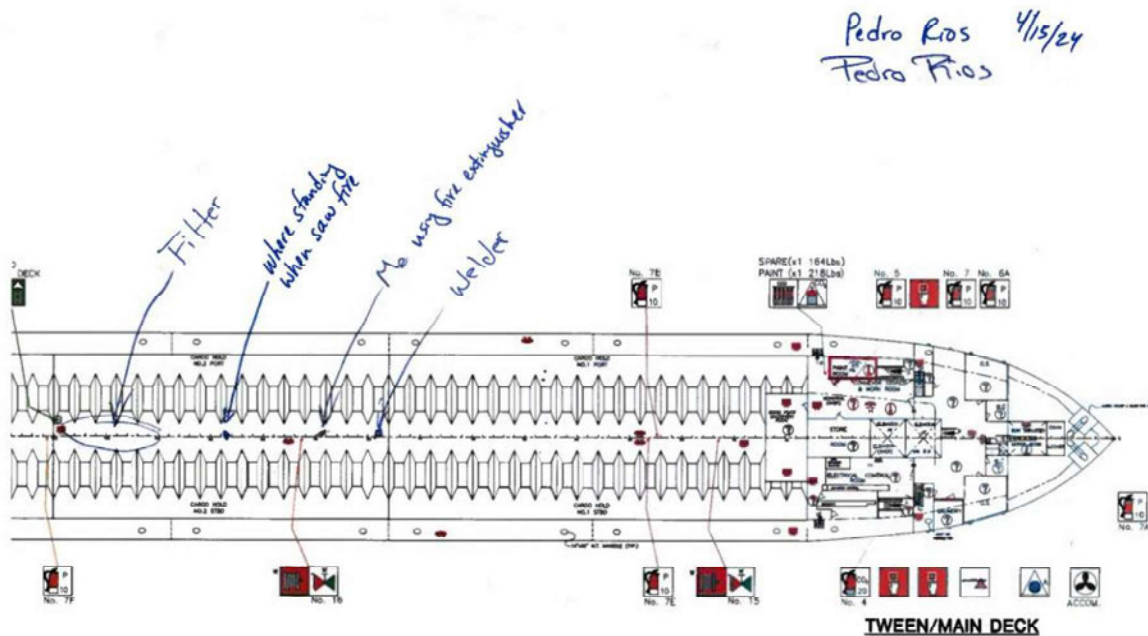
Figure 9. Location of SMS' welder, fitter, and fire watch when the fire was discovered in *Cuyahoga's* Cargo Hold No. 2. Source: U.S. Coast Guard. Diagram obtained during an interview on April 15, 2024, with SMS' fire watch.

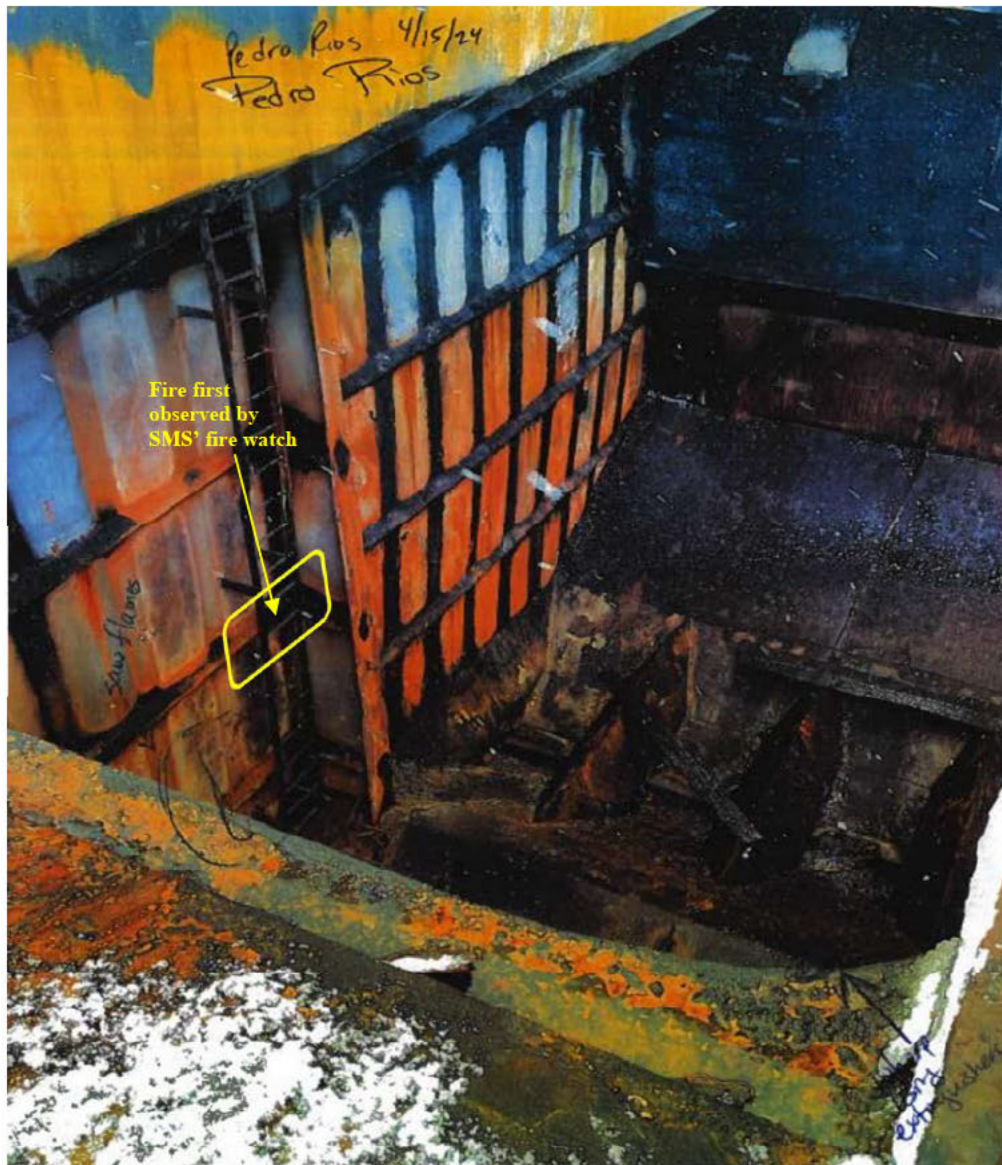
Figure 10. Location where SMS' fire watch discovered the initial flames in *Cuyahoga*'s Cargo Hold No. 2.  
Source: U.S. Coast Guard. Diagram obtained during an interview on April 15, 2024, with SMS' fire watch.

6.1.2 The initiating event for this casualty occurred when a fire ignited on the forward bulkhead in *Cuyahoga's* Cargo Hold No. 2. The fire originated on the forward bulkhead approximately 3' above the gates and port side of the forward ladder. Actions and conditions that most likely caused the fire were: (1) an electrical arc from the welder or extension cord; and (2) nut coke residue from the previous cargo combined with the Amerthane 490 epoxy coating on the bulkhead.

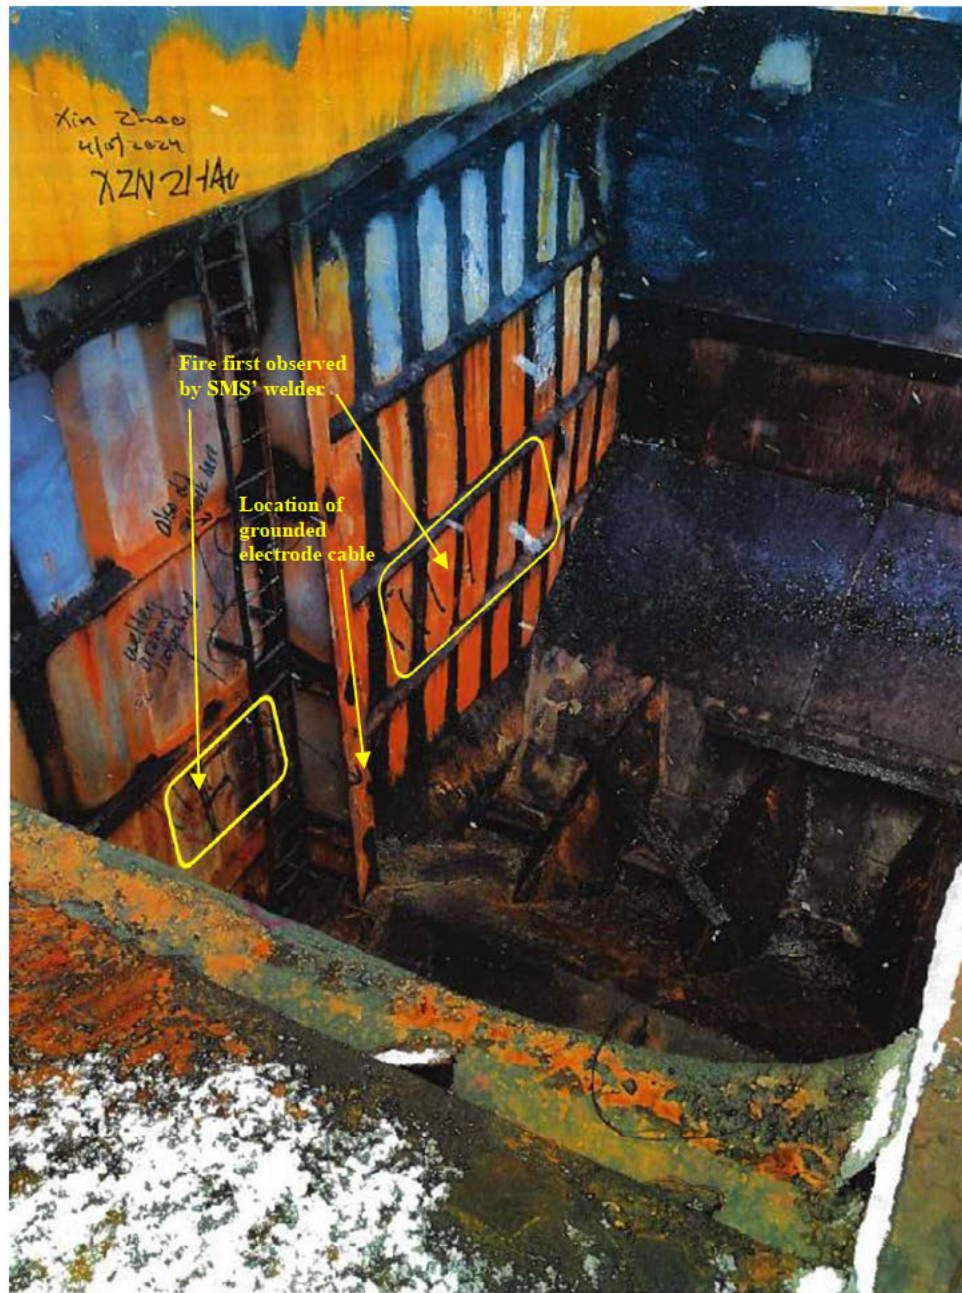
Figure 11. Location where SMS' welder discovered the initial flames in *Cuyahoga's* Cargo Hold No. 2.  
Source: U.S. Coast Guard. Diagram obtained during an interview on April 15, 2024, with SMS' welder.

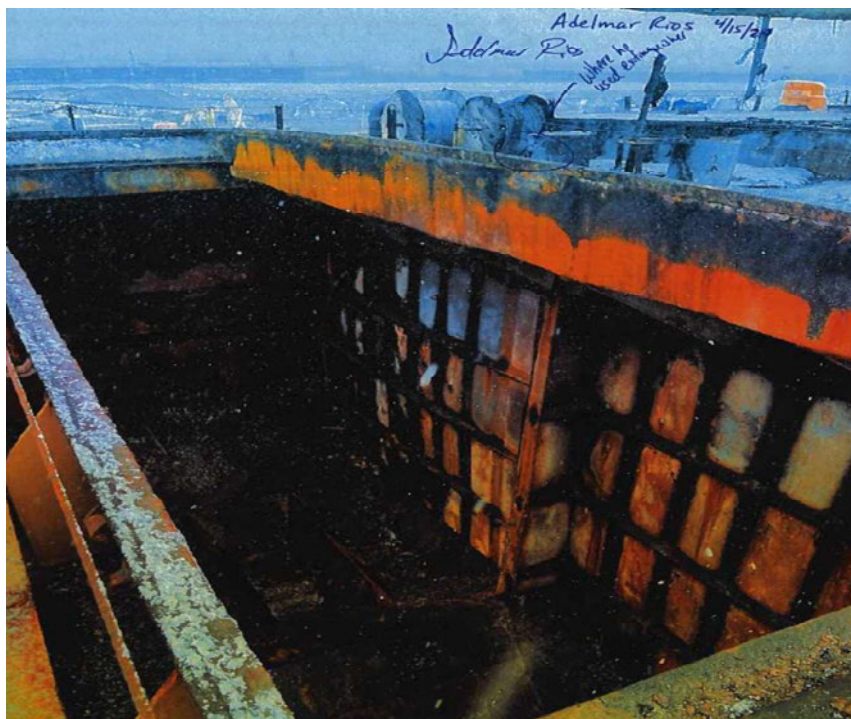
4.1.51. SMS' fitter evacuated Cargo Hold No. 2 via the hold's aft ladder with an empty water canister fire extinguisher to retrieve another fire extinguisher and did not return to the hold. As SMS' fitter arrived on *Cuyahoga*'s weather deck, he walked to the stern of the ship to retrieve additional fire extinguishers. He encountered a *Cuyahoga* crewmember who gave him two fire extinguishers of an unknown type. SMS' fitter returned to the fire and gave a fire extinguisher to an unknown person and discharged the other fire extinguisher from above the forward bulkhead, close to Cargo Hold No. 2's forward booby hatch as shown in Figure 12.

Figure 12. Location where SMS's fitter discharged a fire extinguisher into *Cuyahoga*'s Cargo Hold No. 2.  
Source: U.S. Coast Guard. Diagram obtained during an interview on April 15, 2024, with SMS' fitter.

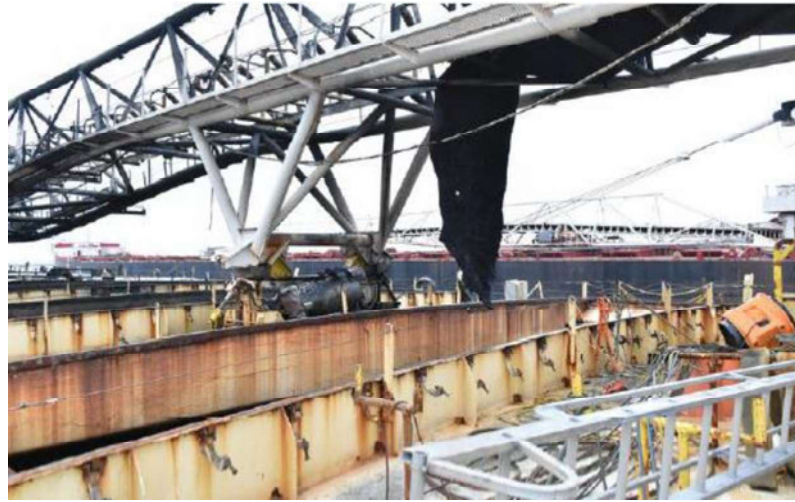
4.1.58. The flames emitting from the top of Cargo Hold No. 2 increased in size and began to impact *Cuyahoga's* cargo boom conveyor belt. *Cuyahoga's* First Mate retrieved another dry chemical fire extinguisher, climbed up the side of the boom, and discharged the extinguisher on the burning cargo boom conveyor belt. The fire appeared to extinguish but quickly reignited within seconds and spread out of control along the conveyor belt, aiding in the rapid spread of fire. Damage to *Cuyahoga's* cargo boom conveyor belt is depicted in Figure 13.

Figure 13. Photograph of *Cuyahoga*'s cargo boom conveyor belt taken post-fire. Source: Ashtabula Fire Department.

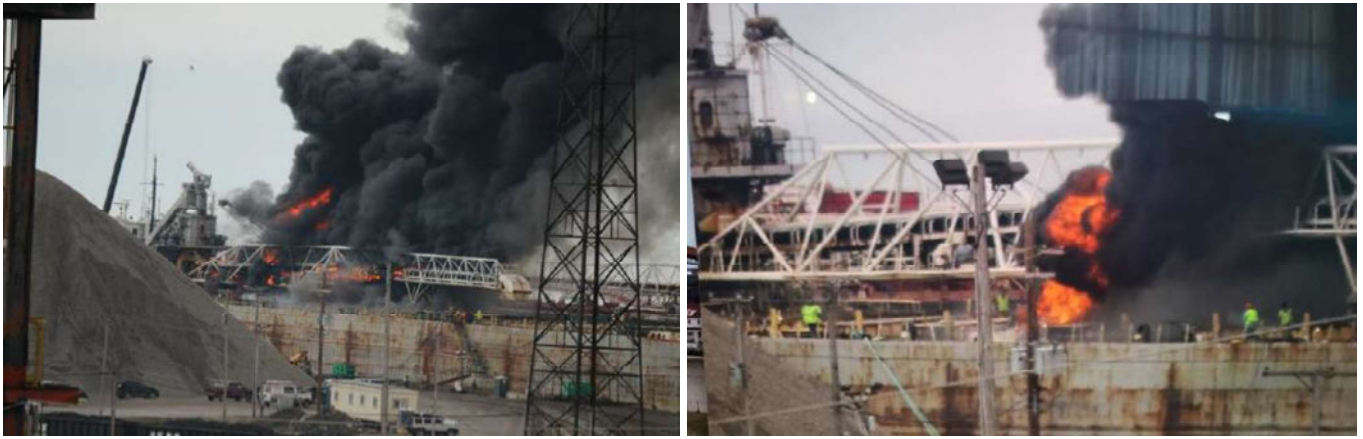
4.1.64. The fire in *Cuyahoga*'s Cargo Hold No. 2 spread to Cargo Hold No. 1, and the heat emitted from these spaces prevented personnel from safely walking forward or aft on *Cuyahoga*'s weather deck as shown in Figure 14.

Figure 14. Photographs of fire onboard *Cuyahoga*. Source: Ashtabula Fire Department.

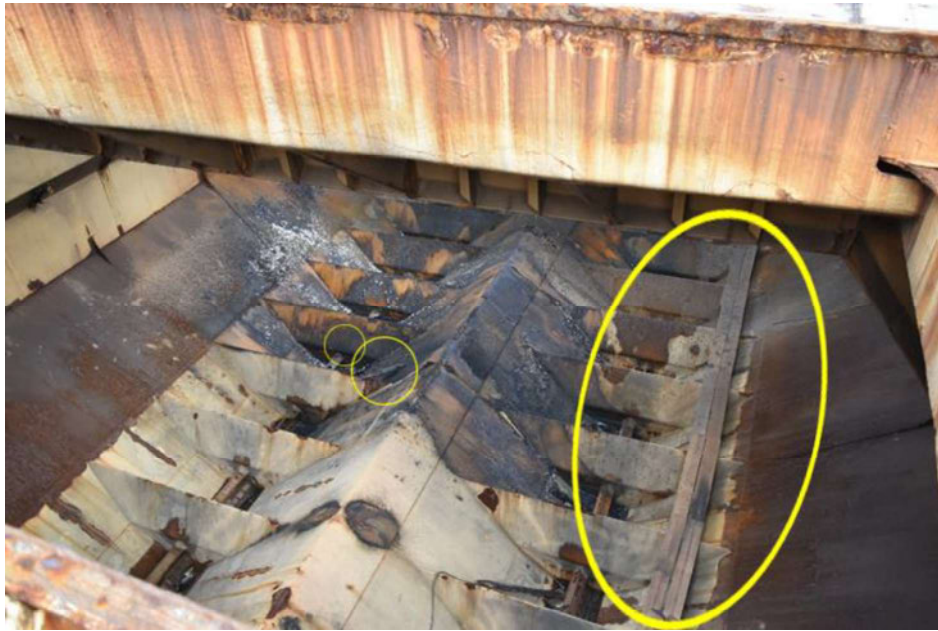
4.2.15. Wood scaffolding planks were in Cargo Hold No. 2 along the starboard side and locations along the portside. Scaffolding planks closest to the origin of fire were burned during the fire, and charred remnants can be seen in Figures 15 and 16.

Figure 15. Photograph of charred (portside) and uncharred (starboard side) wood scaffolding planks located inside *Cuyahoga*'s Cargo Hold No. 2. Source: Ashtabula Fire Department.

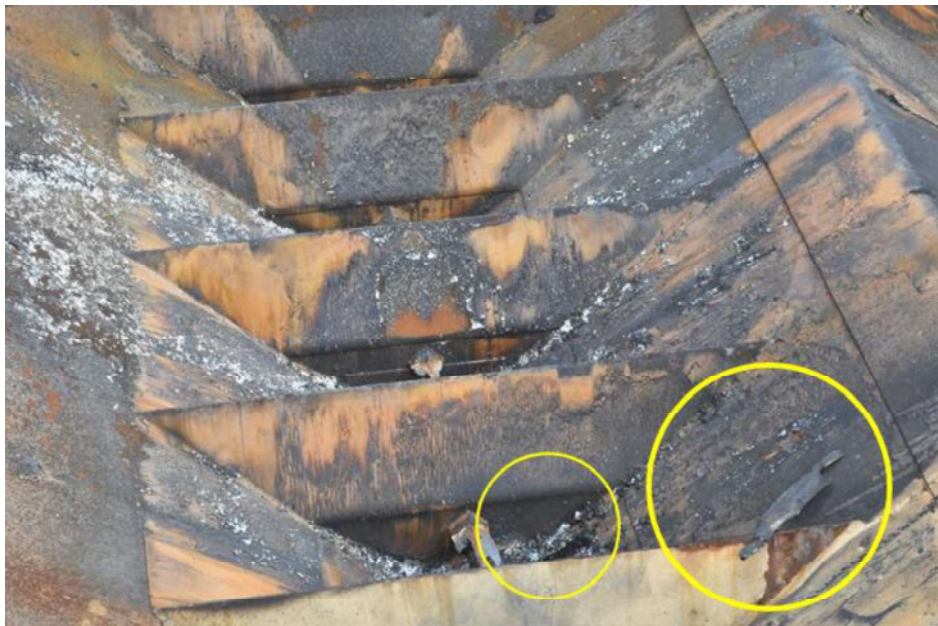
Figure 16. Close up photograph of charred wood scaffolding planks located inside *Cuyahoga*'s Cargo Hold No. 2. Source: Ashtabula Fire Department.
