**LOSS OF LIFE DURING THE ALLISION OF THE  
DAVID AULD SCUDDER (CT3911 BL) WITH THE  
MARINE PARKWAY BRIDGE, BROOKLYN, NY  
ON DECEMBER 4, 2023**

MISLE ACTIVITY NUMBER: 7893517. MISLE CASE NUMBER: 1376578.

**LOSS OF LIFE DURING THE ALLISION OF THE DAVID AULD SCUDDER  
(CT3911BL) WITH THE MARINE PARKWAY BRIDGE, BROOKLYN, NY, ON  
DECEMBER 4, 2023**

**INVESTIGATING OFFICER'S REPORT**

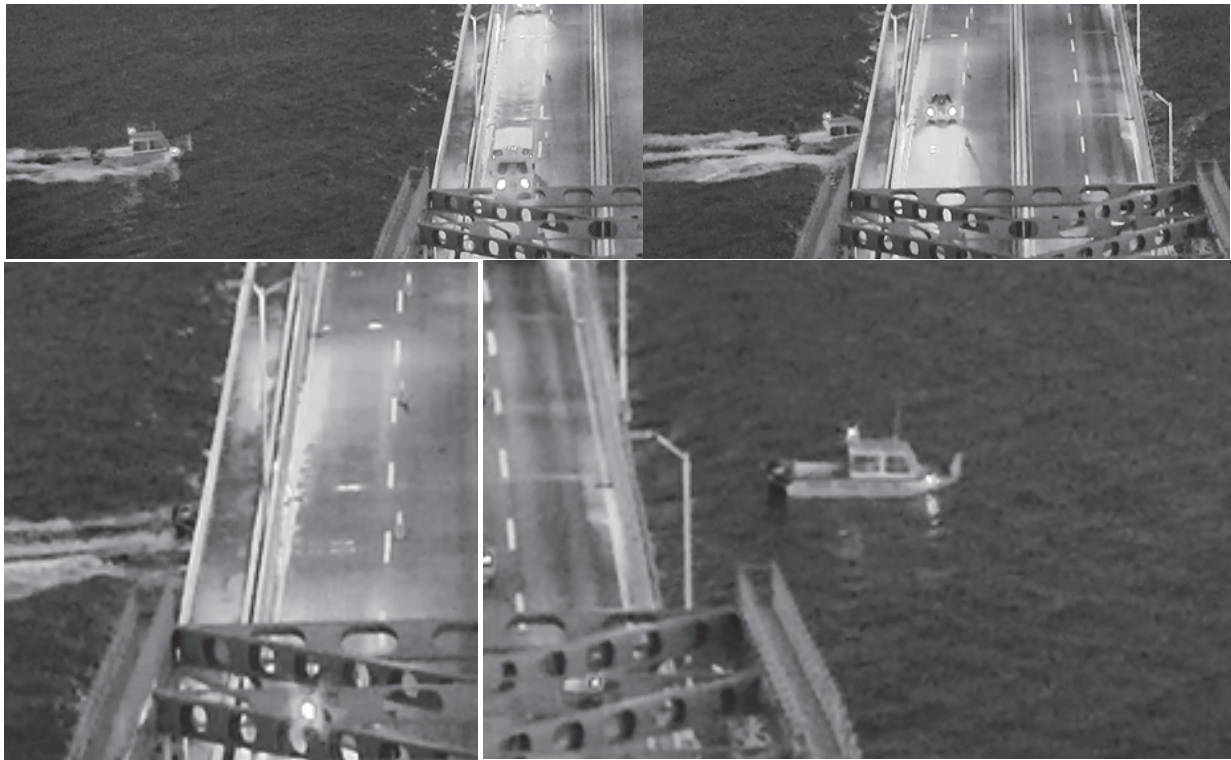
4.1.3. At approximately 0630, the DAVID AULD SCUDDER allided with the west side of the Marine Parkway Bridge.

Figures 2, 3, 4, and 5: Marine Parkway Bridge Surveillance Video Screenshots moments before the DAVID AULD SCUDDER allided with the west side of the bridge, as it allided with the west side of the bridge, and drifting on the east side of the bridge post-allision.

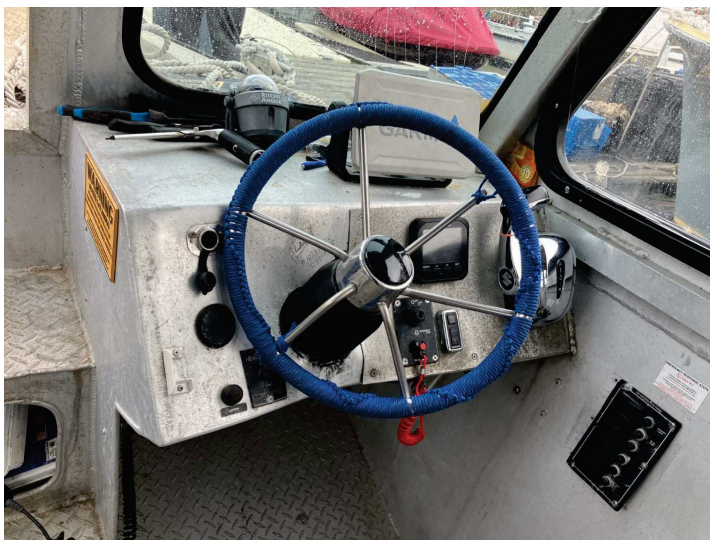
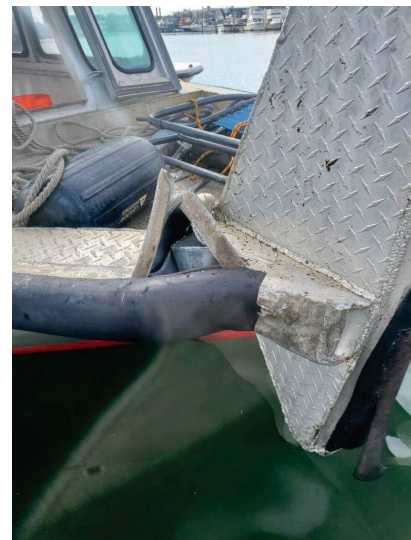
4.1.10. Employees 1 and 2 saw physical damage to the DAVID AULD SCUDDER and the throttle lever in the full-throttle position. The engine was not running.

Figures 7 and 8: NYPD photos of DAVID AULD SCUDDER throttle in full position, helm, and bow damage.

**5.2. Master's Contact with the Steering Console.** When the allision occurred between the DAVID AULD SCUDDER and the Marine Parkway Bridge, Newton's First Law of Motion applied, which caused the Master to continue moving in the direction and speed of the vessel until acted upon by an external force. The steering wheel on the DAVID AULD SCUDDER was bent on the left side, indicative that the Master made forceful contact with it. Had the Master not impacted the steering wheel, it is likely he would have impacted another portion of the console and sustained similar blunt force trauma.

6.1.2.1. The impact of the allision caused the Master to make forceful contact with the steering console of the DAVID AULD SCUDDER. The Office of Chief Medical Examiner, City of New York, Report of Autopsy stated the cause of death as blunt force trauma of the torso.

7.1. As a result of this investigation, Northeast Work & Safety Boats LLC amended and increased the company's safety procedures. Every morning, the company's Vice President of Operations contacts all employees working that day for a formal check-in. The check-in consists of a cell phone call first, then a radio check with whatever vessel that mariner is assigned to. A detailed recording system had been created, displaying every active project the company is involved in, employees assigned at each, and the status of each mariner and vessel to better maintain positive communication between shoreside personnel and mariners on the water.
