UNITED STATES COAST GUARD

**REPORT OF THE INVESTIGATION
INTO THE
HEAVY LIFT DERRICK BARGE EPIC HEDRON (ON
002056), LOSS OF LIFE IN THE GULF OF MEXICO,
EUGENE ISLAND BLOCK 276, ON AUGUST 25, 2024**

**LOSS OF LIFE ABOARD THE HEAVY LIFT DERRICK BARGE EPIC HEDRON
(O.N. 002056) IN EUGENE ISLAND BLOCK 276 IN THE GULF OF AMERICA,
65 NAUTICAL MILES OFFSHORE OF ST. MARY PARISH, LOUISIANA
ON AUGUST 25, 2024**

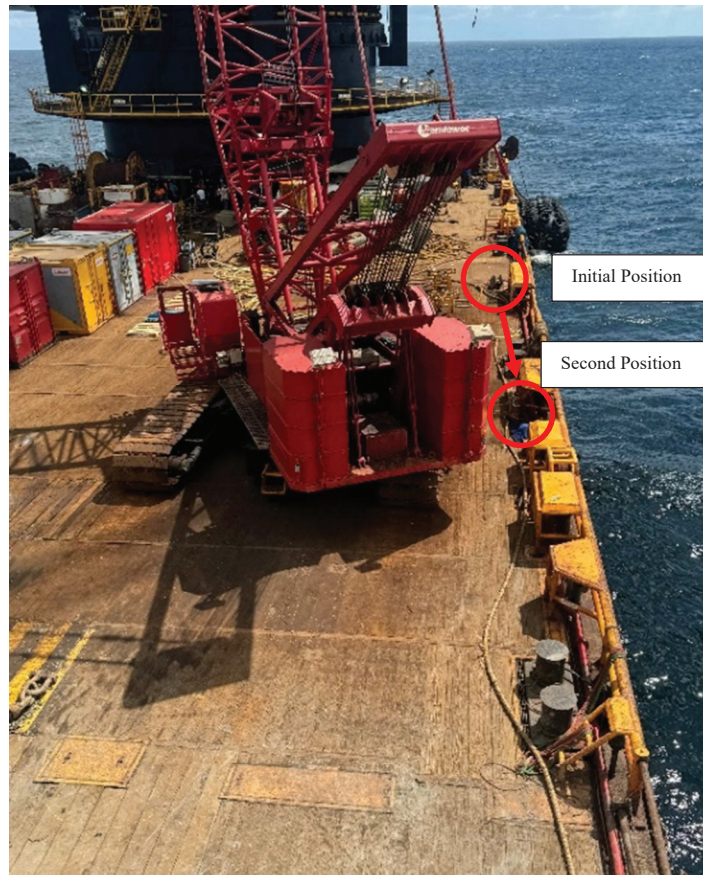
Figure 2. Photograph of the 14000 deck crane on EPIC HEDRON taken by USCG on 24 August 2024

4.1.6. At 1401, the Lead Mechanic moved their position from the safe area on the deck to the railing next to the 14000 Deck Crane to observe the transfer. See Figures 2 and 4.

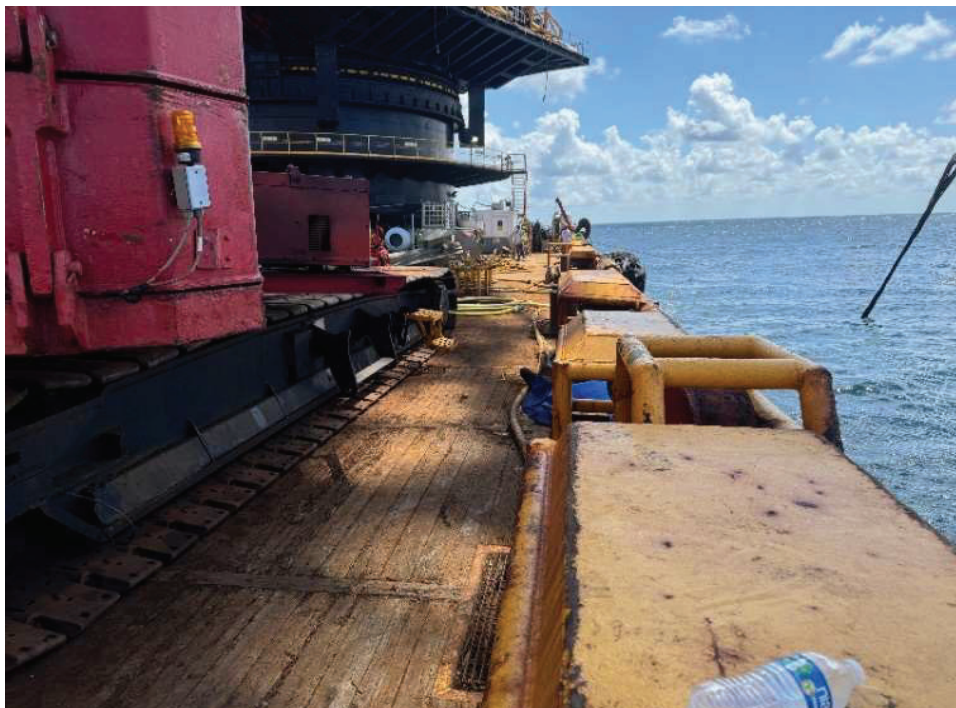
Figure 3. Photograph of the deck crane and deck railing on EPIC HEDRON taken by USCG 24 August 2024

4.1.8. The Lead Mechanic was fatally injured after being crushed between the counterweight of the crane and the deck railing.

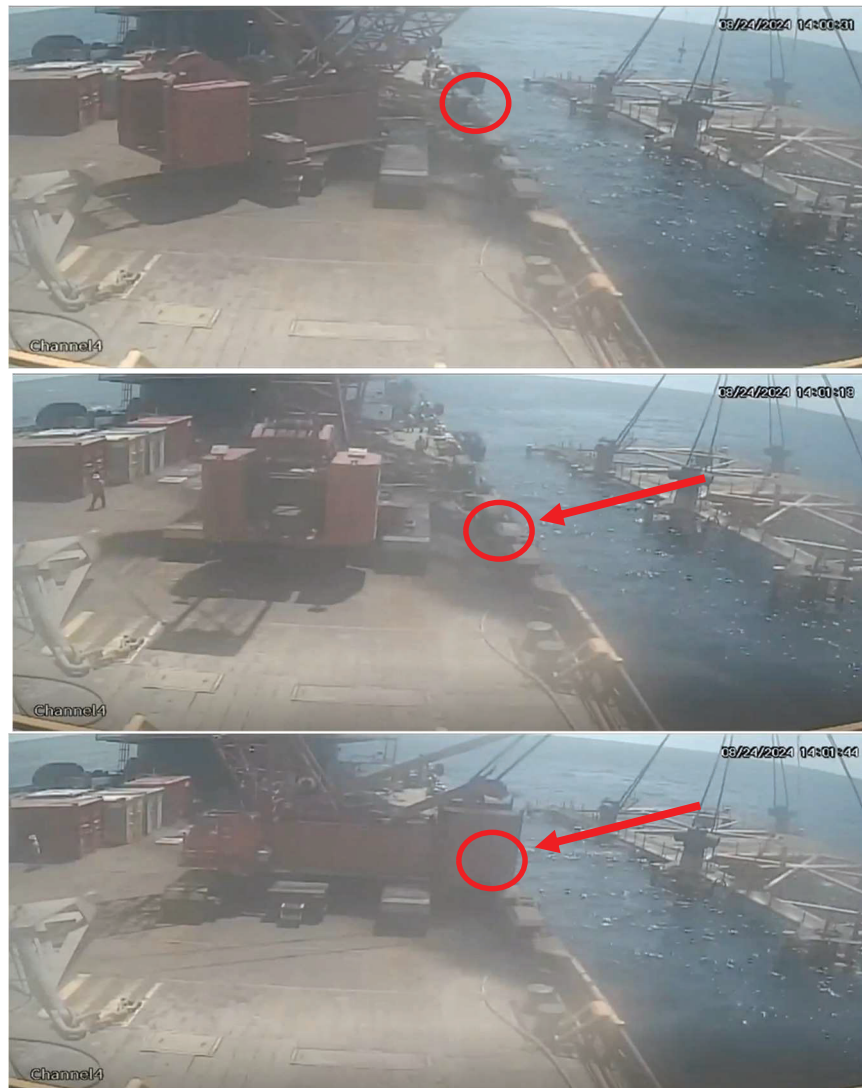
Figure 4. Screenshots of movement of deck crane and Lead Mechanic on 24 August 2024 from EPIC HEDRON surveillance tape.

4.2.6. Video footage confirmed that the Lead Mechanic made eye contact with the Crane Operator before crane operations began and initially moved out of harm's way. The footage then showed the Lead Mechanic re-entering the swing zone then being pinned under the crane's counterweight.
