# UNITED STATES COAST GUARD

## REPORT OF INVESTIGATION INTO THE CIRCUMSTANCES SURROUNDING

### THE SINKING WITH LOSS OF LIFE ABOARD THE VESSEL EXITO (O.N. 273458)

**THE SINKING OF THE COMMERCIAL FISHING VESSEL EXITO (O.N. 273458)  
RESULTING IN THE LOSS OF TWO LIVES WHILE TRANSITING THE AKUTAN  
PASS, 11 NAUTICAL MILES NORTHEAST OF DUTCH HARBOR, ALASKA  
ON DECEMBER 6, 2016**

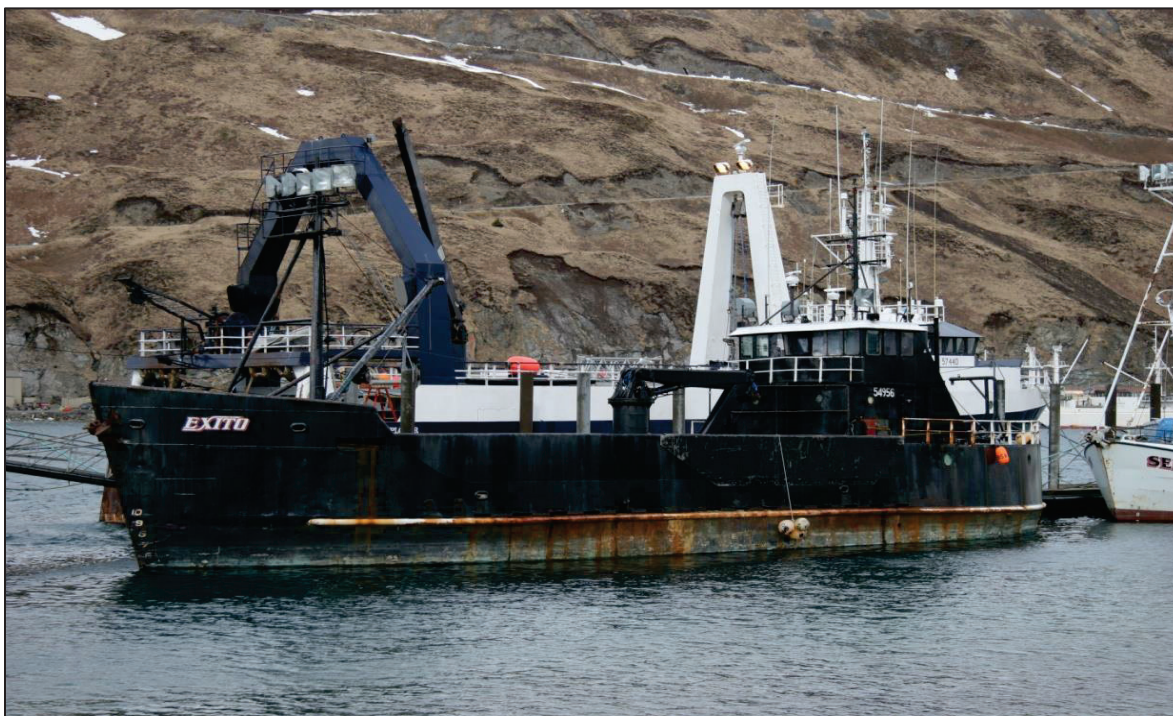
**Figure 2:** *EXITO Port-Side View (note: photo was taken in March of 2006).*

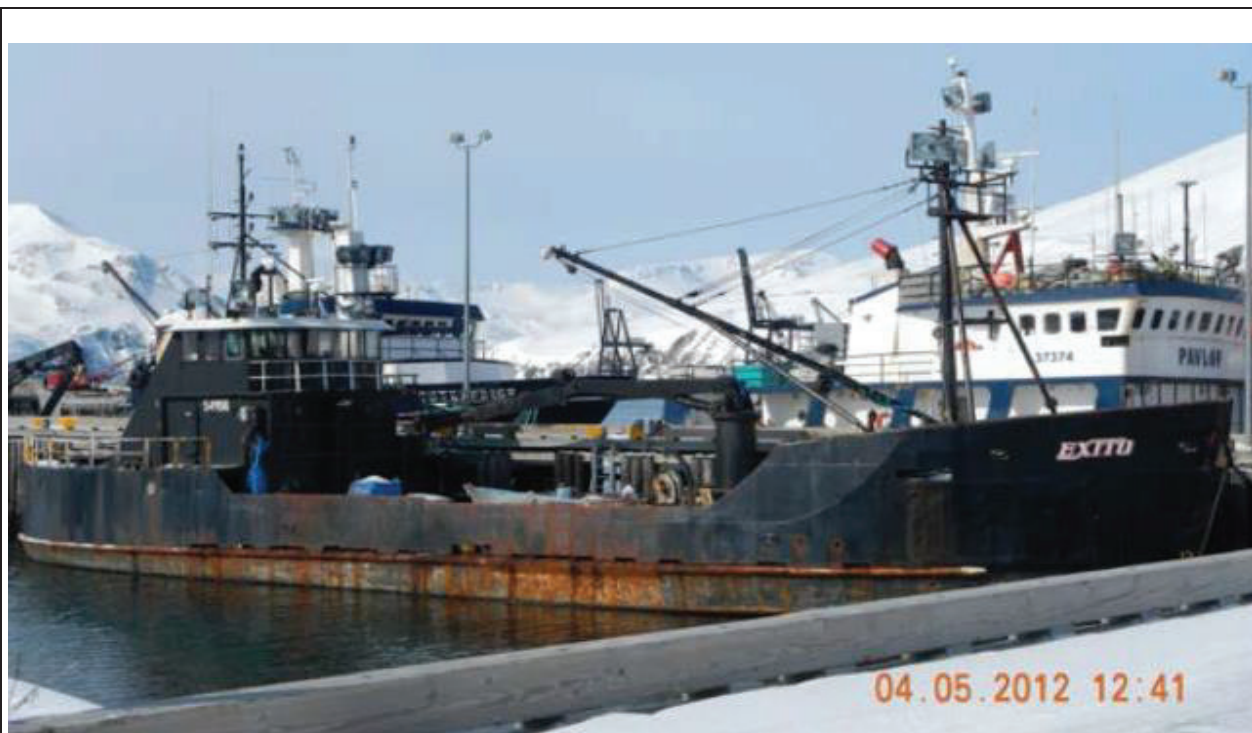
**Figure 3:** *EXITO Starboard-Side View.*

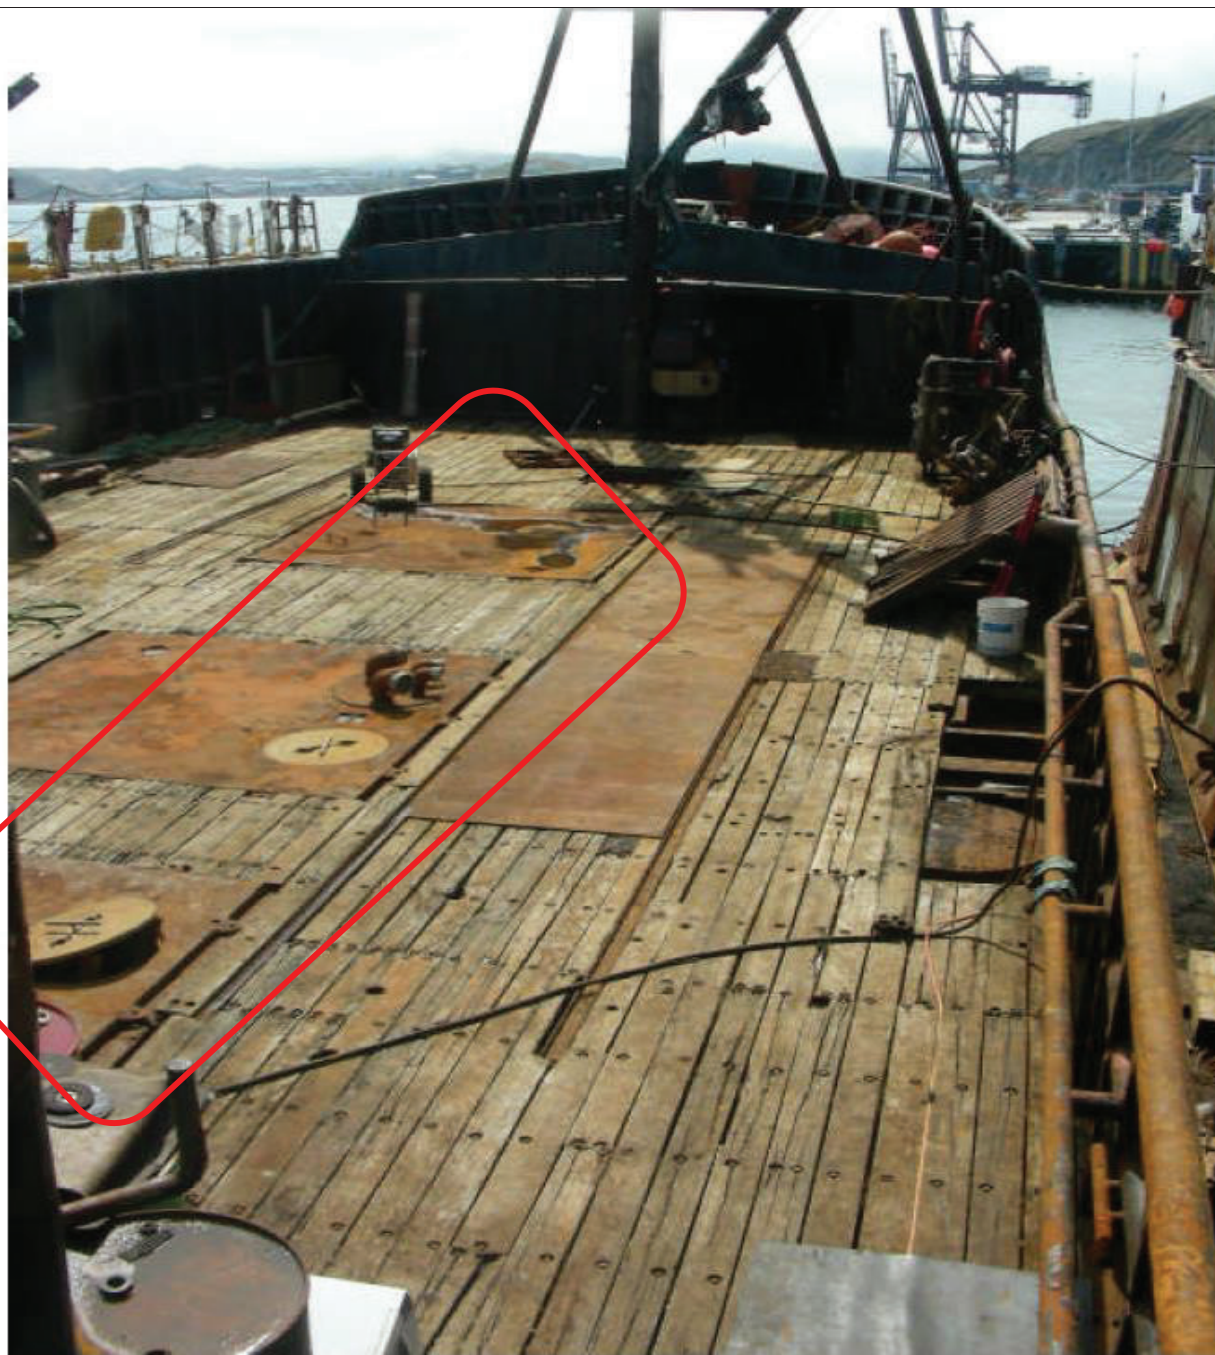
26. The centerline tanks had raised steel coamings and bolt down hatch covers. A wooden decking surface was installed on top of the steel main deck flush with the coamings.

**Figure 4:** *EXITO Main Deck, looking forward, outlining the location of the three center-line tank covers. (note: photo was taken in May or June of 2013, while the vessel was last dry-docked).*

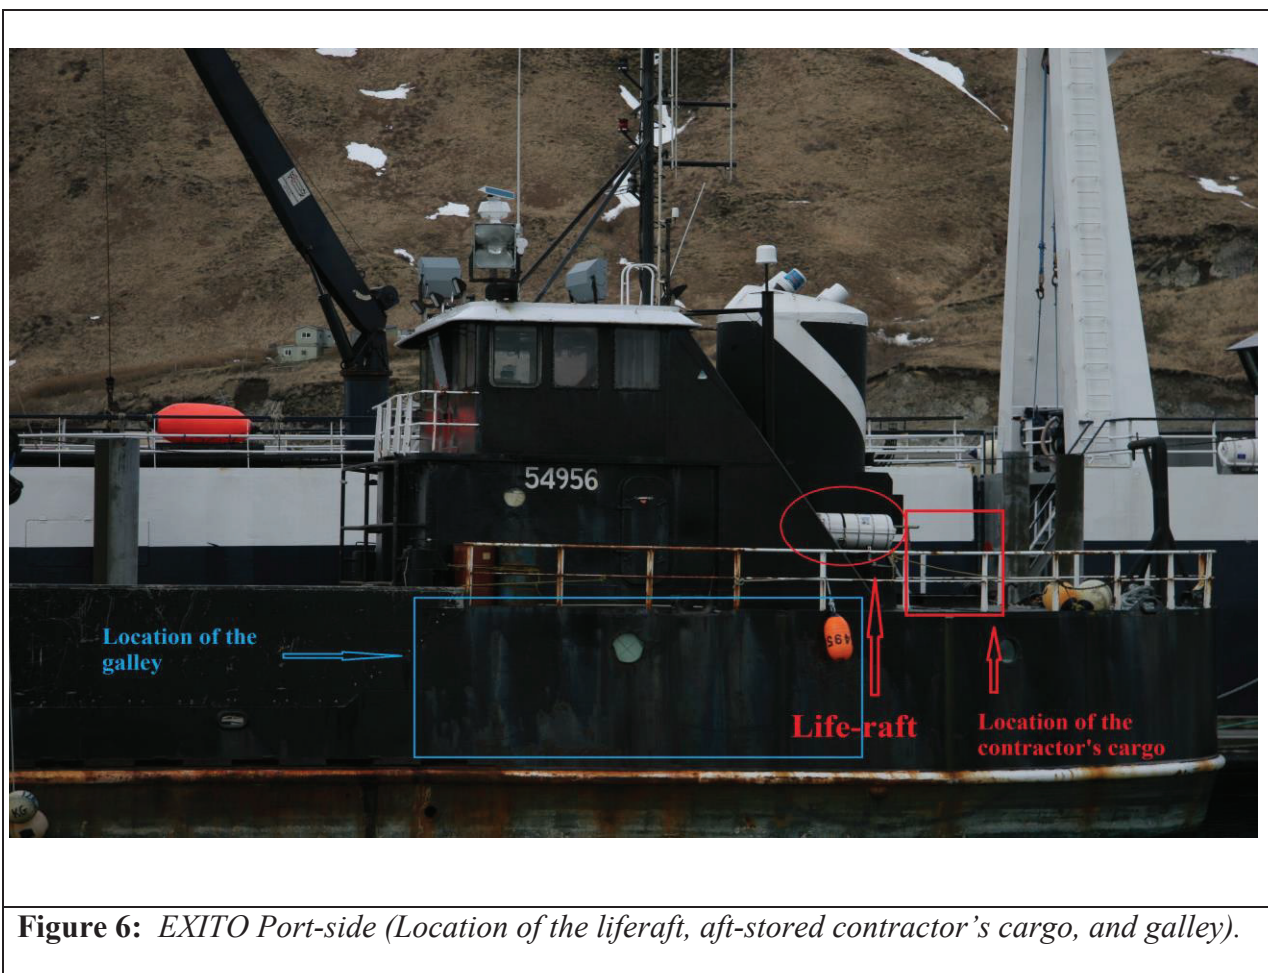
29. The vessel's only liferaft was stowed on the aft port-side of the Deck 2 weather deck.

**Figure 6:** *EXITO Port-side (Location of the liferaft, aft-stored contractor's cargo, and galley).*

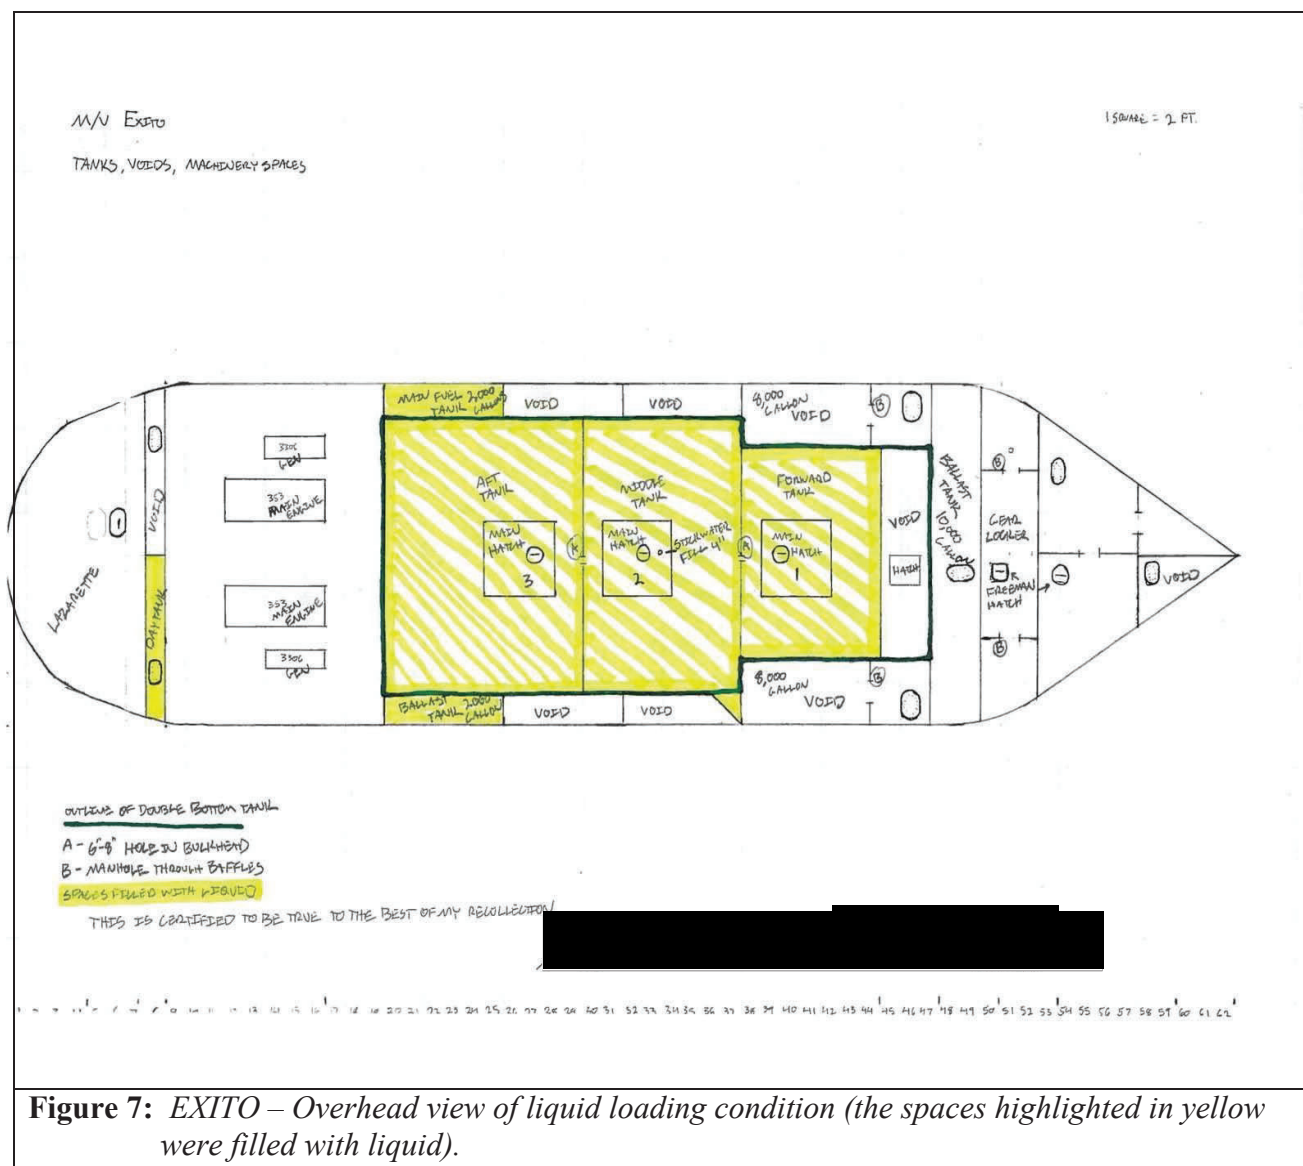
**Figure 7: EXITO – Overhead view of liquid loading condition (the spaces highlighted in yellow were filled with liquid).**

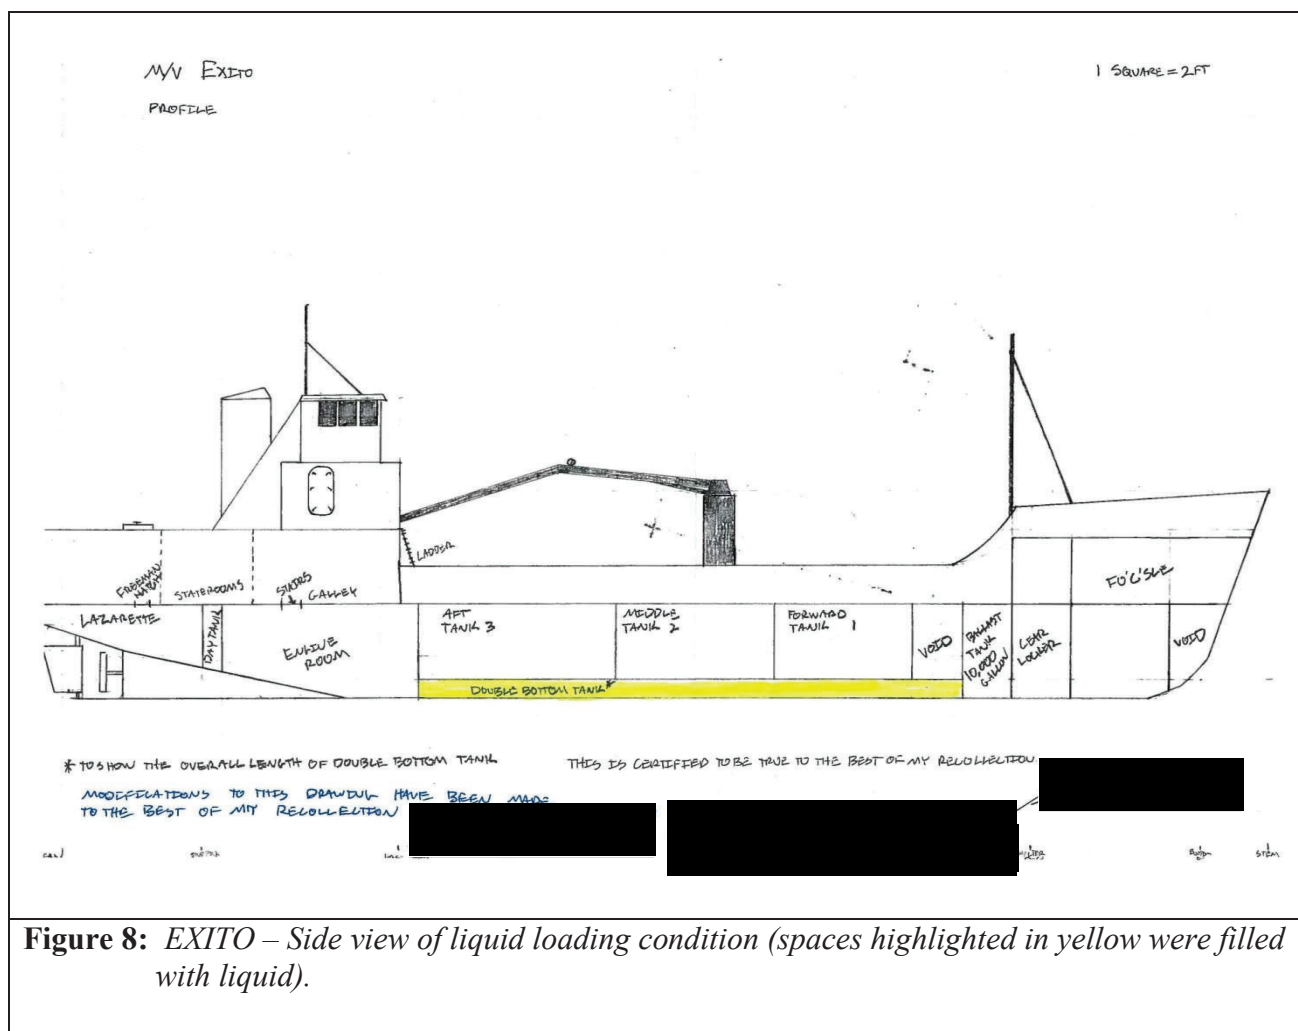
**Figure 8:** EXITO – Side view of liquid loading condition (spaces highlighted in yellow were filled with liquid).

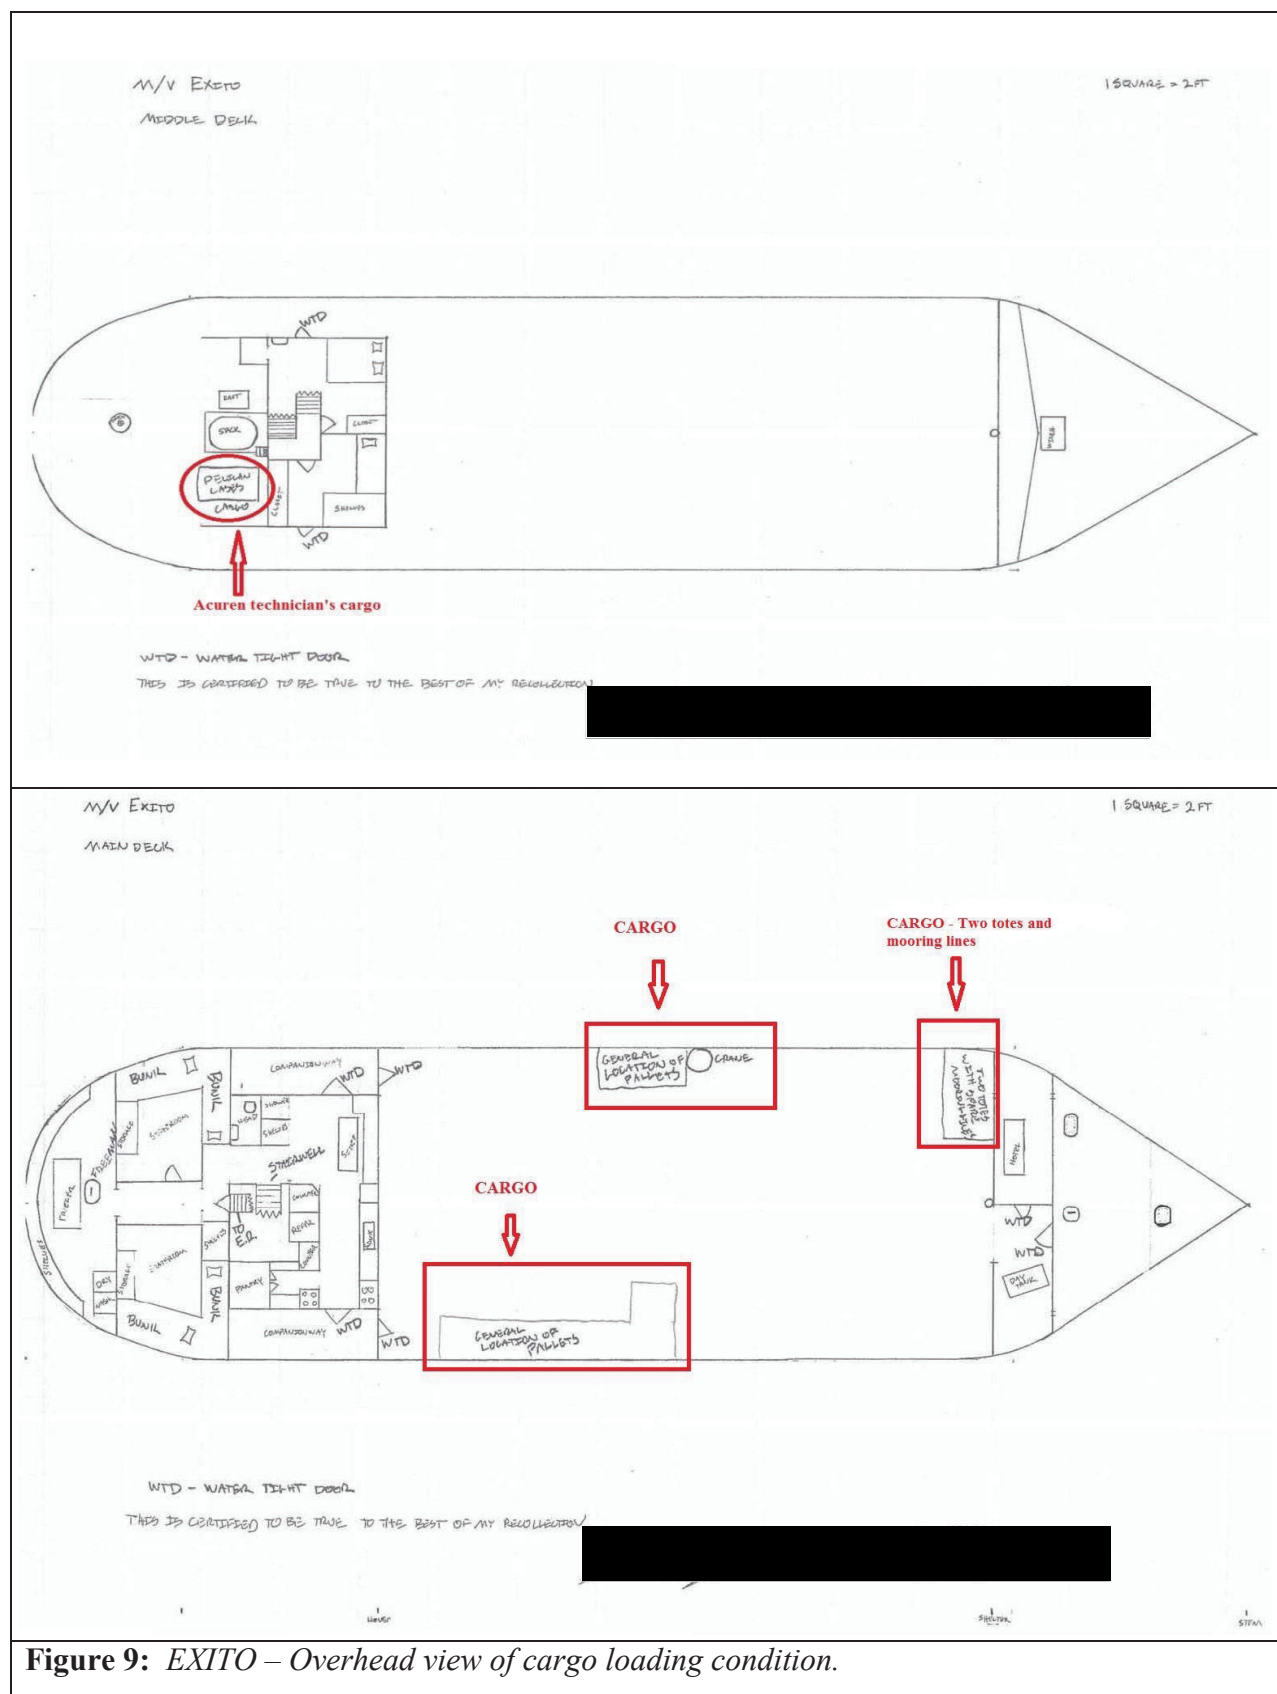
83. On December 6, 2016, the reported overall cargo that was loaded aboard the EXITO was estimated to have weighed from 19,000 lbs to 20,000 lbs, which included (see figure 9):

- 800 lbs to 1000 lbs of Acuren technician's cargo/equipment stowed on the vessel's outside aft starboard-side deck
- Estimated total cargo stowed on the vessel's main deck, in excess of 19,000 lbs, (Trident Seafoods' cargo/equipment)
- Cargo of an undetermined amount stowed mid-ships along the vessel's port-side rail.
- Cargo of an undetermined amount stowed mid-ships along vessel's starboard-side rail & forward along the starboard-side rail

Figure 9: EXITO – Overhead view of cargo loading condition.
