**REPORT OF INVESTIGATION
INTO THE
LOSS OF LIFE ONBOARD THE PONTOON
VESSEL FL 1161 PS WHILE IN THE
CHOCTAWHATCHEE BAY, DESTIN, FL ON
APRIL 21, 2019**

MISLE ACTIVITY NUMBER: 6670600

**LOSS OF LIFE WHILE SNORKELING FROM THE UNINSPECTED PASSENGER
VESSEL FL1161PS IN CHOCTAWHATCHEE BAY NEAR DESTIN, FLORIDA
ON APRIL 21, 2019**

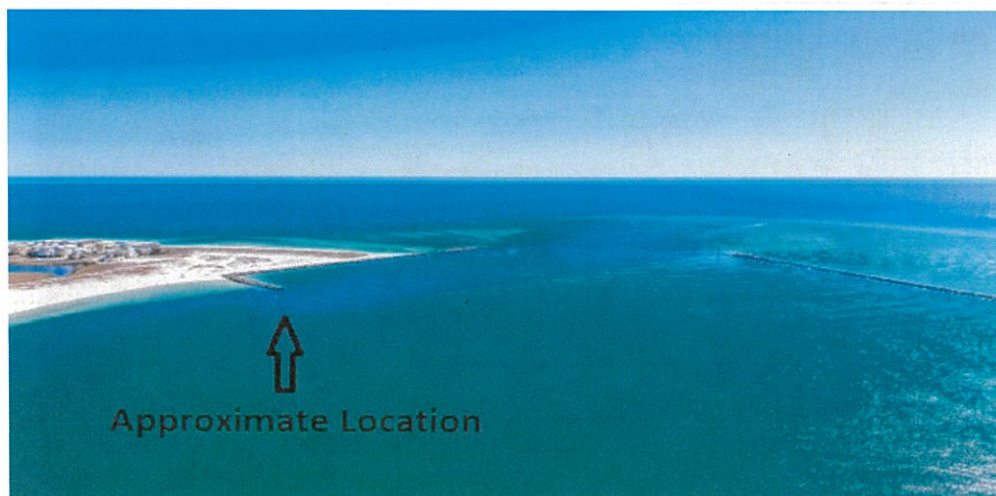
Figure 2. Destin Pass, East Jetty (February 21, 2020/Ocean Reefs Resorts)

5.1. *Unsafe Environmental Conditions.* Destin East Pass, the general location of the incident, has the topographical makeup of an area highly susceptible to rapid changes in tide, and therefore, current. According to involved persons, the passengers entered the water near the Destin East Pass, East Jetty at 1800, a time when the tide was on the latter half of a downward trend. Further, the winds recorded at the time of the incident marked gusts up to 13 mph. Taking into account the apparent tidal currents and wind conditions, it is noted that the environmental conditions, particularly that of the current, were less than favorable. Ultimately, the Master, whom despite not being a properly licensed mariner at the time of the incident but nevertheless maintained 40 years familiarity with the surrounding conditions and the appropriate safety precautions to be met, bared the responsibility of dictating the present conditions as being safe or unsafe for water entry. Had the Master determined said conditions as being unsafe or otherwise too dangerous for swimming, the passengers would have presumably followed the Master's commands to refrain from entering the water. Without water entry, it is likely that no drowning incident would have occurred.
