**REPORT OF THE INVESTIGATION
INTO THE
SCHOONER GRACE BAILEY (085754) DEMASTING
WITH THE LOSS OF ONE LIFE AND FIVE PASSENGER
INJURIES ON PENOBSCOT BAY, ROCKLAND, MAINE,
OCTOBER 9, 2023**

MISLE Activity Number: 7836612

**DISMASTING OF THE SMALL PASSENGER SAILING VESSEL GRACE BAILEY
(O.N. 085754) RESULTING IN THE LOSS OF ONE LIFE ON PENOBSCOT BAY
NEAR ROCKLAND, MAINE ON OCTOBER 9, 2023**

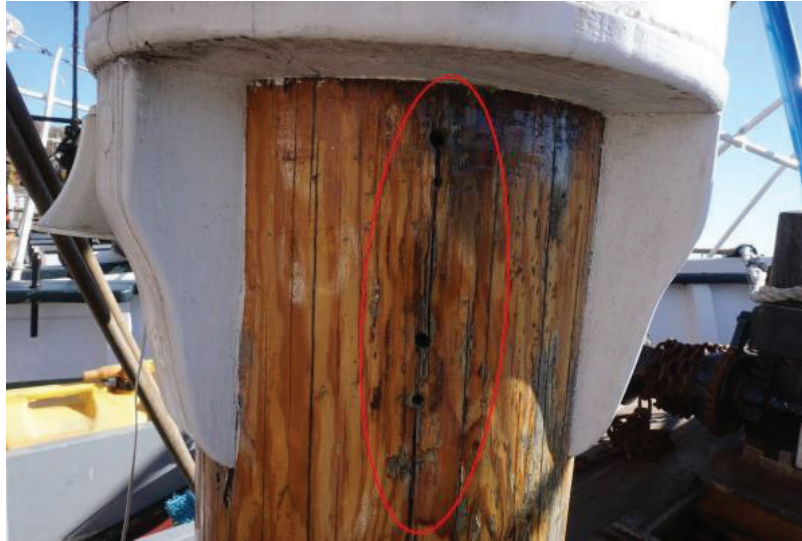
6.2.13.5. On November 23, 2022, GRACE BAILEY Navigation Company contracted a pre-purchase survey through the same local marine surveyor who completed the Insurance Survey on May 5, 2022. During this survey, the surveyor identified a 10 inch by 1 inch area of rot on the starboard side of the foremast under the boom saddle. The surveyor recommended that rot in the foremast be investigated further and repaired, noting the mast would need to be unstepped to facilitate repairs.

Figure 14 - Foremast rot identified during survey, November 23, 2022. (Source: Maine Design report of survey)

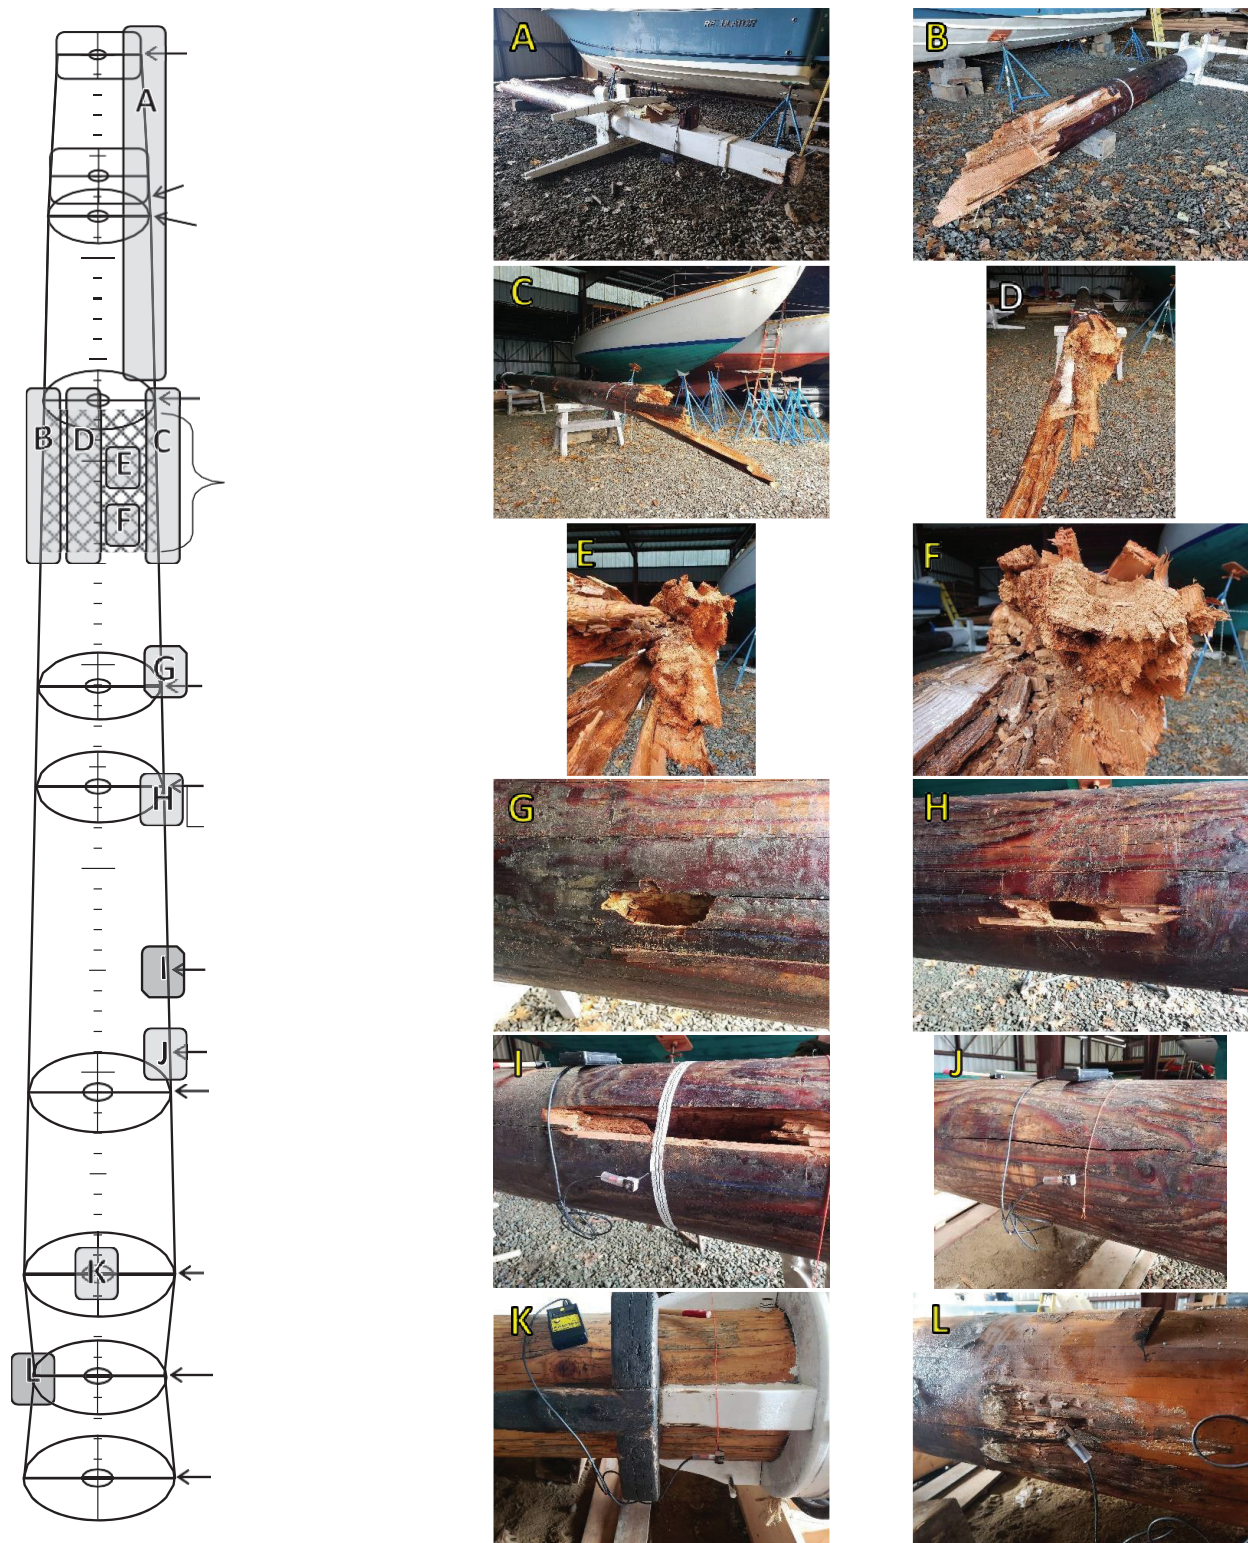
The broken top of the mast is shown in **Figure 1A**. The fracture surface is shown in **Figures 1B** to **1F**. Evidence of fungal decay is present as the white coloration in **Figures 1B, 1D, and 1F**. **Figures 1E and 1F** show regions of brash failure as well as cubical fracturing, both of which are evidence of fungal decay of wood. Extensive internal decay was observed within the inspection holes. **Figures 1G, 1H, and 1I** show inspection holes created prior to the FPL inspection. The holes allowed access to the interior of the mast. Fungal decay, evidence of brash failed wood, and cubical wood remnants was visible in all three locations where the holes were created. **Figure 1J** shows the first evidence of suspect wood at approximately 21-ft from the base of the mast, which is in the middle of the scarf joint from the 2014 scarf repair. **Figure 1K** shows the condition of the mast at deck height. **Figure 1L** shows surface decay.

Figure 1. Documented features observed along the mast length. The diagram of the mast shows the location of each photograph. A) broken top of the mast; B-F) Fracture surface G-I) Examination holes created prior to FPL inspection; J) First observable internal decay from SWTT; K) Mast at deck height; L) Surface rot.

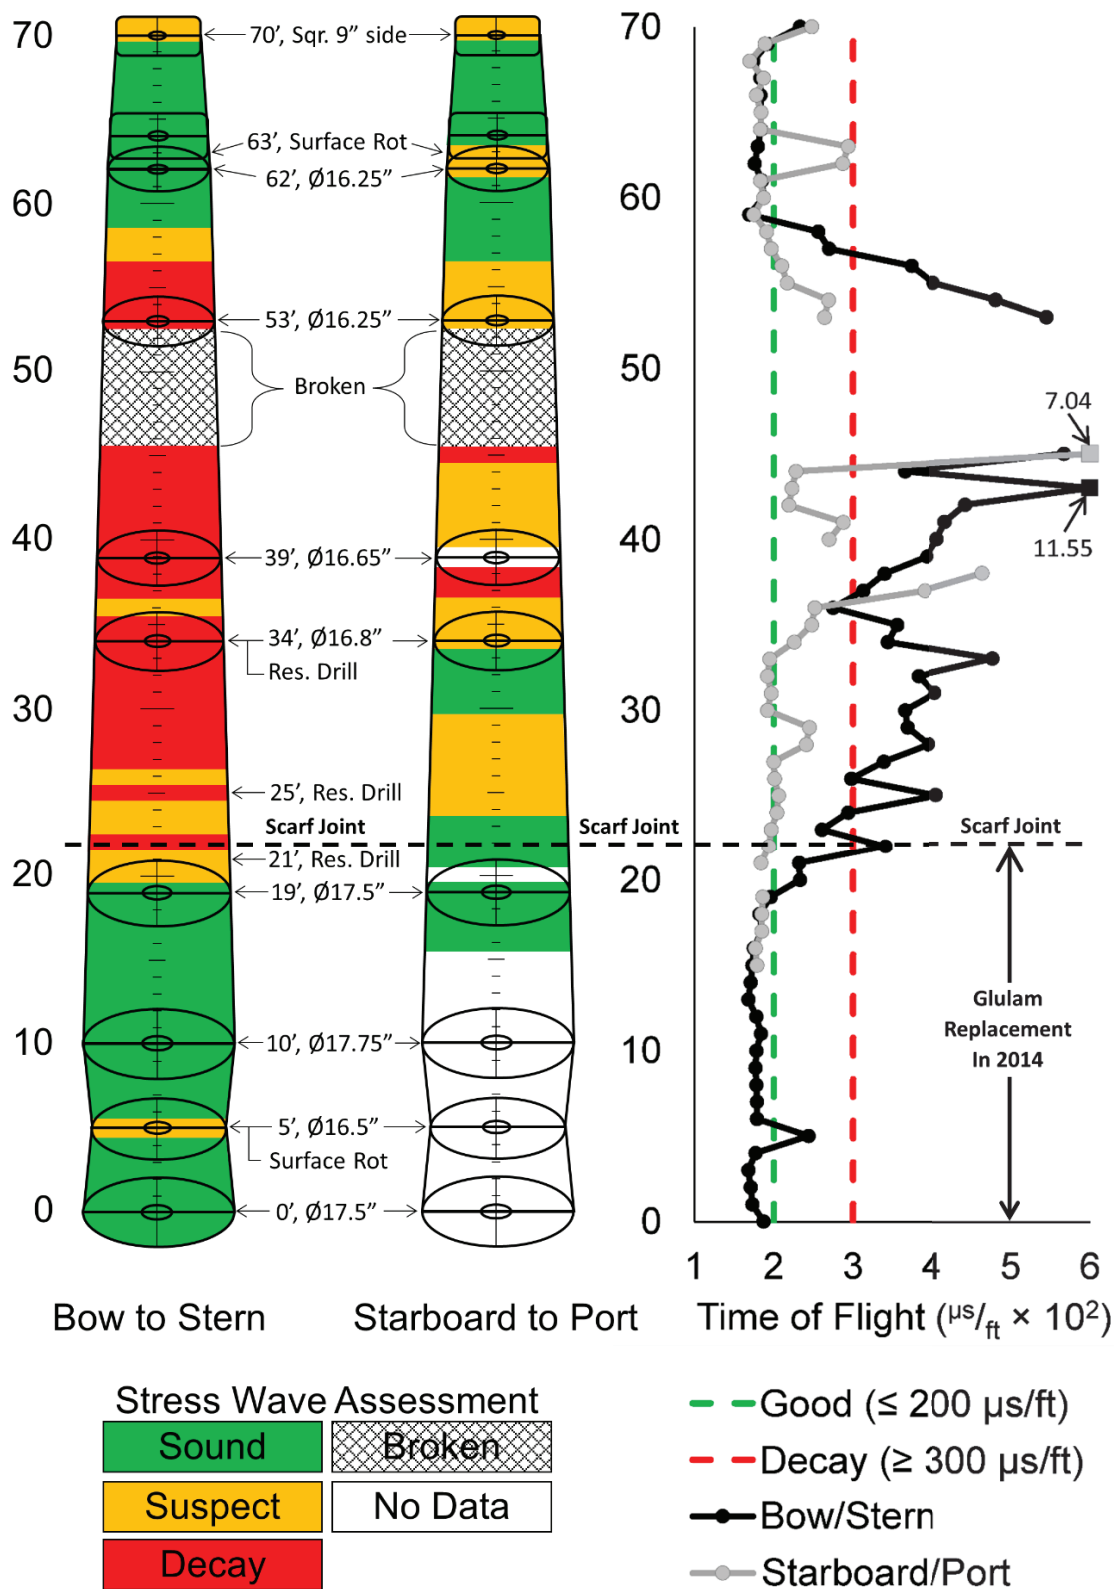
Figure 2. Assessment of mast condition from SWTT. The images on the left show mast condition as indicated by SWTT for the directions of Bow to Stern and Starboard to Port. Time of flight values are given in the chart on the right. Values between 200 and 300 $\mu\text{s}/\text{ft}$ are assumed to be suspect.

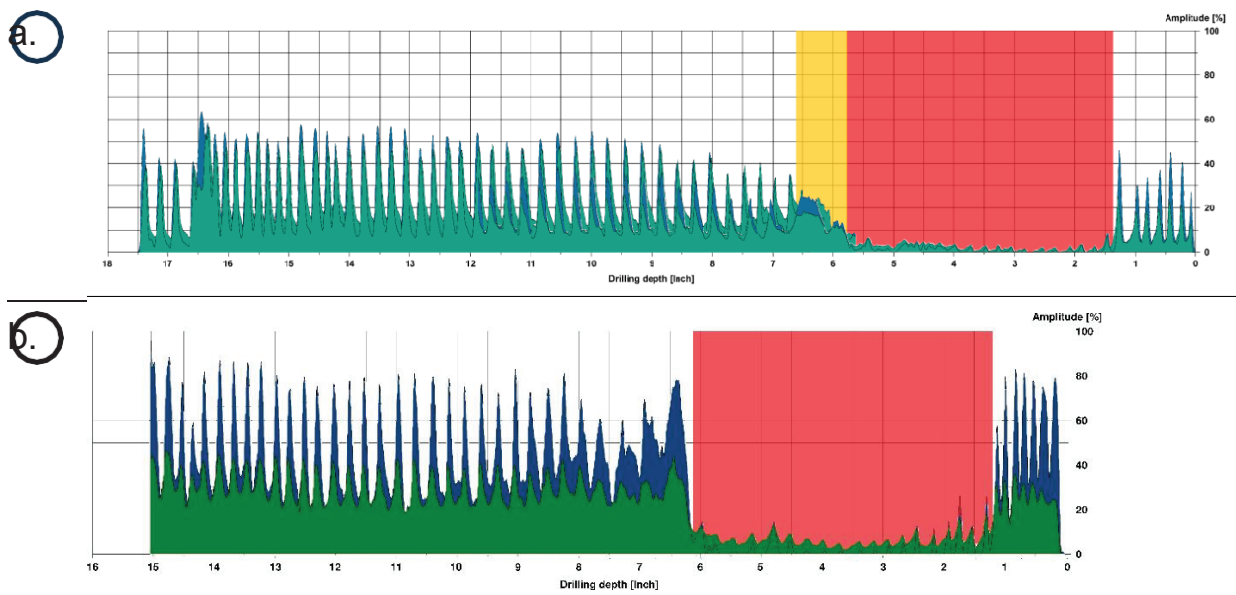
Figure 4. Comparison of Coast Guard and Forest Products Laboratory (FPL) measurements. **A)** Coast Guard measurements at 20-ft height of the mast. **B)** FPL measurements at 21-ft height. Both show decay starting at or above 1.5-in from the front of the mast and extending radially to approximately 6-in.

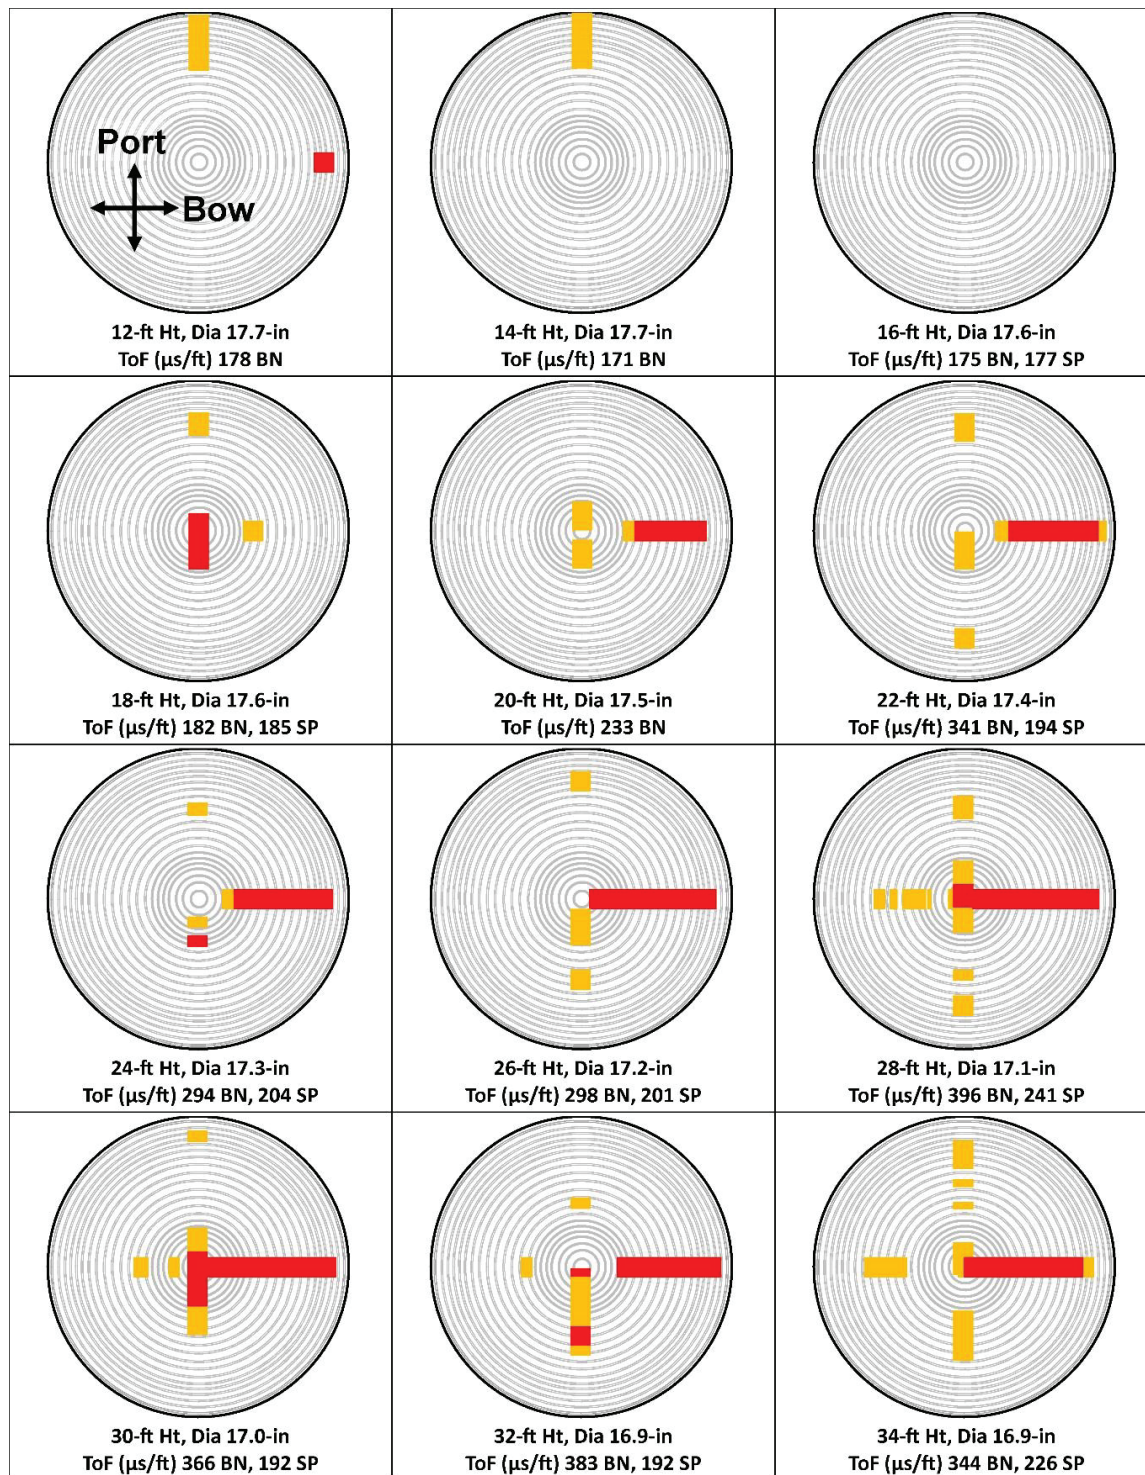
Figure 5a. Resistance drilling results from Coast Guard from 12 to 34-ft mast height. Decayed and suspect wood are indicated by red and yellow shading, respectively. Mast diameter, time of flight (ToF) across the Bow/starN axis (BN) and across the Starboard/Port (SP) axis are given at each height.

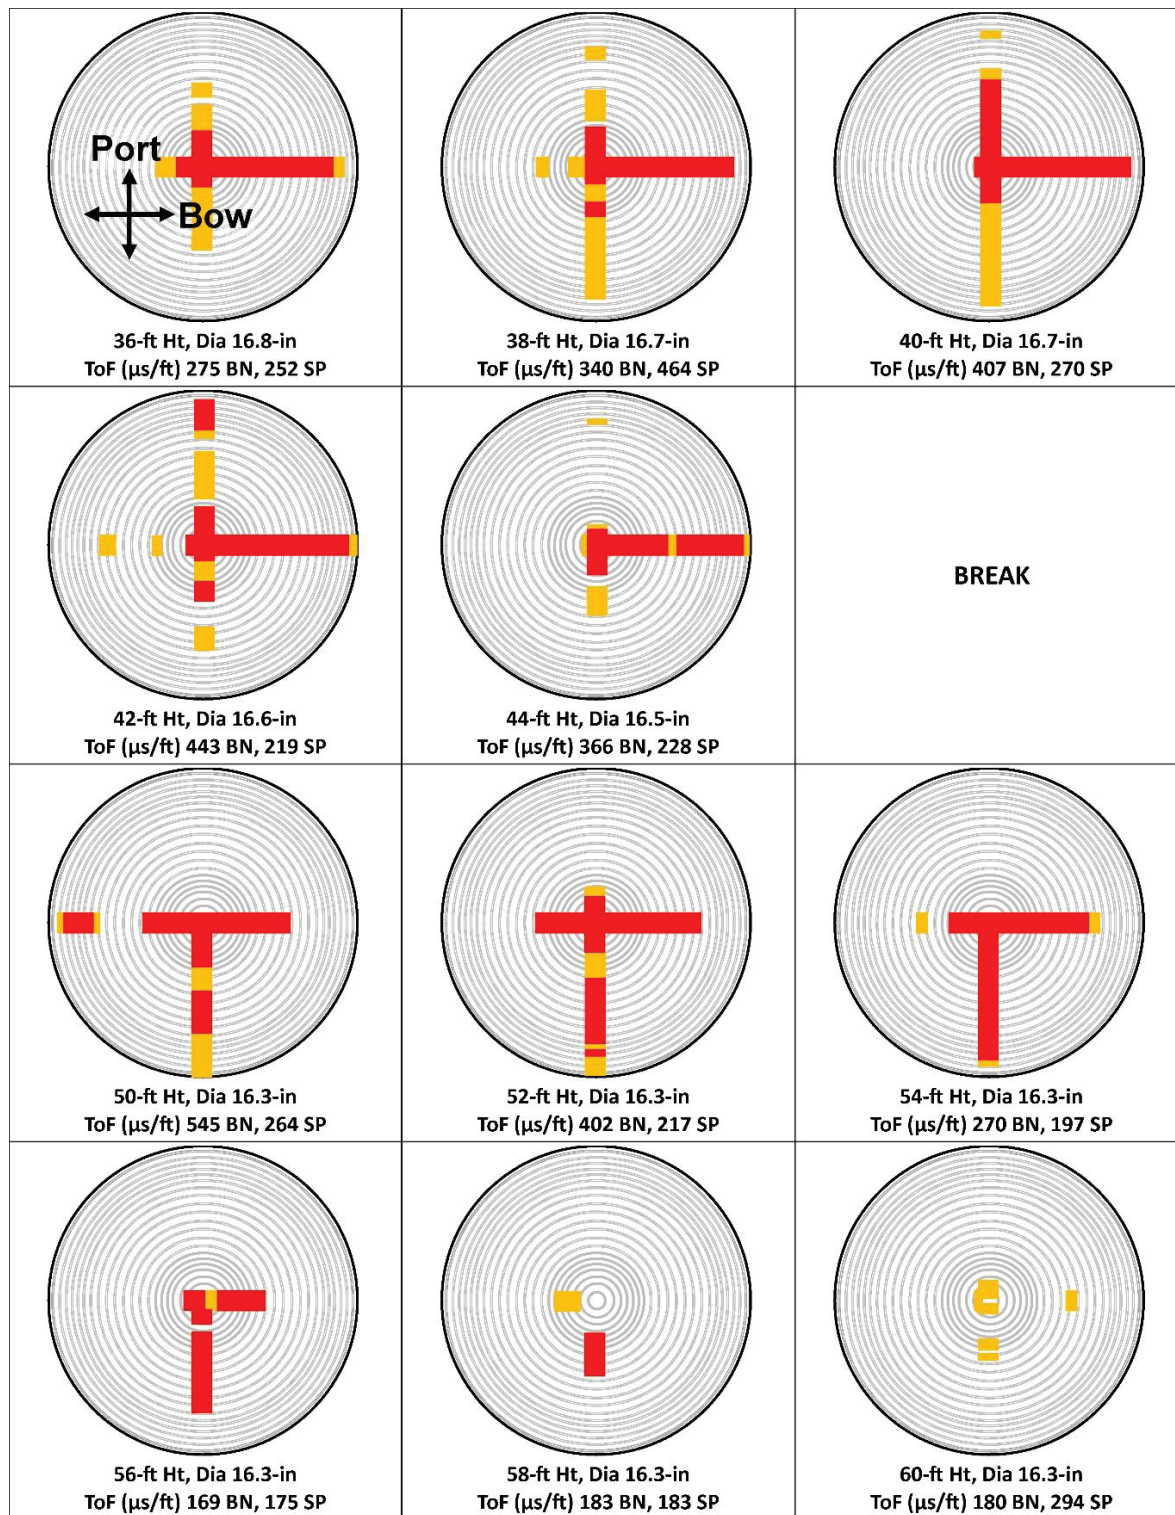
Figure 5b. Resistance drilling results from Coast Guard from 36 to 60-ft mast height. The mast is broken between 44 and 50-ft. Decayed and suspect wood are indicated by red and yellow shading, respectively. Mast diameter, time of flight (ToF) across the Bow/starN axis (BN) and across the Starboard/Port (SP) axis are given at each height.

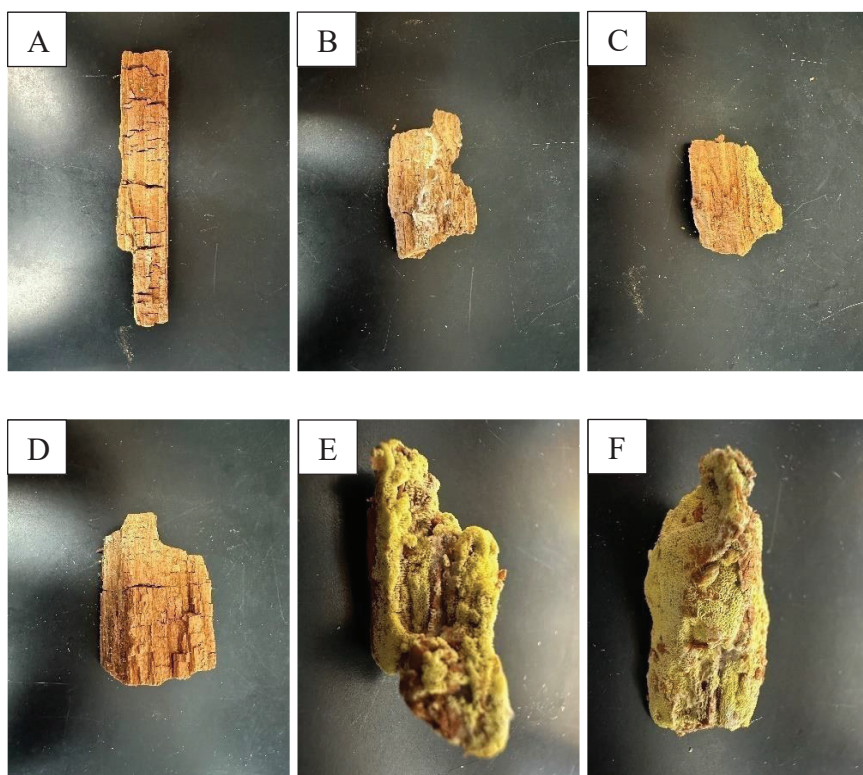
Brown-rot decayed wood was visually observed in the sections of mast brought to FPL. The presence of a yellow, porous fungus was visually seen on samples of decayed mast. Figure 6 details the 6 sections of decayed wood. Each section of Figure 6 is a result of different sections of decayed mast: A corresponds to breaking point 47-48, B corresponds to the upper breaking point, C corresponds to breaking point 36, D corresponds to breaking point 28, E and F corresponds to breaking point 43 and show active fungal mycelia. The initial examination of the unknown polypore, which caused extensive brown-rot decay of the mast, had a citric yellow pore surface containing small pores. From this examination, it was hypothesized that the unknown polypore could be *Auriporia* (encrusted cystidia), *Laetiporus* (no clamps), *Wolfiporia* (no clamps), *Anomoporia* (monomitric with no skeletal hyphae), or *Antrodia*. Further examination showed dimitic, generative hyphae with multiple clamps and unbranching, thick-walled skeletal hyphae. *Auriporia* typically has encrusted cystidia (sterile cells viewed under the microscope) however, none were found from the unknown polypore. It was determined that the unknown polypore belonged to the genus *Antrodia* and likely is either *Antrodia xantha*, synonymous to *Daedalea xantha*, (Fr.) A. Roy & A.B. De or *Antrodia alpina* (Litsch.) Gilb. & Ryvarden. The Ryvarden and Gilbertson key to North American polypores lists the definitive character between the two as number of pores per millimeter, with 2-4 for *Antrodia alpina* and 5-7 for *Antrodia xantha*. The unknown specimen has frequent instances of 5+ pores/mm, and comparing it to herbarium specimens, the larger pores on *Antrodia alpina* herbarium specimens (2 available and examined) are obvious, with frequent instances of 2 pores/mm. In contrast, herbarium specimens of *Antrodia xantha* examined had frequent instance of 5+ pores/mm, the same range as the unknown specimen. With this information, it is highly likely the unknown polypore is *Antrodia xantha*.

Figure 6. Sections of Douglas-fir decayed mast showing brown-rot and yellow fungal mycelia. A) breaking point 47-48; B) upper breaking point; C) breaking point 36; D) breaking point 28; E-F) breaking point 43.

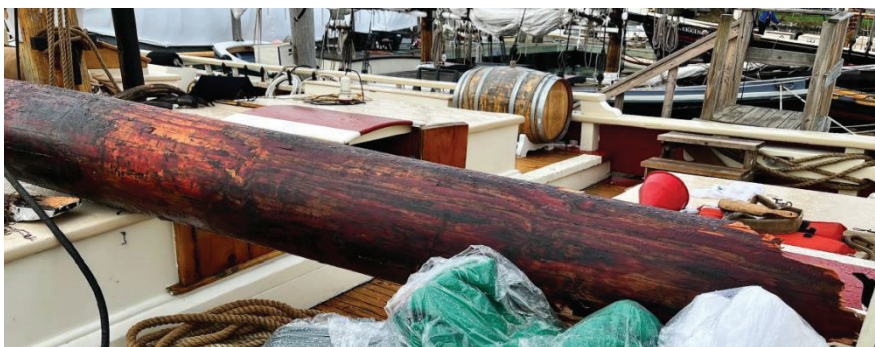
- 1.3. Visual inspection revealed extensive internal rotted conditions at the break point of the mainmast. However, the initial evaluation did not reveal any external signs of deterioration that would have prompted an enhanced evaluation had the inspection been part of an annual Coast Guard

Figure 1 – Grace Bailey mainmast, October 19, 2023

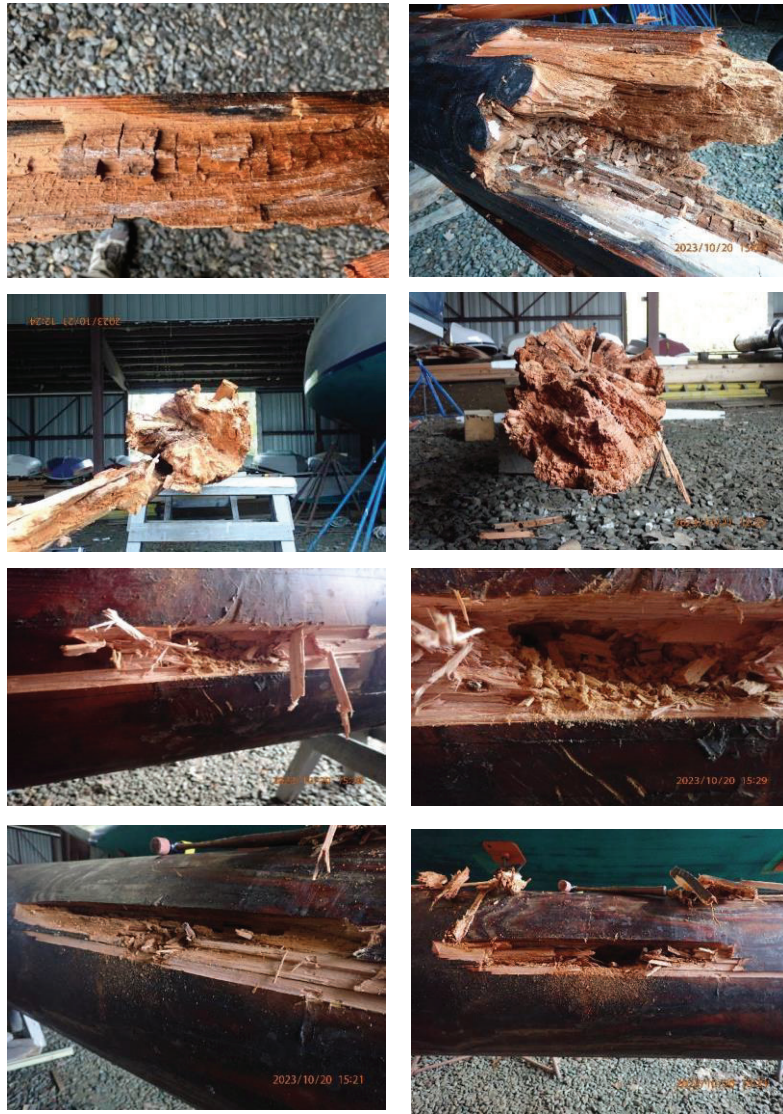
Figure 5 – Photos depicting brown rot decay at the breakpoint and various locations along lower portion of the broken mainmast.

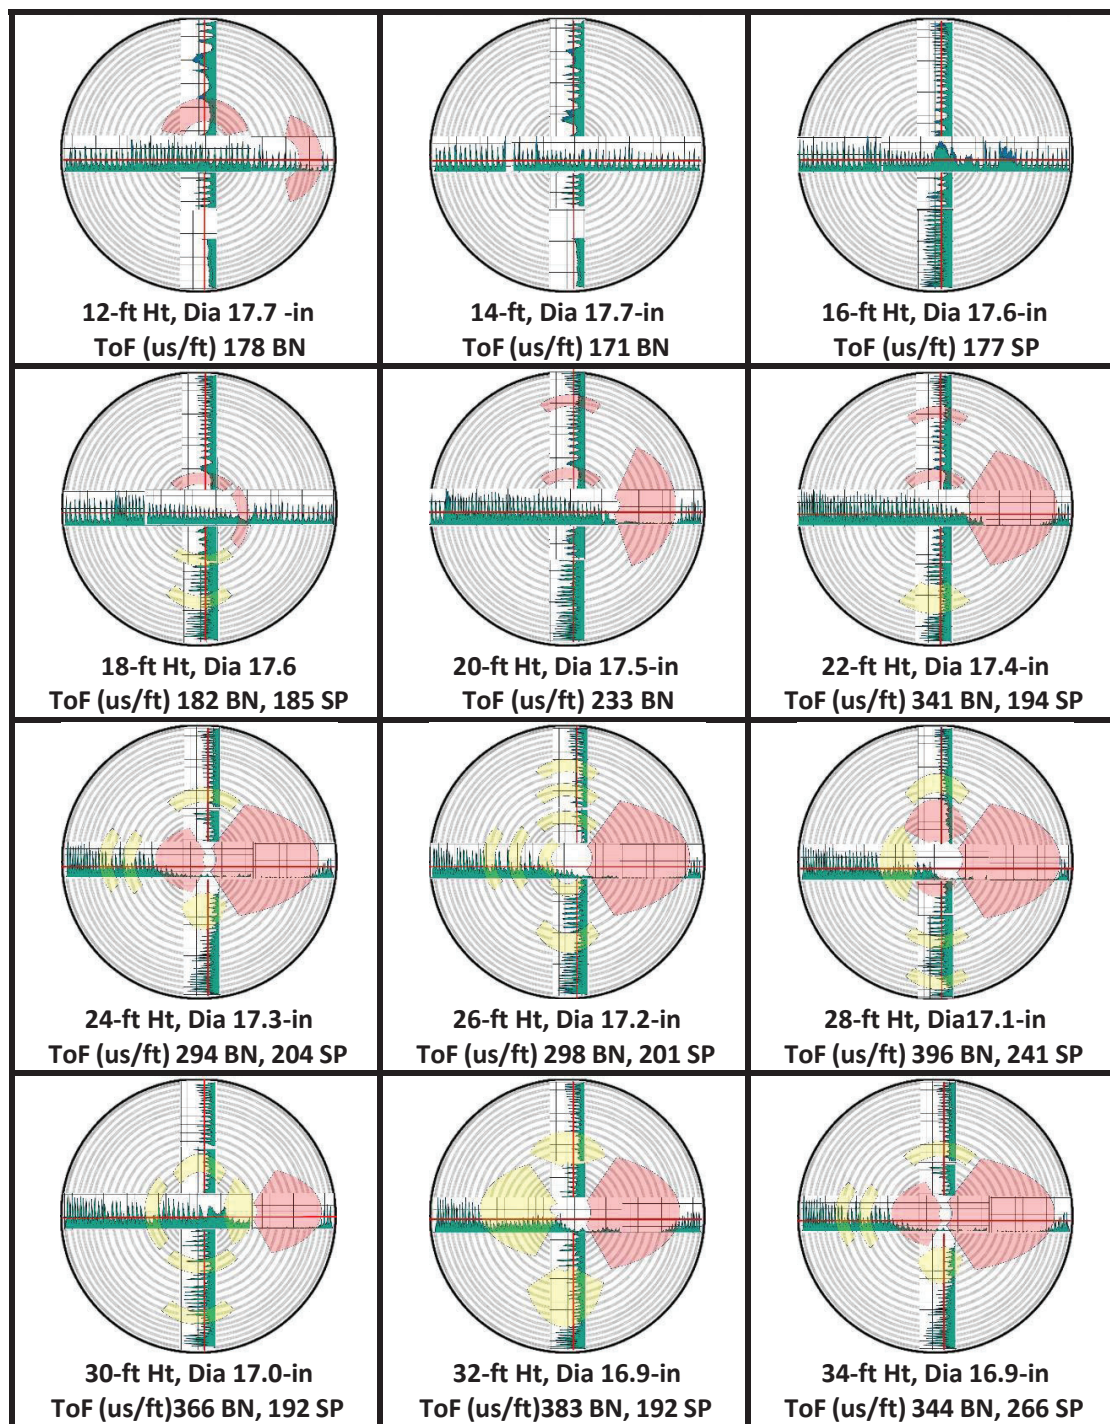
Figure 7 – Resistance drilling results from 12 to 34 ft mast height. Decayed and suspect wood are indicated by red and yellow shading respectively. Mast diameter, time of flight (ToF) across the bow/stern axis (BN) and across starboard/port axis (SP) are given at each height.

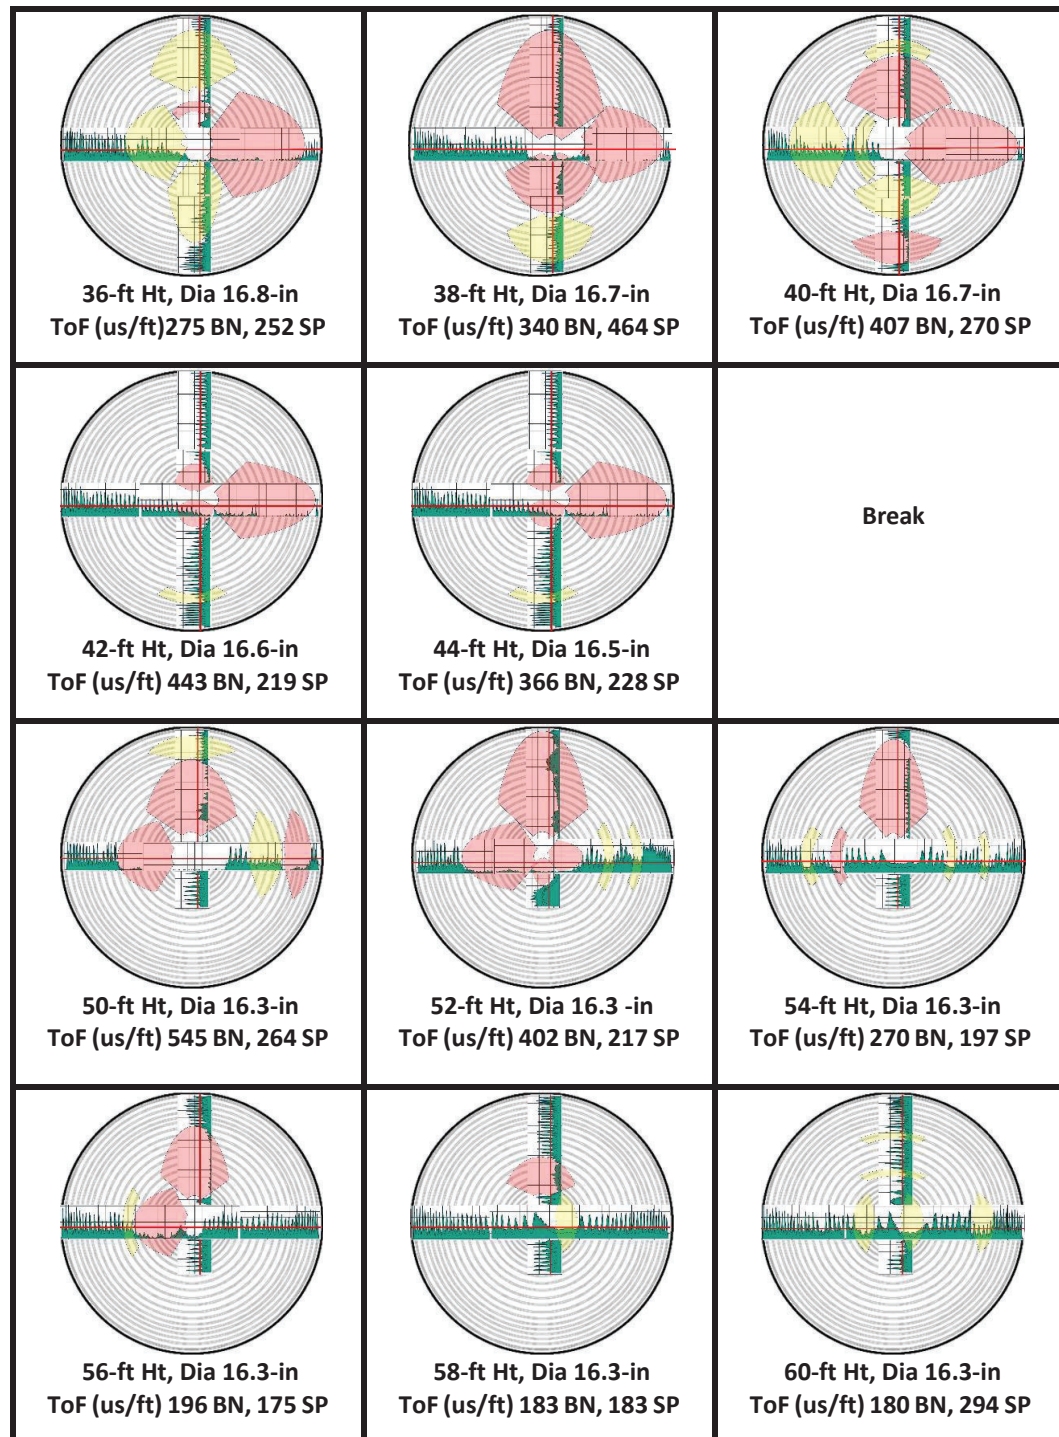
- 1.16. ToF values indicated severe decay, throughout the length of the mast. Severe decay was identified between 26 ft and 56 ft above the mast base in the bow to stern axis. Suspect wood was found along the bow to stern axis from 20 to 26 ft and 56 to 58 ft above the mast base. Along the starboard to port axis, suspect wood was found from 24 to 56 ft with decay at 37 to 38 ft, and severe decay at 45 ft.

Figure 8 - Resistance drilling results from 36 to 60 ft mast height. Decayed and suspect wood are indicated by red and yellow shading respectively. Mast diameter, time of flight (ToF) across the bow/stern axis (BN) and across starboard/port axis (SP) are given at each height.

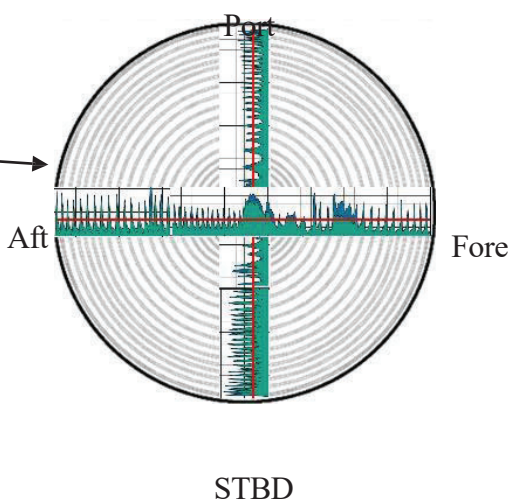
Figure 11 – Idealized cross section showing resistance drill results at 16 feet above the base, no indication of decay or suspect material found.

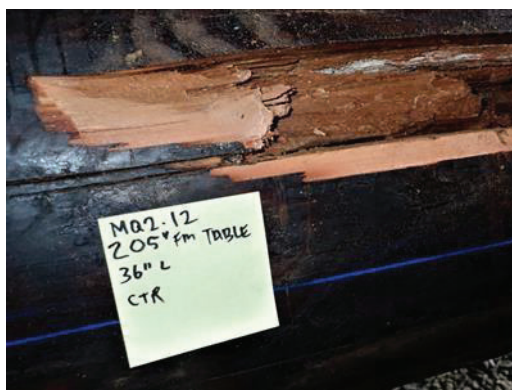
Figure 20 – Check Number 2.12 (36" length). Soft wood apparent with probing. Probe was able to penetrate to the center without resistance.

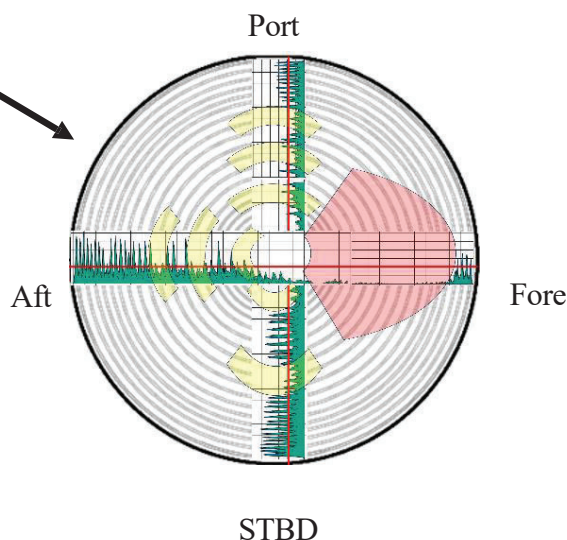
Figure 22 – Idealized cross section showing resistance drill results at 28 feet above the base. Severe decay found along fore/aft axis beginning ~1" inside fore external surface and extending to pith. Small pockets of suspect wood on both axes.

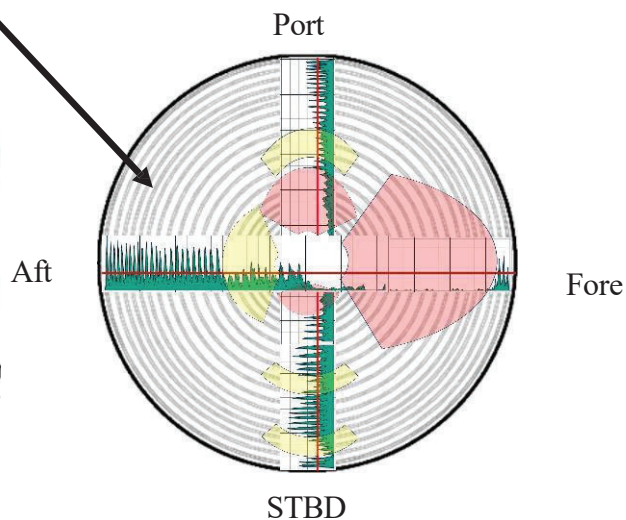
Figure 25 – Idealized cross section showing resistance drill results at 30 feet above the base. Severe decay found along fore/aft axis beginning ~1" inside fore external surface and extending to pith. Small pockets of suspect wood and decay found on both axes.

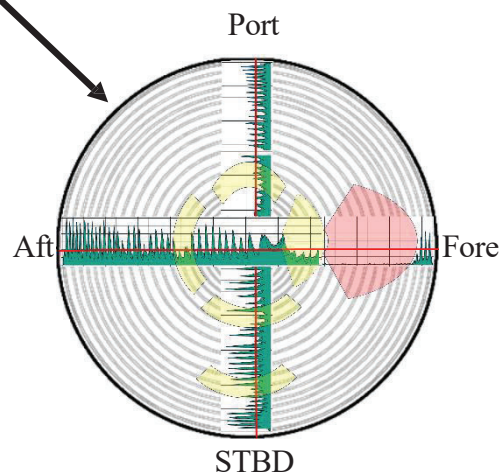
Figure 27 – Idealized cross section showing resistance drill results at 32 feet above the base. Severe decay found along fore/aft axis beginning ~1" inside fore external surface and extending to pith. Small pockets of suspect wood and decay found on both axes.

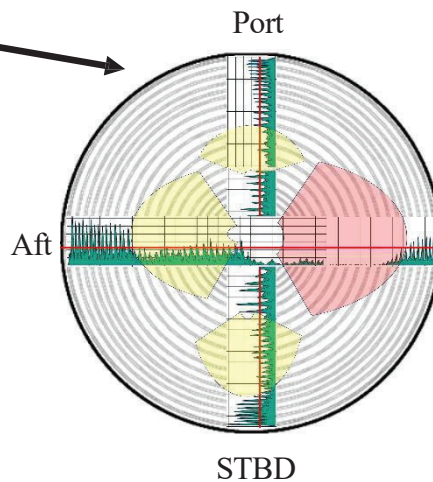
Figure 30 – Idealized cross section showing resistance drill results at 34 feet above the base. Severe decay found along fore/aft axis beginning ~2" inside fore external surface and extending to pith. Pockets of suspect wood and decay found on both axes.

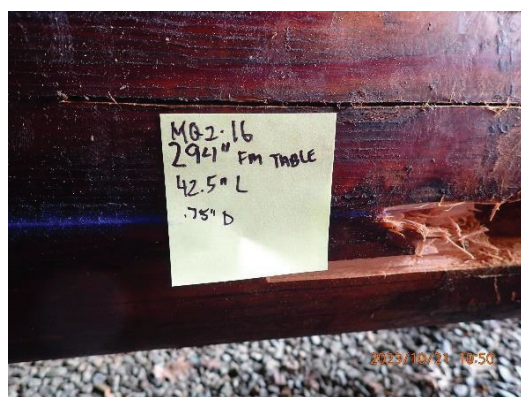
Figure 31 – Check Number 2.16 (42 ½" length x ¾" depth). Probing revealed soft wood.

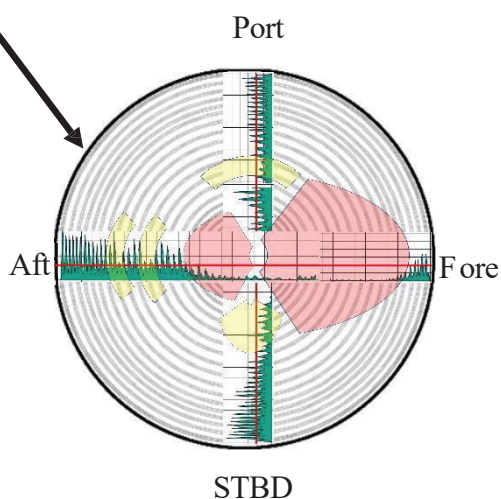
Figure 33 – Idealized cross section showing resistance drill results at 36 feet above the base. Severe decay found along fore/aft axis beginning ~2" inside fore external surface and extending to pith. Small pockets of suspect wood and decay found on both axes.

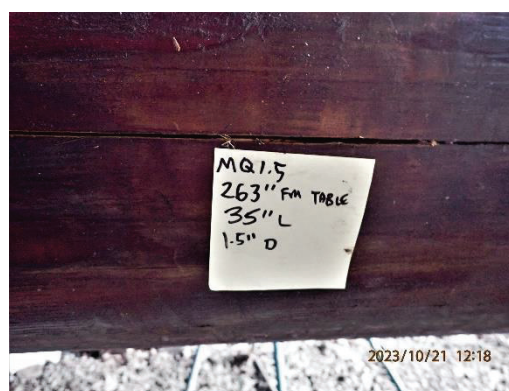
Figure 34 – Check Number 1.5 (35" length x 1 ½" depth). Probing revealed soft wood.

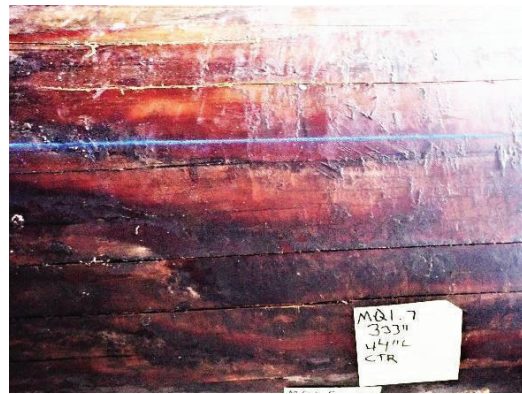
Figure 36 – Check Number 1.7 (44" length). Probing revealed soft wood, penetrating into the center without resistance.

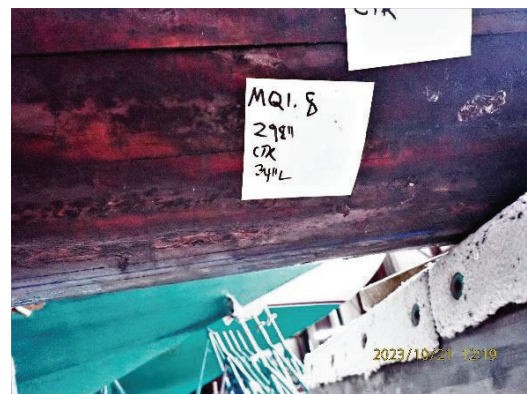
Figure 38 – Check Number 1.8 (44" length). Probing revealed soft wood, penetrating into the center without resistance.

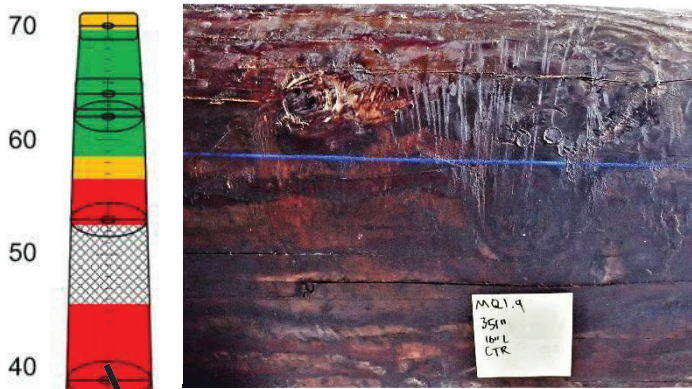
Figure 39 – Check Number 1.9 (35" length). Probing revealed soft wood, penetrating into the center without resistance.

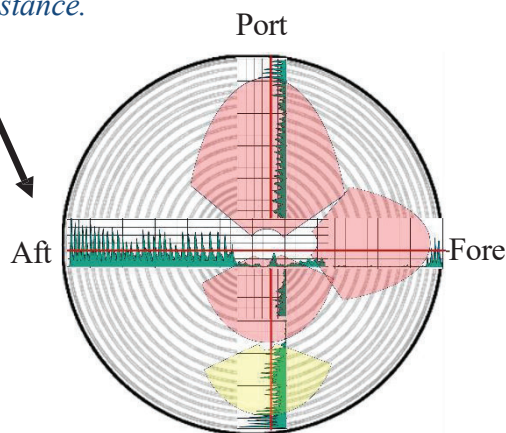
Figure 41 – Idealized cross section showing resistance drill results at 40 feet above the base. Severe decay found along fore/aft axis beginning ~1" inside fore and port external surface and ~4" inside the starboard external surface.

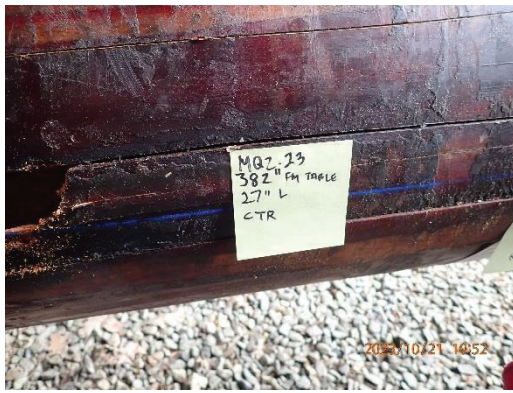
Figure 43 – Check Number 2.23 (27" length). Probing revealed soft wood, penetrating into the center without resistance.

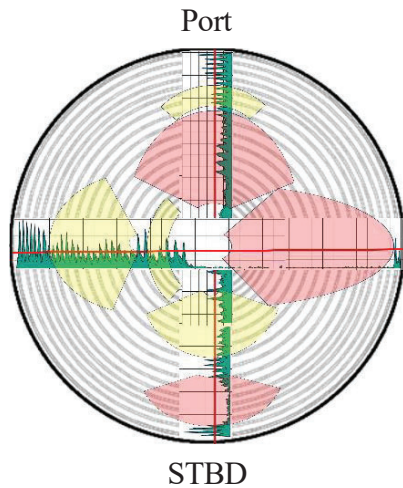
Figure 45 – Idealized cross section showing resistance drill results at 42 feet above the base. Severe decay found along both axes beginning ~1" inside fore and starboard external surface and ~3" inside the port external surface.

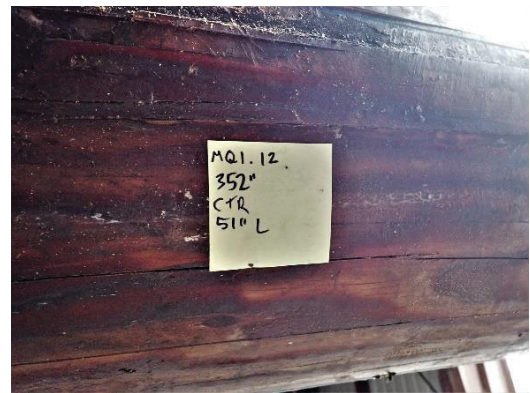
Figure 44 – Check Number 1.12 (51" length). Probing revealed soft wood, penetrating into the center without resistance.

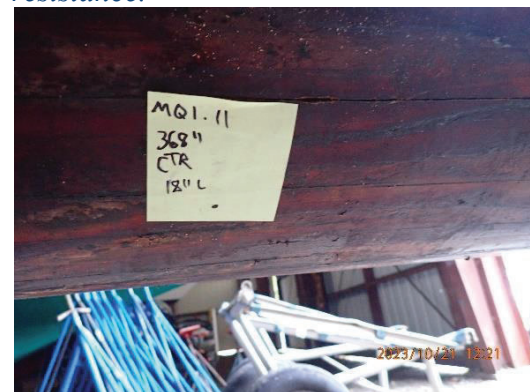
Figure 46 – Check Number 1.11 (18" length). Probing revealed soft wood, penetrating into the center without resistance.

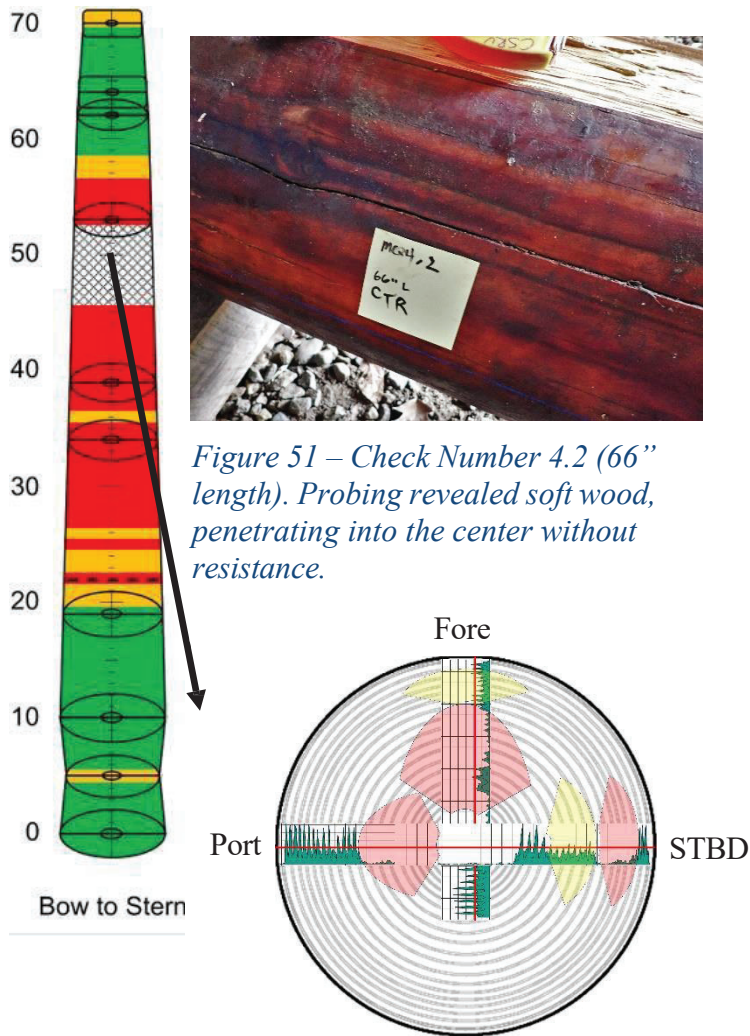
Figure 51 – Check Number 4.2 (66" length). Probing revealed soft wood, penetrating into the center without resistance.

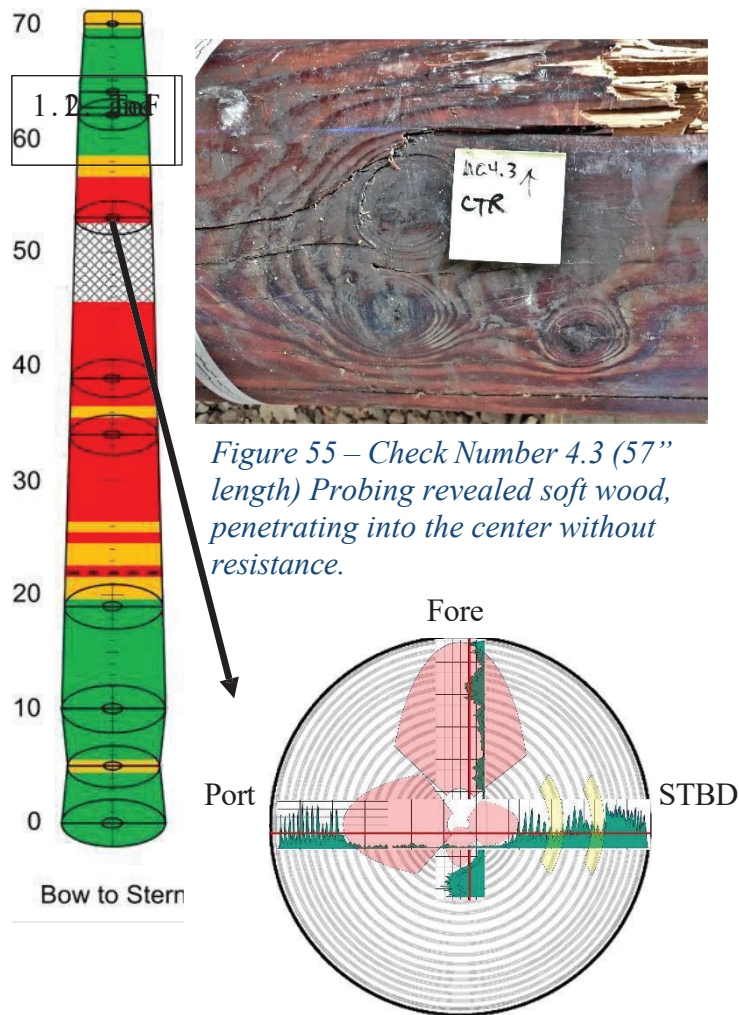
Figure 57 – Idealized cross section showing resistance drill results at 52 feet above the base. Severe decay found along both axes beginning ~1" inside fore external surface and ~3" inside the port external surface.

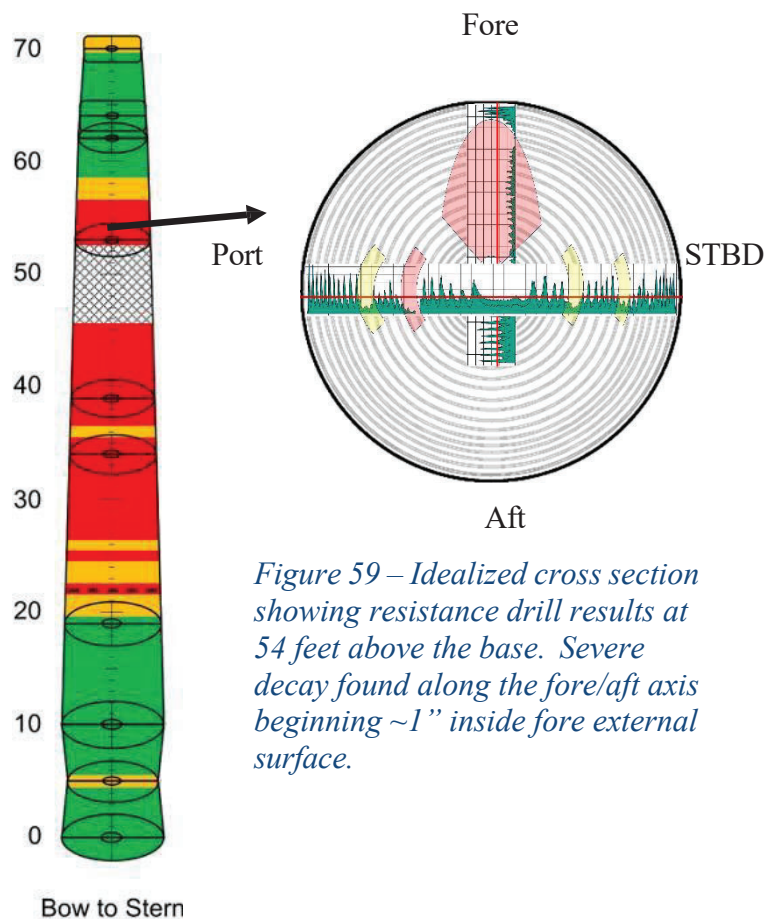
Figure 59 – Idealized cross section showing resistance drill results at 54 feet above the base. Severe decay found along the fore/aft axis beginning ~1" inside fore external surface.

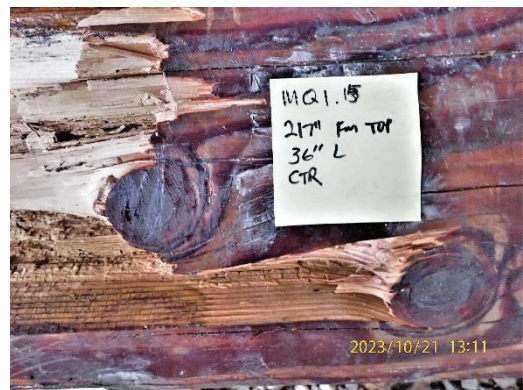
Figure 60 – Check Number 1.15 (36" length). Probing revealed soft wood, penetrating into the center without resistance.

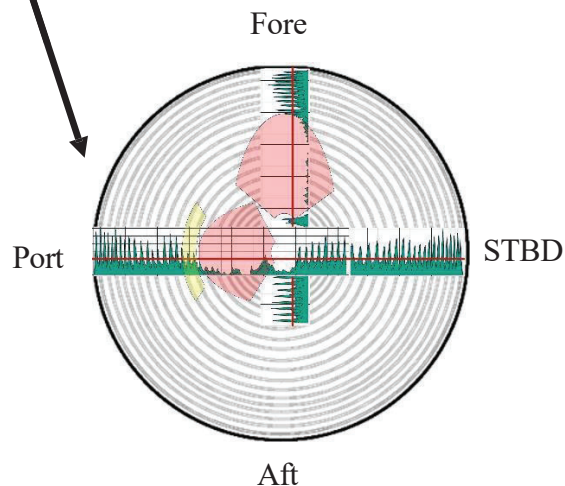
Figure 63 – Idealized cross section showing resistance drill results at 56 feet above the base. Severe decay found along both axes beginning ~2" inside fore external surface and ~6" inside the port external surface.
