**REPORT OF THE INVESTIGATION
INTO THE
SCHOONER GRACE BAILEY (085754) DEMASTING
WITH THE LOSS OF ONE LIFE AND FIVE PASSENGER
INJURIES ON PENOBSCOT BAY, ROCKLAND, MAINE,
OCTOBER 9, 2023**

MISLE Activity Number: 7836612

**DISMASTING OF THE SMALL PASSENGER SAILING VESSEL GRACE BAILEY
(O.N. 085754) RESULTING IN THE LOSS OF ONE LIFE ON PENOBSCOT BAY
NEAR ROCKLAND, MAINE ON OCTOBER 9, 2023**

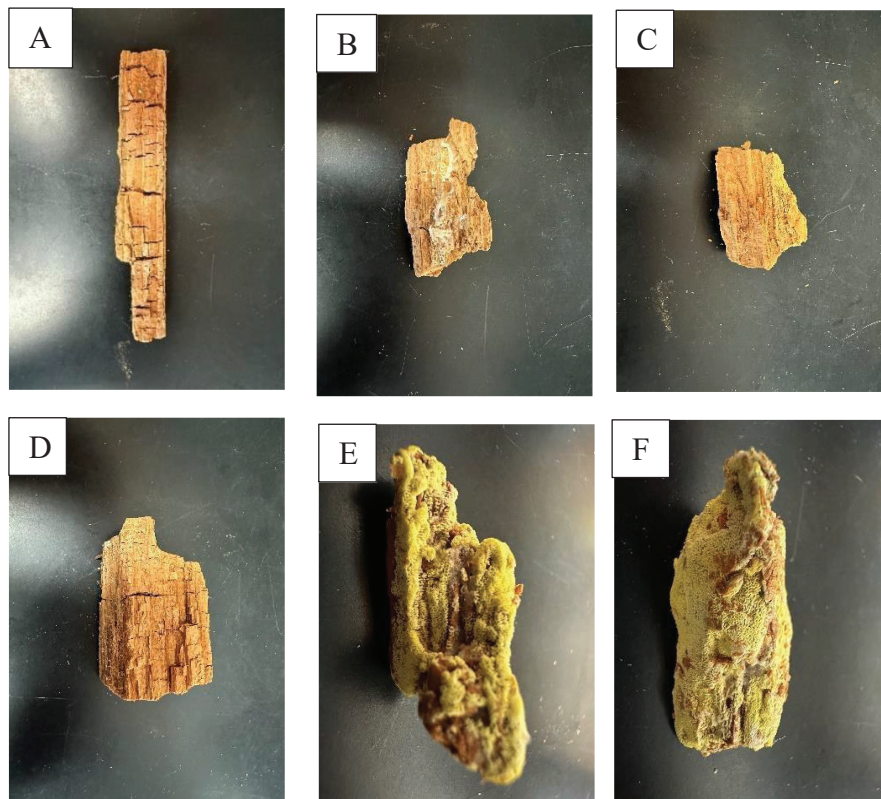
Figure 64 – Sections of decayed mast showing brown-rot and yellow fungal mycelia. A) breaking point 47-48 ft; B) upper breaking point; C) breaking point 36 ft; D) breaking point 28 ft; E-F) breaking point 43 ft.

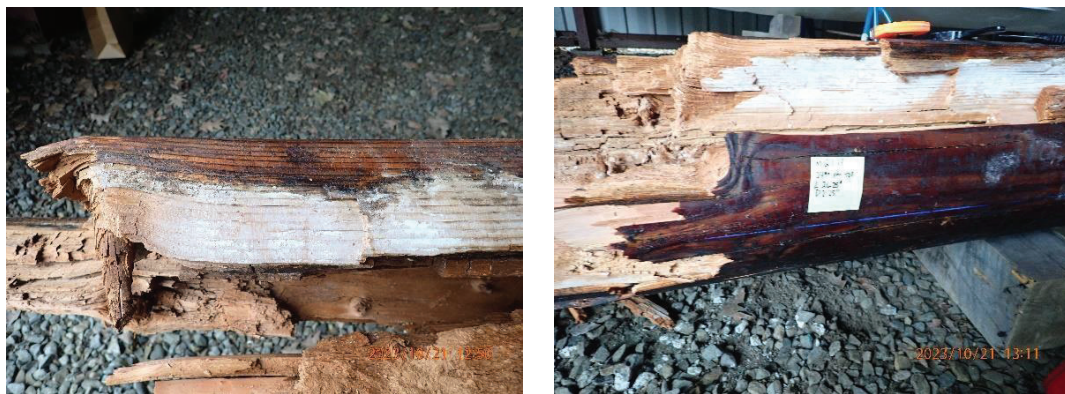
Figure 65 – White mycelial matting observed along check surfaces
