**REPORT OF INVESTIGATION  
INTO THE  
LOSS OF LIFE WHILE DIVING FROM THE  
SMALL PASSENGER VESSEL H2O BELOW  
(O.N. 1 136903), AT THE USS ORISKANY  
WRECK DIVE SITE 24 NM SOUTHEAST OF  
PENSACOLA, FL ON JUNE 1, 2020**

MISLE ACTIVITY NUMBER: 6966090

**INVESTIGATING OFFICER'S REPORT**

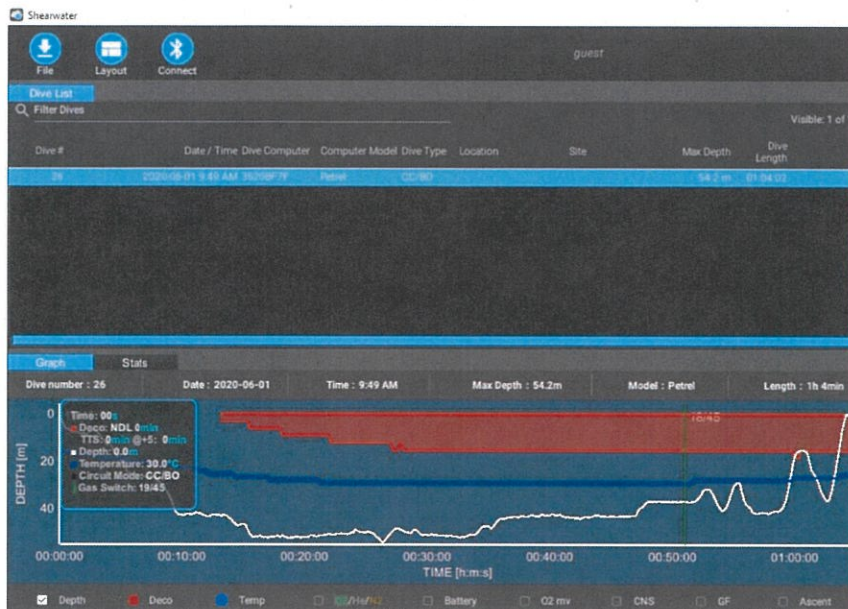
4.1.14. At 1145, Passengers 1 and 2 made a rapid ascent to approximately 59.05ft, a rapid descent to approximately 124.67ft, and a rapid ascent to the surface, bypassing the decompression stop at 15 meters required by their dive computers.

Figure 3: Passenger 2's USS ORISKANY dive retrieved from his personal dive computer.  
Source: Sector Mobile IO

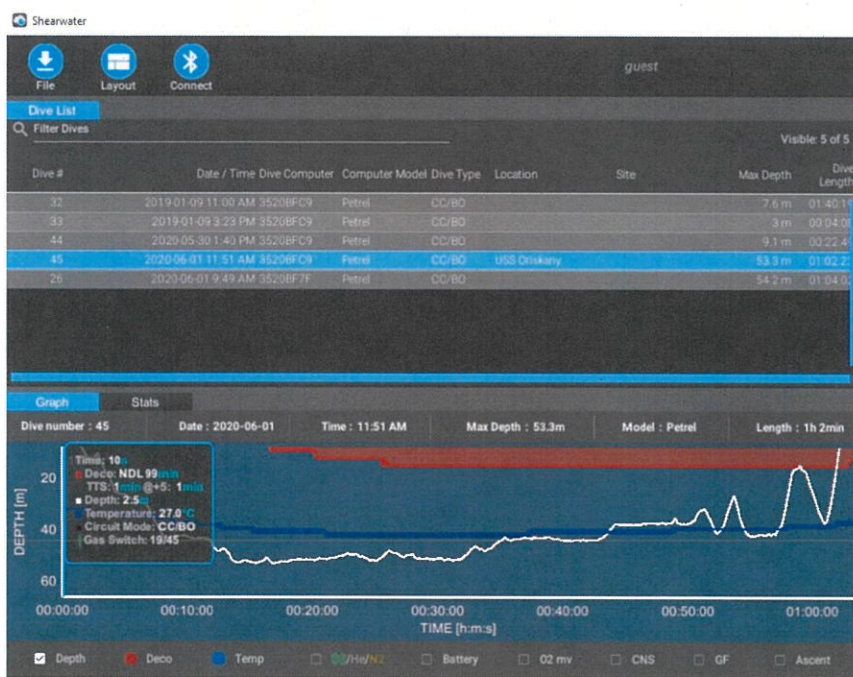
Figure 4: Passenger 1's USS Oriskany Dive retrieved from his personal dive computer.  
Source: Sector Mobile IO

5.1. *Failure to Adhere with Recommended Dive Computer Decompression stops.* According to passenger 1's recorded dive history, he did not complete his dive computers recommended decompression stop at approximately 15 meters prior to surfacing. Passenger 1 conducted a dive lasting 1 hour and 2 minutes that included rapid changes in depth. Passenger 2, who conducted the same dive profile, surfaced exhibiting symptoms of decompression sickness and was subsequently treated in a hyperbaric chamber. Dive computers are essential tools designed to enhance diver safety by calculating ascent profiles and reducing the risks of decompression sickness. These devices track depth and dive duration and apply decompression models to estimate nitrogen absorption in the body during a dive. As divers descend deeper, nitrogen levels increase and require controlled ascent, and decompression stops to allow safe release from the tissues. By failing to complete the decompression stop indicated by the dive computer, Passenger 1 surfaced without allowing for sufficient time for inert gas to be safely released from body tissues. If passenger 1 had completed the dive computer's recommended decompression stop prior to surfacing, it is probable that Passenger 1 may not have suffered decompression sickness and a subsequent loss of life.
