## **REPORT OF THE INVESTIGATION INTO THE FIRE ON BOARD THE OFFSHORE SUPPLY VESSEL HARVEY ENERGY (O.N. 1243697) IN PORT FOURCHON, LOUISIANA ON APRIL 28, 2023**

**MISLE ACTIVITY NUMBER: 7681968**

16732/IIA #7681968  
02 Sep 2025

**FIRE ABOARD THE OFFSHORE SUPPLY VESSEL HARVEY ENERGY (O.N. 1243697)  
RESULTING IN TWO INJURIES WHILE MOORED IN PORT FOURCHON, LOUISIANA  
ON APRIL 28, 2023**

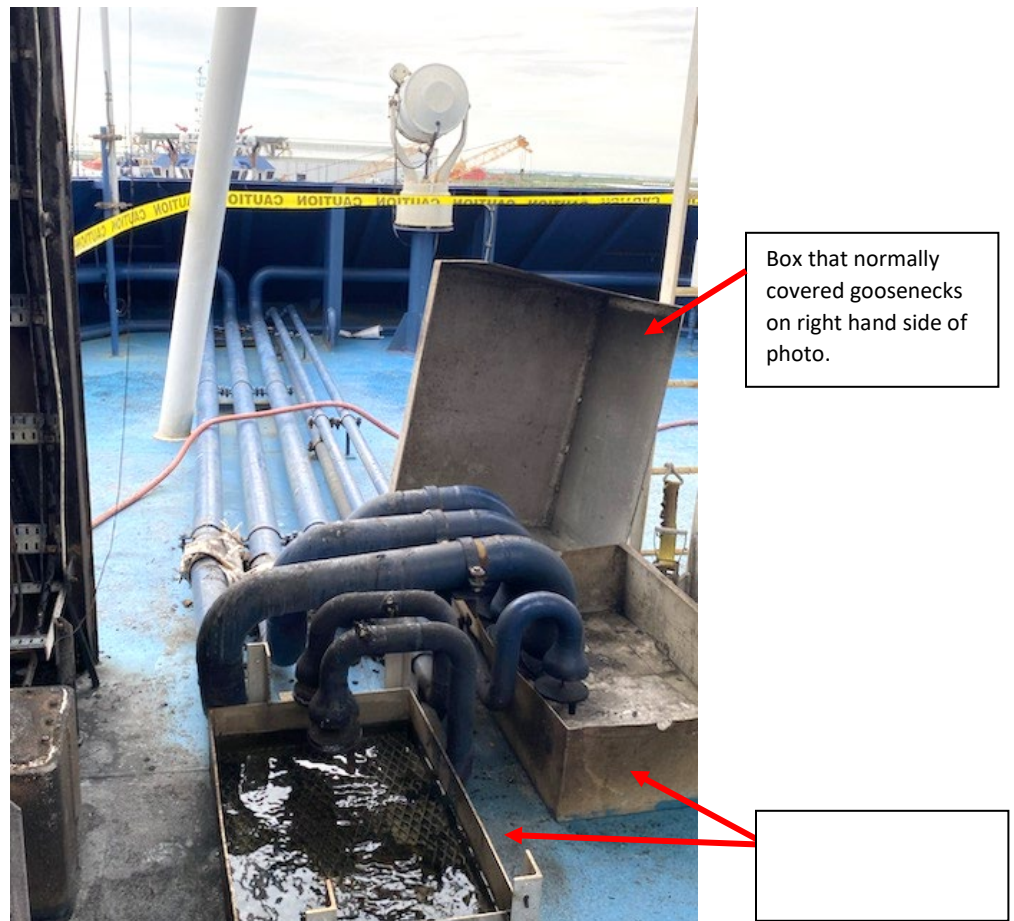
4.2.9. The main engine purge lines and crankcase vents terminated approximately 2' off the air castle main deck making the area a hazardous zone. There were two containment boxes directly underneath the goosenecks. One purge line and all crankcase ventilation piping were also covered by a metal box. No explanation was provided for this arrangement. The flame screens were also blown out and ineffective on the goosenecks but appeared to have been in this condition prior to the fire.

4.2.10. The manufacture openly acknowledges that its equipment is subject to methane slip, and that methane slip is more significant when operating the vessel at low loads. At the time of the incident, crew members and Harvey Gulf employees estimated the vessel was operating at 10% load. Methane was therefore likely present in the crankcase ventilation in addition to the changeover purge pipe.

Figure 3. HARVEY ENERGY crankcase ventilation and purge piping arrangement. Source: U.S. Coast Guard.

**5.3. Ineffective construction of ventilation design and purge vents.** At the time of the incident, the venting arrangement for both the methane purge piping and the crankcase ventilation terminated in the vicinity of the main air castle deck with gooseneck vents approximately 2 feet above the deck. Additionally, both ventilation arrangements were surrounded by containment boxes, further increasing the possibility of natural gas settling on the air castle main deck. All crankcase ventilation piping and one of the methane purge valves were covered by an unsecured metal box with three sides that fit over the crankcase ventilation and one methane purge vent. The box was not approved by the Coast Guard or the American Bureau of Shipping (ABS) and there was no provided explanation from the company for the installation of this box, but it likely contributed to the accumulation of flammable vapors in the vicinity of the air castle main deck. The engine manufacturer openly acknowledges that methane slip occurs into the crankcase of its dual fuel engines, and further explains that the rate of methane slip is increased when the generators are operating on low loads. The Chief Engineer estimated the generator to be operating on roughly 10% load at the time of the incident, which likely means methane could have been present in the crankcase ventilation fumes. If the crankcase ventilation and the purge vents terminated higher above the deck and away from the structure of the air castle, it is reasonable to assume that natural gas would not have accumulated to as significant of a degree on deck and within the superstructure of the air castle.

Recommend Commandant reassess the vessel’s current vent heights and locations. The current height of the engine purge and crankcase vents is approximately 2’ off the deck and located under the vessel’s air castle. While this configuration is in compliance with The International Code of Safety for Ships Using Gases or Other Low-Flashpoint Fuels (IGF Code), the current height of the vents and position of the vents do not allow for proper venting of gases and allows for the accumulation of flammable methane gas in that area. This could lead to additional fires onboard the HARVEY ENERGY, and on other vessels with the same design. Changing the vent heights and/or location would allow the gases to more freely vent into the atmosphere, greatly reducing the possibility of methane accumulation onboard the vessel.

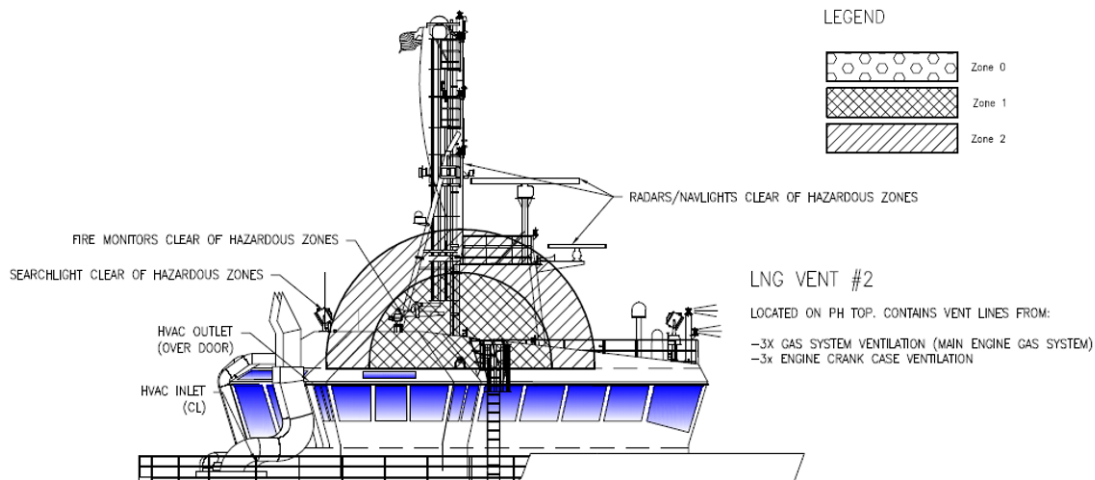
4.2.12. The vessel's approved hazardous location plan clearly annotated the area above the bridge as a hazardous location.

Figure 4. HARVEY ENERGY excerpt from approved Hazardous Location Plan. Source: U.S. Coast Guard.

There were no markings around the air castle specifying that the area was a hazardous location, but the vessel's hazardous location plan shows several "bubbles" of Zone 1 and Zone 2 locations directly where AB 1 and AB 2 were working on the day of the casualty. If the vessel had markings of the hazardous location prior to the incident, it is reasonable to assume the master may have known not to allow any work in the area while the vessel was operating on natural gas. Additionally, if there had been hazardous location markings around the air castle, AB 1 and AB 2 may have been hesitant to start hot work without verifying with the rest of the crew that equipment had been locked and tagged out to ensure the area around the air castle was not a hazardous location while hot work was being conducted.

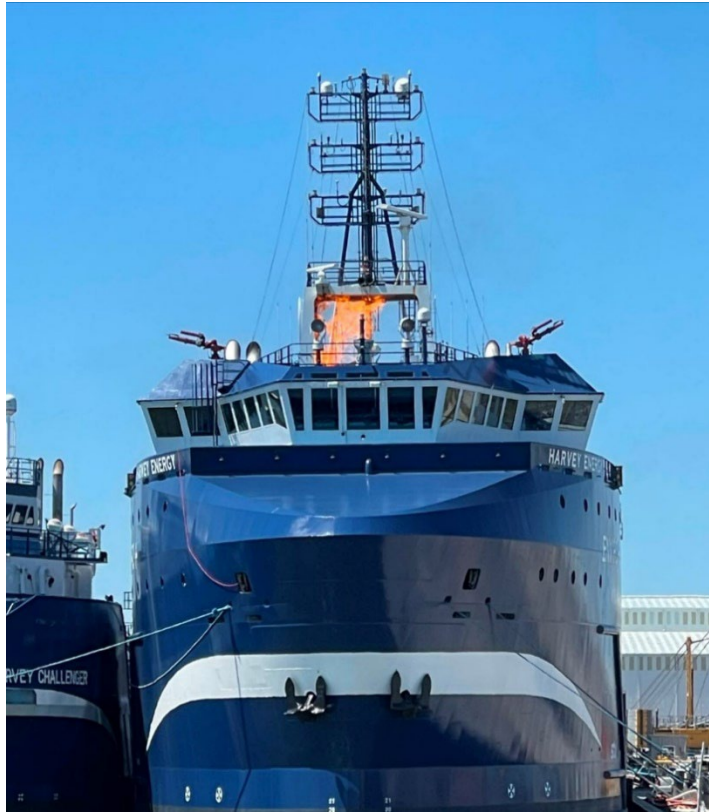
4.1.9. The flame introduced into the hazardous zone ignited the methane which had accumulated in the vicinity of the air castle. The ignition of the methane caused a fire approximately 30 feet high by 20 feet wide.

Figure 5. HARVEY ENERGY Fire taken on April 23, 2023. Source: Anonymous Facebook post.
