UNITED STATES COAST GUARD

REPORT OF INVESTIGATION INTO THE JMC 300 (O.N. 1094810) LOSS OF LIFE IN THE GULF INTRACOASTAL WATERWAY NEAR AMELIA LOUISIANA, ON FEBRUARY 10, 2024

MISLE ACTIVITY NUMBER: 7969744

INVESTIGATING OFFICER'S REPORT

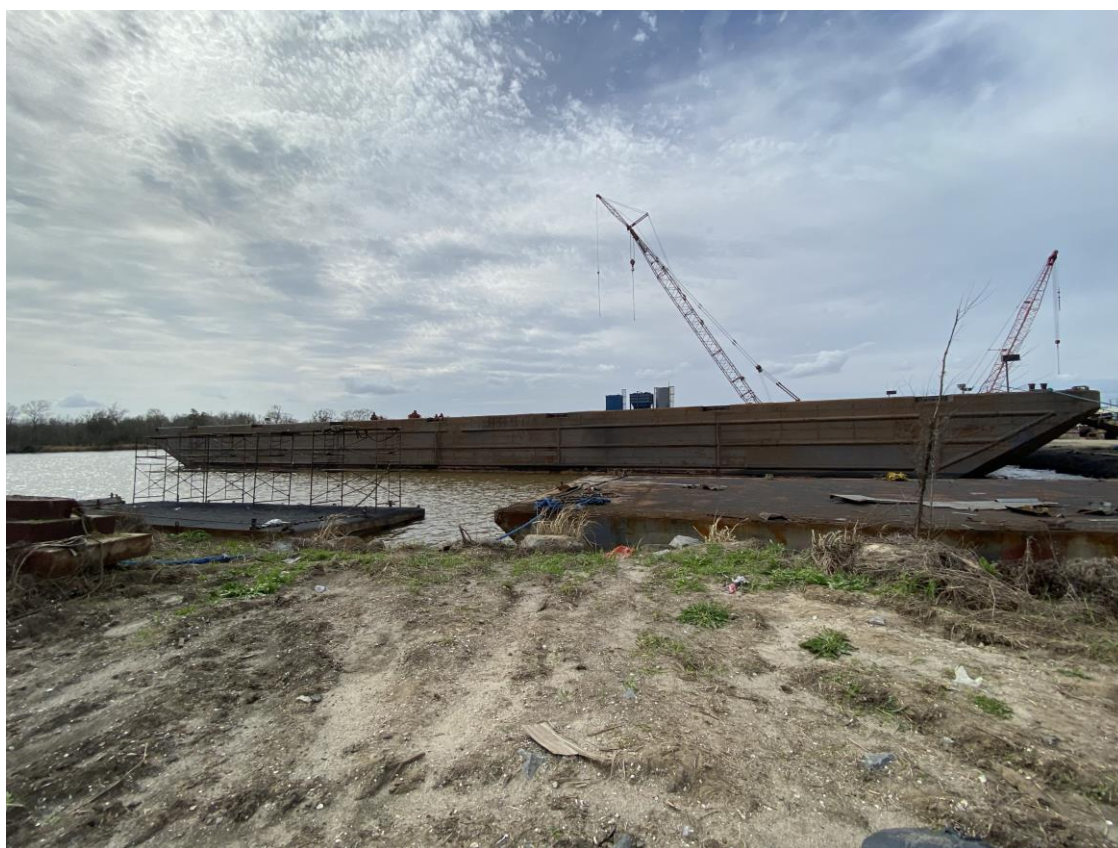
Figure 1. Photograph of JMC 300 moored at LAD Shipyard; taken February 10, 2024.

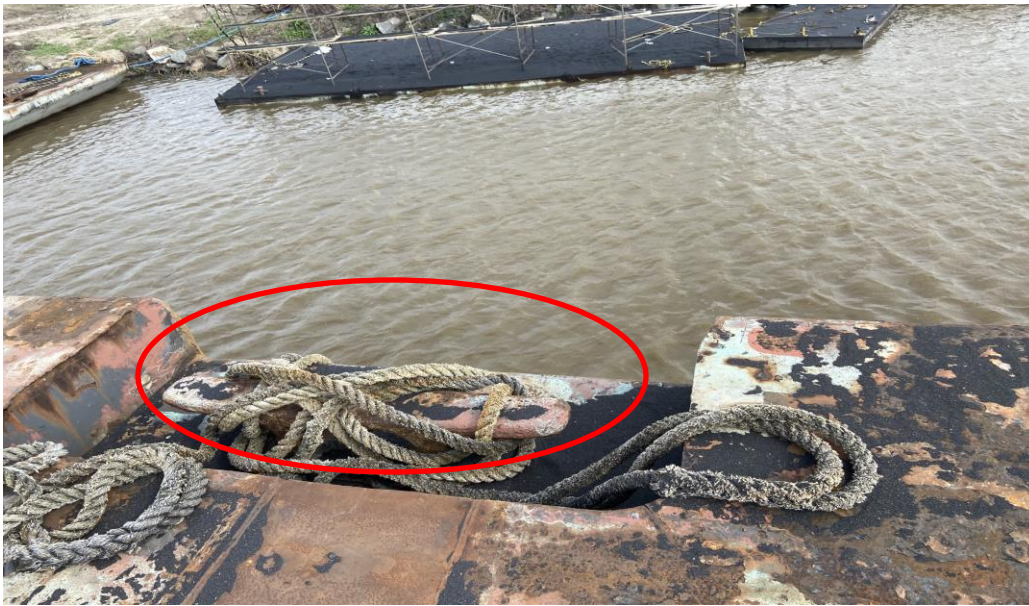
Figure 2. Photograph of cleat with mooring line secured to it on the top deck of the JMC 300; taken on February 10, 2024.

4.2.12. The cleats on the JMC 300 were permanently fixed to the barge. They were housed in a manner which required small sections of the top deck to be cut out to fit the cleat, which meant the portions of the deck surrounding the cleat were lower than the rest of the top deck, creating small holes around the cleats. This design allowed the cleat to be flush with the top deck of the barge and provided ample room for the mooring line to be tied around the cleat.

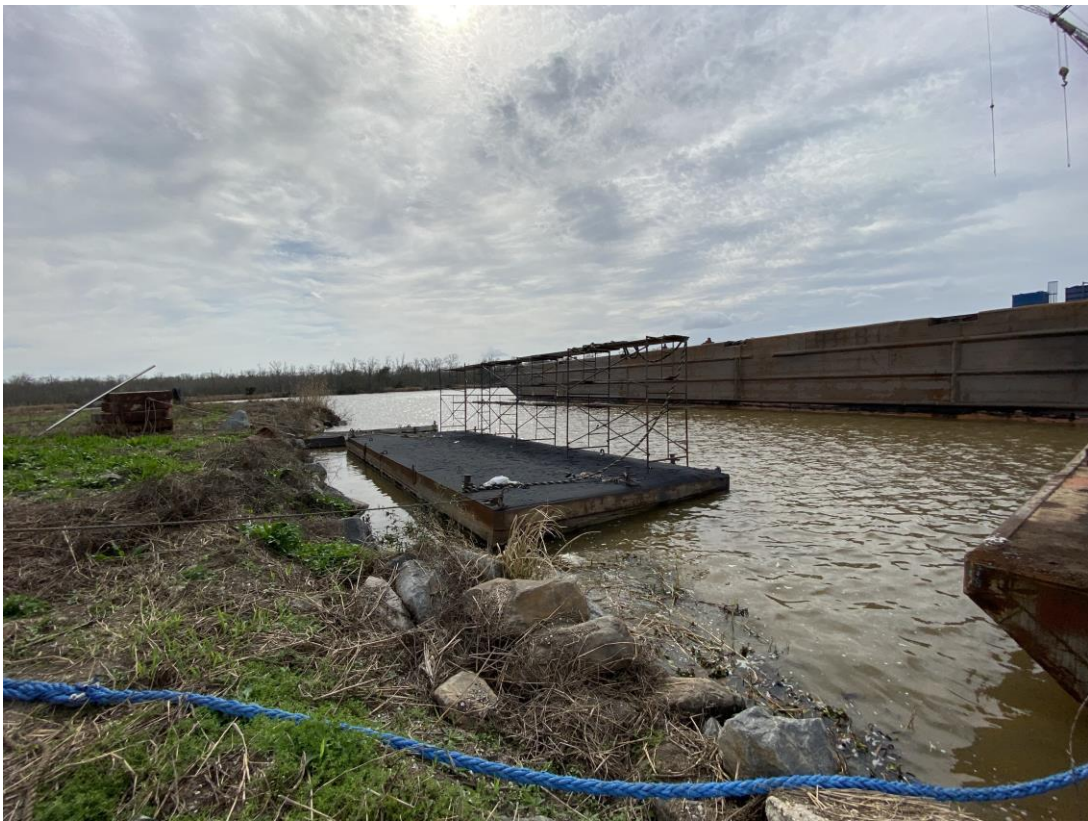
4.1.4. At 0600, the team began working. Painting was to be accomplished by using a small work barge with vertical scaffolding on top of the barge which gave painters on the work barge access to sections of the side hull that were out of reach. The work barge was tied alongside the JMC 300 using mooring lines. These mooring lines were used to prevent the work barge from drifting away from the JMC 300. This was executed by tying the mooring lines to cleats on the work barge as well as the top deck of the JMC 300. These cleats and their housing areas are located directly adjacent to the edge of the barge. The team members that were not involved in painting were tasked to sandblast the top deck of the JMC 300. The foreman oversaw the entire operation while the Paint Supervisor oversaw the safety of the painters aboard the work barge.

Figure 3. Photograph of small work barge with scaffolding adjacent to the side hull of the JMC 300; taken February 10, 2024.

reduced to only tying and untying the mooring line from the cleats aboard the JMC 300, which is a much safer task than pulling the work barge with mooring lines. Had a written policy for assist boats been in place, and an assist boat been utilized to push the work barge to different locations around the JMC 300, it is reasonable to believe that the risk of the Paint Supervisor tripping over a cleat and falling over would be drastically reduced, due to the increased safety of the task. In turn, this may have prevented any incident from occurring.

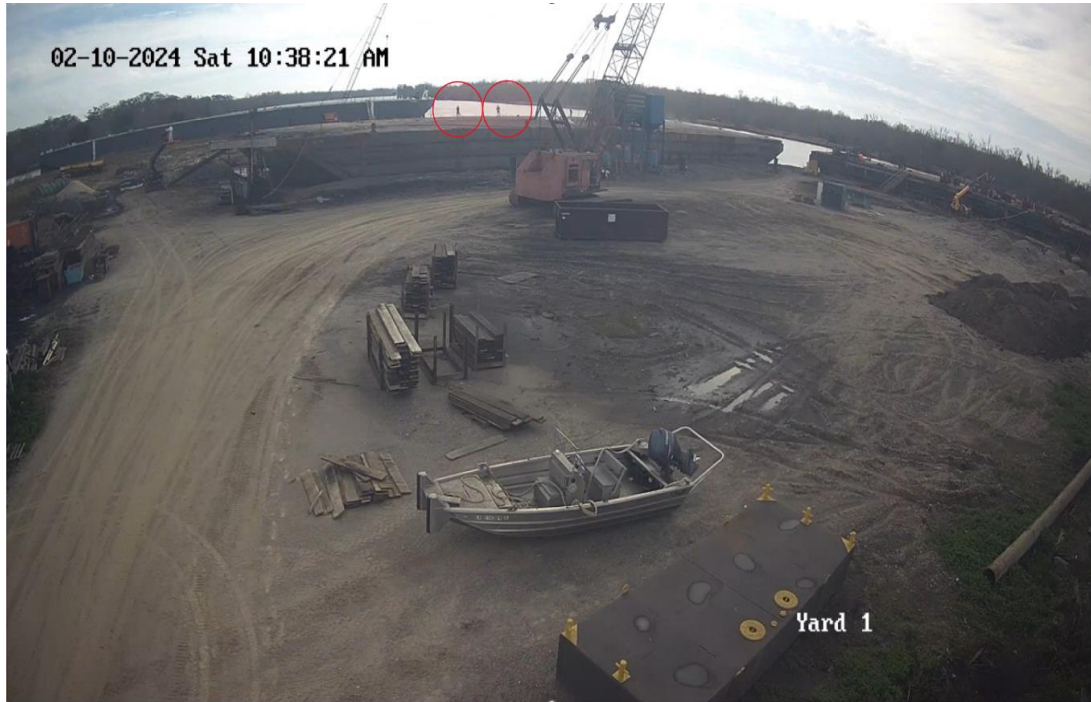
4.1.7. The Paint Supervisor and additional team member untied the work barge from the cleat it was secured to, and with his back turned to the nearby edge of the JMC 300, the Paint Supervisor began pulling on the mooring line to move the work barge.

Figure 4. Screenshot of security camera footage showing the Paint Supervisor and paint team member on top of the JMC 300 assisting in moving the work barge.

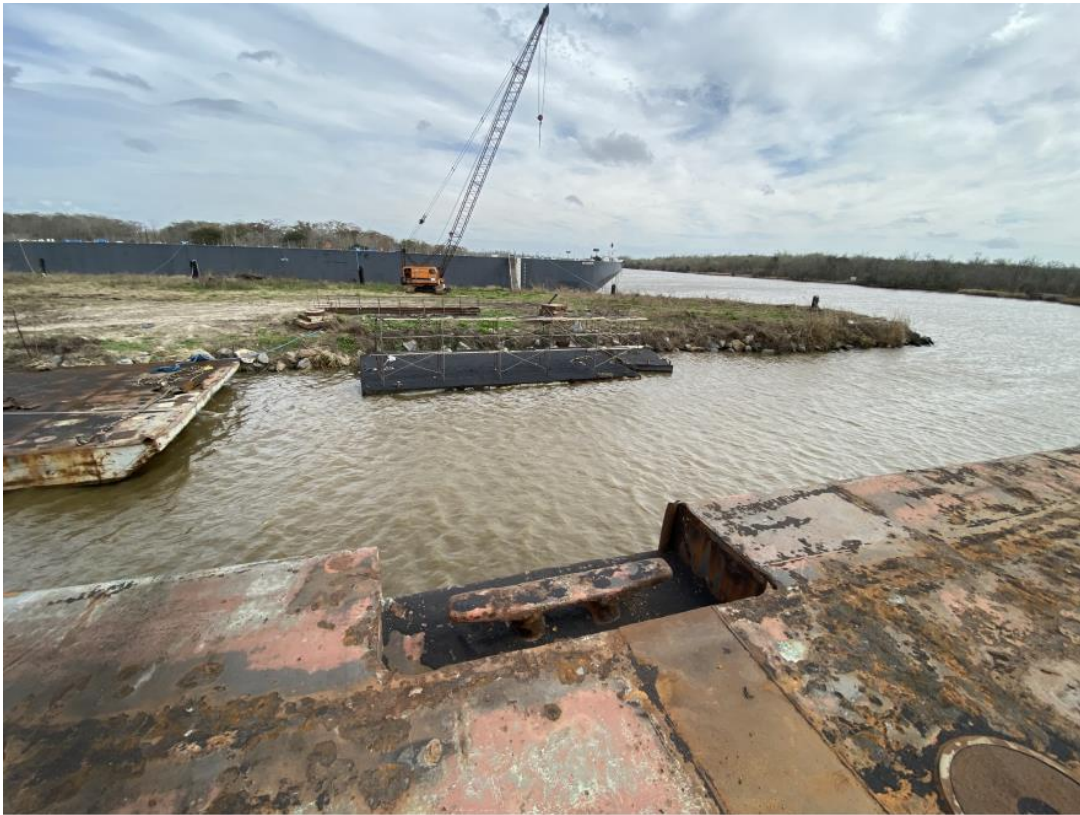
4.1.8. At 1038, the Paint Supervisor, with his back still facing the nearby edge of the JMC 300, tripped on a cleat aboard the JMC 300 and fell over the side of the barge. As he was falling, his hardhat fell from his head.

Figure 5. Photo of cleat that the Paint Supervisor tripped over aboard the JMC 300 with the work barge in the background.

5.1. Trip and fall hazards. The installed cleats on the JMC 300 presented unforeseen trip and fall hazards. They were installed in such a manner that increased the chances of tripping and falling by having the cleat placed in a housing area which was slightly below the top deck of the JMC 300. Although this eliminated the hazard of tripping over the mooring line configuration, it created a hole on the surface of the top deck in the area surrounding the cleat. This created a dangerous situation when someone unintentionally steps in this area as it causes a portion of body weight to shift down to the level where the cleat is housed, creating an uneven distribution of weight as it's now placed on two horizontal surfaces with differing vertical heights. This greatly increases the risk of losing balance. Additionally, the cleats and their housing areas are located directly adjacent to the edge of the barge, so the unevenly distributed weight can also be shifted to the direction of the edge of the barge depending on the direction an individual is coming from when they step into the housing area. This poses risk of falling over the side of the barge. The Paint Supervisor was also not facing the cleats, which created a trip hazard as his back was to the cleats, eliminating the ability to see the cleats while engaged in work thus increasing the chances of tripping and falling. This also made it increasingly difficult to regain balance after it was lost when his foot stepped into the cleat housing area. Had the trip and fall hazards created by the cleat installation and the Paint Supervisor having his back to the cleats not existed, it is reasonable to believe that the Paint Supervisor may not have tripped and fallen into the water while he was utilizing the mooring line to pull the work barge into a new position.

6.1.1.1. Trip and fall hazards present aboard the JMC 300.

- A findings of Concern has been released encouraging shipyards to create and enforce policies requiring assist vessels when moving small work barges to eliminate the hazard of personnel pulling on mooring lines and potentially tripping or falling. It is also recommended shipyards create and enforce policies regarding use of a guard rail system, safety net or personal fall arrest system while working on vertical or horizontal walking/working surface with a side or edge six feet or more above a lower level as well as the use of hardhats with chinstraps. Hardhats without chinstraps are susceptible to falling of the person's head should they fall off a high surface.

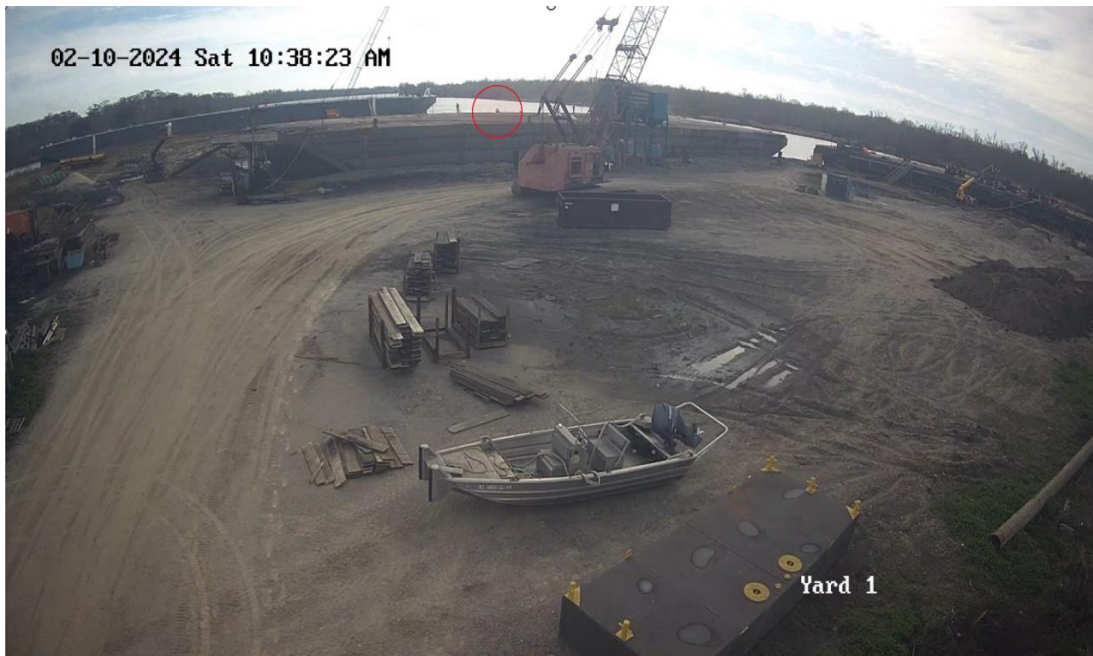
Figure 6. Screenshot of security camera footage showing the Paint Supervisor falling off of the JMC 300.

4.1.9. As the Paint Supervisor fell off the JMC 300, his head hit the side of the work barge, causing him to suffer a blunt force trauma to the head and killing him before he eventually fell into the water.

5.2. Failure of the shipyard to install temporary handrails aboard the JMC 300. On the date of the incident, temporary handrails were not installed on the edges of the JMC 300 despite this being common shipyard practice and a direct requirement from LAD Services of Louisianas HSE manual for certain situations in which the painting of the JMC 300 would apply. Guard rails were not installed as the crew believed they could quickly accomplish the painting of the JMC 300 without high risk. Temporary handrails serve as a defense against falling over the side of barges as they provide something to grab on to in the event someone is placed in a situation in which falling overboard is a risk, such as tripping. These handrails also provide a constant support option for individuals who are simply standing near the edge of the barge by facilitating continuous anchor point, even if they are NOT performing actions that pose a direct risk of falling overboard. Once the Paint Supervisor tripped, he had nothing to grab or hold on to due to the absence of handrails. Had temporary handrails been installed by the shipyard aboard the JMC 300, it is reasonable to believe that the Paint Supervisor would have utilized them and therefore, may not have fallen overboard.

5.4. Failure to wear PPE relative to the hazards presented. Although PPE was worn, PPE relative to the hazards presented by the nature of the job was not utilized on the date of the incident. This included a hardhat which was equipped with a chin strap. Chinstraps were not required by company policy and not provided to the workers. After he had tripped and began to fall, his hardhat, which had no chinstrap, fell from his head, causing his head to make direct contact with the work barge below him. The contact resulted in a blunt force trauma to the head that ultimately rendered him deceased. A chinstrap on the hardhat, if properly worn, could have prevented the direct contact between the Paint Supervisor's head and work barge by preventing the hardhat from falling off his head. Had PPE relative to the hazards presented by the nature of the job such as a hardhat with chinstrap been utilized, it is reasonable to believe the blunt force trauma caused by the Paint Supervisor's head colliding with the barge would have been reduced and the resulting death may not have occurred.
