**UNITED STATES COAST GUARD**

**REPORT OF THE INVESTIGATION  
INTO THE  
UNINSPECTED TOWING VESSEL JOEY DEVALL  
(O.N. 599385), DECKHAND LOSS OF LIFE ON  
SEADRIFT BAY IN SEADRIFT, TX ON JUNE 30,  
2017**

**MISLE ACTIVITY NUMBER: 6323290**

### INVESTIGATING OFFICER'S REPORT

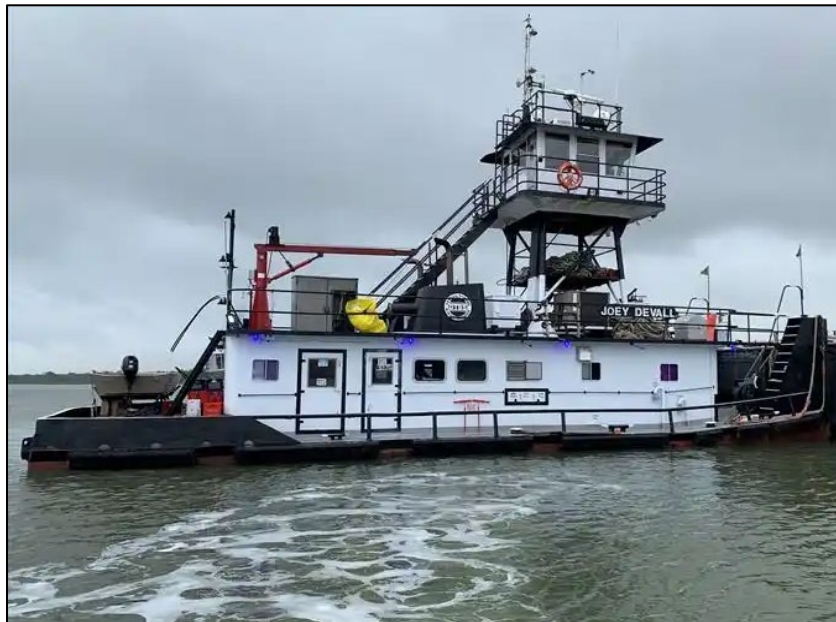
Figure 1. Uninspected Towing Vessel JOEY DEVALL, railings were not installed at the time of accident. (Date Unknown / Marine Traffic)

4.2.1. The UTV JOEY DEVALL did not have a railing installed above the bulwarks on the perimeter of the vessel.

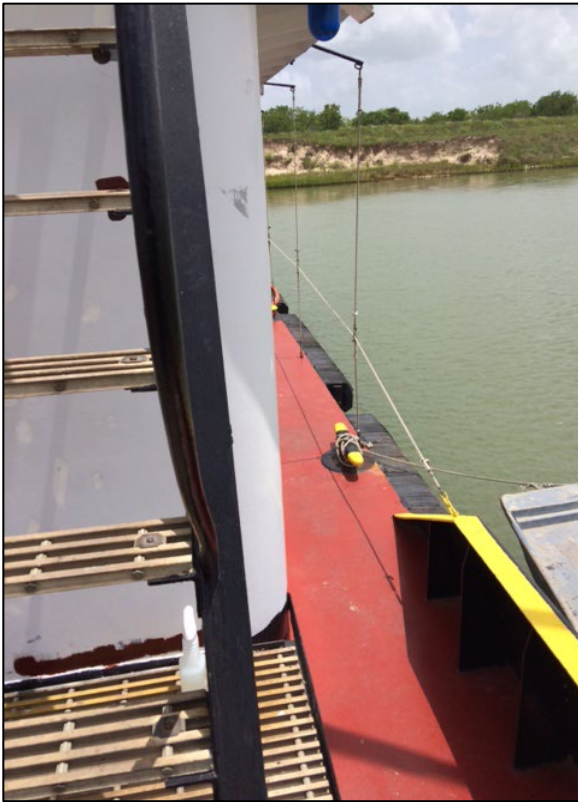
4.1.9. At 1715, the Captain awakened for watch change and walked out on deck. The Captain noticed an air hose being dragged off the starboard side and the step ladder on deck as shown in Figure 3. The Captain pulled the air hose with needle scaler still attached back on deck. He then started looking for Deckhand 2 onboard.

Figure 3. Looking at deck cabin Deckhand 2 was working at time of incident, starboard aft taken from stern. (July 1, 2017 / USCG)

5.3. Lack of railing. As seen in Figures 2, 3, and 4, the UTV JOEY DEVALL did not have a railing on the perimeter of the vessel. Without a railing, there is an increased risk of individuals inadvertently falling overboard. Although the specific bulwark heights were not measured, they appear relatively low compared to the height of the 2-step ladder observed on deck. Additionally, regulations applicable to the UTV JOEY DEVALL at the time of the incident did not have a bulwark height or railing height requirement. Had there been a railing along the perimeter, it may have prevented Deckhand 2 from entering the water if he fell.

6.1.1.3. Lack of railing above the bulwark to prevent falling overboard.

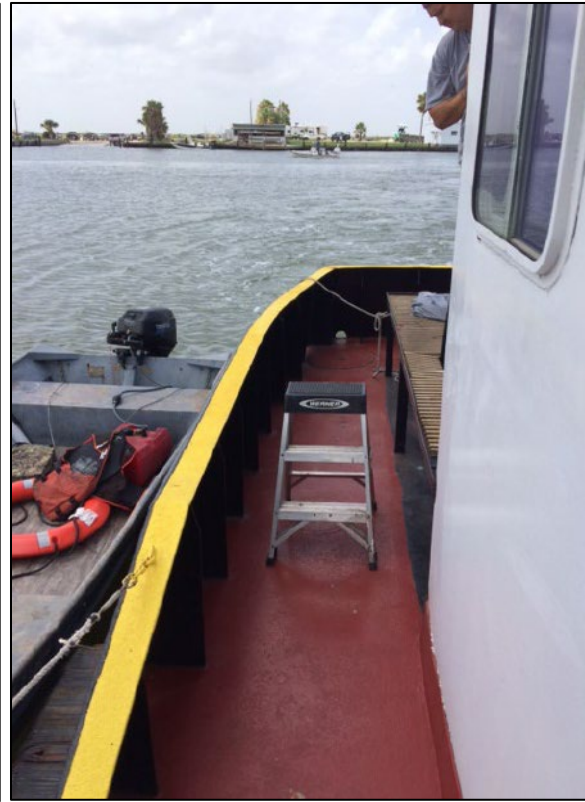
Figure 2. Ladder location when Deckhand 2 discovered missing, starboard aft side. (July 1, 2017 / USCG)

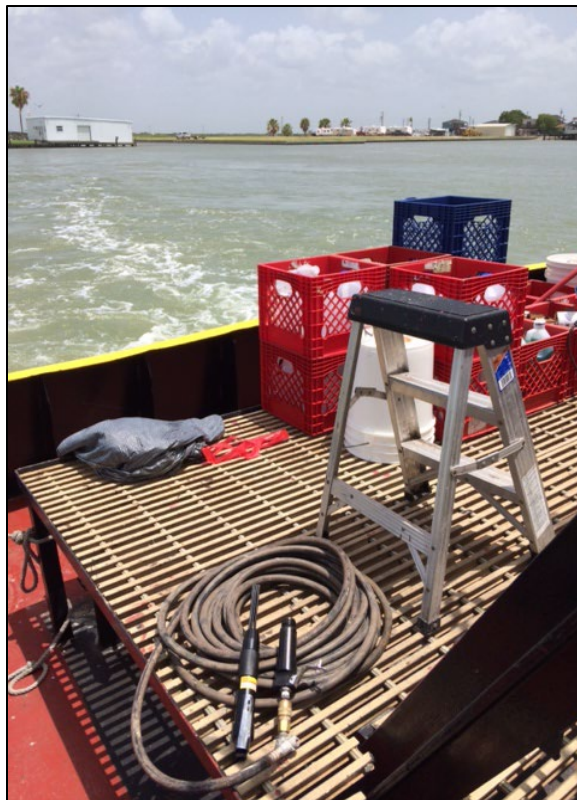
4.1.3. At 0700, Deckhand 1, as directed by the Captain, commenced sanding and chipping maintenance on the starboard aft quarter with a needle scaler and 2-step ladder (Figure 4) on the UTV JOEY DEVALL.

4.2.3. Deckhand 2 was not wearing a lifejacket while chipping the main deck cabin. The maintenance equipment used is shown in Figure 4.

Figure 4. Needle scaler and ladder used by Deckhand 2 (July 1, 2017 / USCG)
