**REPORT OF THE INVESTIGATION
INTO THE
LOSS OF LIFE ON THE KIM LY (O.N. 588734)
WHILE FISHING CORPUS CHRISTI BAY ON
FEBRUARY 20, 2024**

**LOSS OF ONE LIFE ON BOARD THE COMMERCIAL FISHING VESSEL KIM LY
(O.N. 588734) WHILE FISHING IN CORPUS CHRISTI BAY NEAR CORPUS CHRISTI,
TEXAS ON FEBRUARY 19, 2024**

INVESTIGATING OFFICER'S REPORT

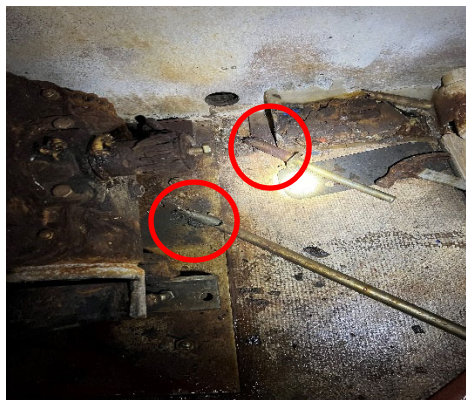
4.1.3. At 2340, the guide for the cable broke and the Operator was entangled in the winch resulting in his death.

Figure 2. Broken cable guide Anne's Bait Shop Ingleside, TX. (February 20, 2024/USCG)

4.2.8. The guide for the winch cable was in a deteriorated and corroded state. A cable guide on a winch serves to properly guide the cable as it winds onto the drum of the winch. The Operator would manually adjust a cable guide on a winch physically moving the guide to the desired position along the winch drum or track to lay the cable evenly.

5.3. Deteriorated state of the cable guide. Photographs taken post casualty show the cable guide laying on the deck next to the winch broken in half. A cable guide on a winch serves to properly guide the cable as it winds onto the drum of the winch. The Operator would manually adjust the cable guide on the winch by physically moving the guide to the desired position along the winch drum. The cable guide's structural failure, as evidenced by its broken and corroded condition, suggests that it may have been compromised during the incident. Had the cable guide not broken in half, it is plausible to suggest that the Operator may not have fallen into the winch, thereby preventing his death.

6.1.1.3. The cable guide broke due to its deteriorated state.

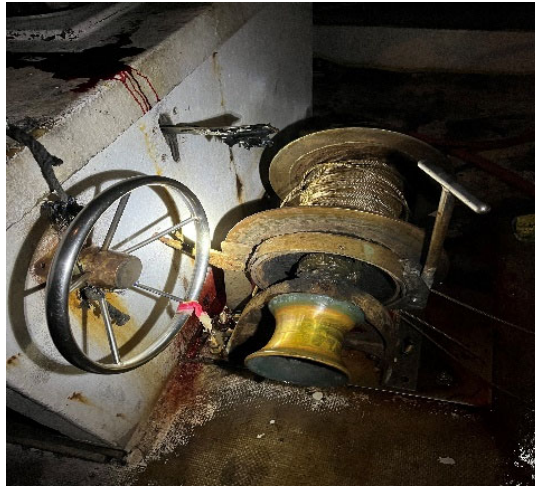
4.2.6. The KIM LY did not have a safety guard installed on the winch. Safety guards help prevent workers' clothing, body parts, or tools from getting caught or trapped in the moving parts of the winch. Without guards, there is a risk of severe injuries or even fatalities if a person becomes entangled in the winch. Commercial Fishing Vessels that do not fish beyond the boundary line or with less than 16 individuals are not required to have safety guards installed in accordance with 46 CFR 28.200.

Figure 3. KIM LY winch with no guard - Anne's Bait Shop Ingleside, TX. (February 20, 2024/USCG)

5.1. Lack of safety guard on winch. The absence of a safety guard on the winch of the KIM LY was captured by post-casualty photographs taken on scene. Safety guards play a vital role in preventing accidents and injuries by shielding workers from contact with hazardous moving parts, such as winch drums and cables. In the absence of safety guards, workers are exposed to significant risks during winch operations. Clothing, body parts, or tools can inadvertently come into contact with the rotating components of the winch, leading to entanglement. The absence of a safety guard increases the likelihood of such incidents occurring and amplifies the severity of potential injuries. By installing a safety guard over the winch, the KIM LY could have substantially reduced the risk of accidents and injuries associated with winch operations. The guard would have acted as a physical barrier, and possibly prevented the Operator from inadvertently making contact the moving parts of the winch and becoming entangled.

6.1.1.1. The vessel did not have a safety guard installed on the winch.

8.1. Safety Recommendation: Recommend that the Commandant of the Coast Guard amend the applicability of 46 CFR § 28.200 to include commercial fishing vessels operating inside the boundary line. Currently, the regulation requires suitable guards or covers for rotary machinery only on vessels operating beyond the boundary line, leaving a gap in safety standards for vessels engaged in nearshore or inland operations.
