UNITED STATES COAST GUARD

**REPORT OF THE INVESTIGATION
INTO THE
UNINSPECTED COMMERCIAL FISHING VESSEL
(CFV) KIM THU (O.N. 917018), FUEL TANK
EXPLOSION THAT RESULTED IN THREE
CREWMEMBER INJURIES AND TWO
FATALITIES WHILE MOORED AT PIER 36,
HONOLULU, HI ON APRIL 26, 2024**

MISLE ACTIVITY NUMBER: 7902559

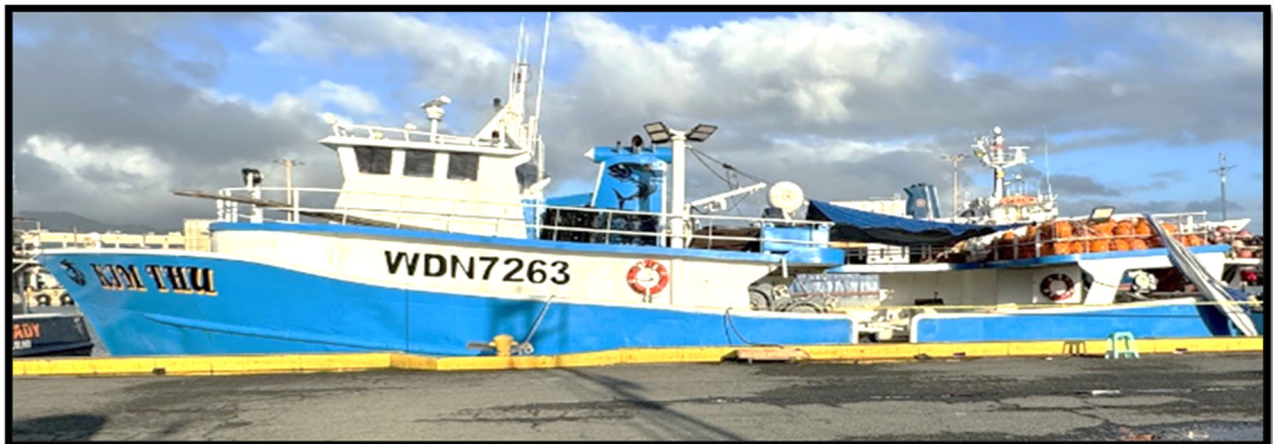
Figure 1. Photograph of the vessel, taken post casualty on April 26, 2024, by the Investigating Officer.

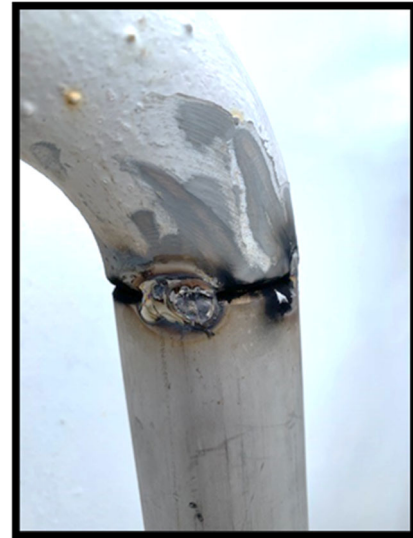
4.1.8. At 1520, the welder began fabrication to the port fuel tank vent by fitting up and tack welding (GMAW - gas metal arc welding) a 1 ½ inch diameter steel pipe extension on the 180° elbow (Figure 3.). Meanwhile, the crewmembers were located throughout the vessel; crew 1 and 2 roaming the main deck, crew 3 in the aux room, crew 4, 5, and 6 in the galley mess conducting fishing gear maintenance, crew 7 in the berthing area, and crew 8 shoreside.

Figure 3. Close up photograph of the tack-weld, taken by the Investigating Officer.

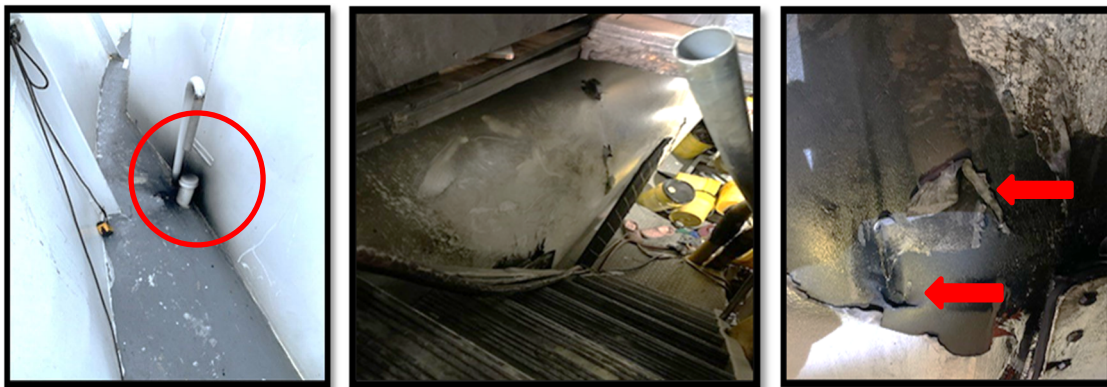
4.1.11. Concurrently, the port fuel tank top buckled and the inner bulkhead was compromised releasing the built-up gaseous pressure, heat, and smoke directly into the engine room, out the exhaust ventilation stack, and up through the vestibule out onto the main deck.

Figure 4. Left: Fuel tank vent pipe (soot residual from explosion), Center: Bulkhead between fuel tank and engine room (ballooned/ exploded), Right: Bulkhead penetrated (fractured from explosion); photographs taken by the Investigating Officer.

6.1.2. The first subsequent event was the material failure of the port fuel tank plating due to the explosion. Based on section 5.6, nothing reasonable could have prevented the material failure as the port fuel tank was built to standard vessel construction.

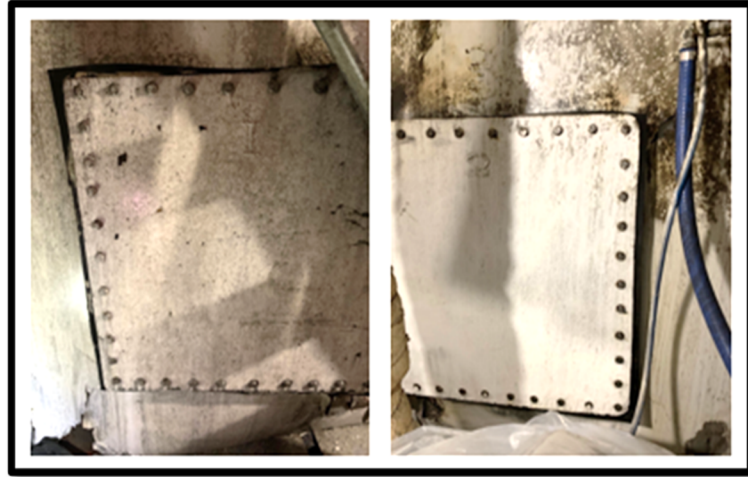
4.1.9. At 1528, the welder shifted position and began welding the initial root pass on the vent pipe extension. Two inspection covers on the longitudinal bulkhead of the port fuel tank remained bolted

5.3. Nonstandard Procedures to Ensure a Gas Free Environment prior to Conducting Hot Work Operations. During an interview, the welder was asked to explain the procedures to prepare a fuel tank for welding based on his prior experience. His response was, in order: 1. take fuel out, 2. clean out everything, 3. chemical clean, 4. air it out (ventilate), 5. fill with water, 6. next day weld. Further went on to state that he had followed this procedure welding on many fuel tanks in the past. When asked how the port fuel tank on *Kim Thu* was prepared for welding, his response was, “Decedent (owner) told him that everything was done and that the fuel tank was cleaned, and all the fuel was transferred out.” The welder later stated he did not verify the tank conditions before welding. Of note, during post casualty walkthrough of the vessel, the Investigating Officer identified two access, or inspection covers on the longitudinal bulkhead of the port fuel tank which could have provided additional ventilation; both covers remained bolted. However, diesel fuel vapors (presumably) primarily vented through the port fuel tank vent, the only open outlet where the welder was working when the explosion occurred. Based on interview testimony and the outcome of the event, it was possible that nothing beyond the removal of fuel was completed, and that the responsible person and the welder assumed that the port fuel tank was sufficiently “gas free” to conduct hot work on the vent pipe. Even if they had properly prepared for hot work and conducted their own atmospheric testing, the final required step, testing and certification by a certified chemist for the port fuel tank, was still necessary and mandated by industry standards, State rules, and federal regulations (discussed further in the next paragraph). Had the port fuel tank been properly prepared and made ready for inspection and testing prior to hot work, this casualty could have been avoided.

Figure 8. Port fuel tank access covers, photographs taken by the Investigating Officer.

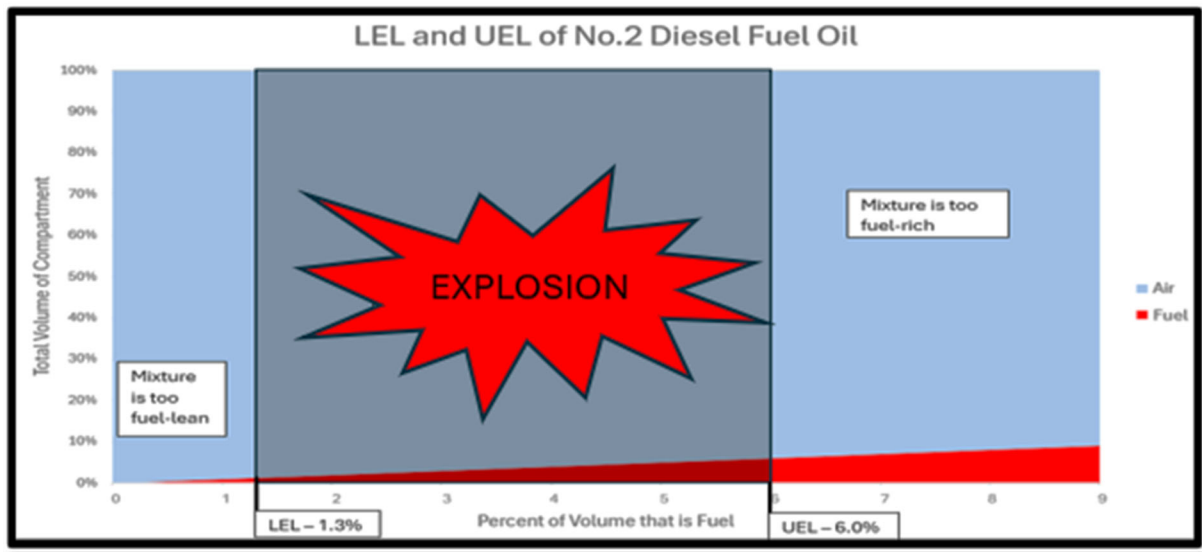
indicated hazards in a space (likely the case in this casualty), this information would have been listed on the certificate; for example, "Not Safe for Workers" or "Not Safe for Hot Work." Therefore, without proper atmospheric testing and certification by a marine chemist, it was probable that the conditions in the tank formed the ideal mixture of diesel fuel oil vapor and air in that space within the flammable range (vapor and air between 1.3% and 6%) and when the welder introduced heat, the ignition source (welding arc) on the vent pipe, it initiated the uninhibited chemical chain reaction in the vapor space of the fuel tank which resulted in an explosive range of flammability (rapid increase of pressure and sudden release of energy caused by combustion of premixed fuel vapor and air); see Figures 6 and 9 for reference.

Figure 9. Flammability scale showing the general range of flammability for No.2 diesel fuel oil; developed by USCG Marine Safety Center; annotated by the Investigating Officer.

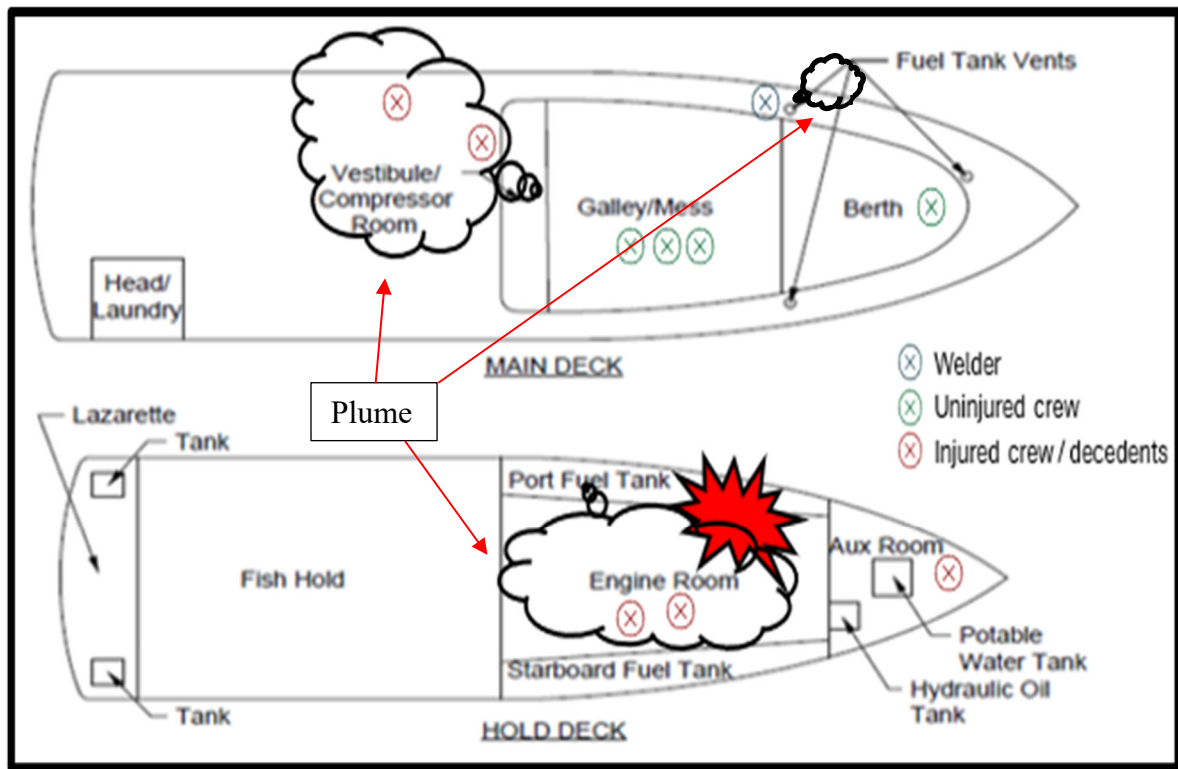
5.7. No Reasonable Defense Exists to Prevent Injuries and Loss of Lives. Unfortunately, in this case, the injured crewmembers and two decedents were in an unfavorable location when

the explosion occurred. The welder, however, managed to avoid serious injuries and did not require professional medical treatment. Had the crewmembers not been where they were aboard the vessel during hot work operations, the results could have been different. In this instance, it would have been an unreasonable requirement for the crewmembers to don personal protective equipment (PPE) for protection against an explosion hazard during hot work operations. Video evidence pulled from the vessel's main deck closed-circuit television (CCTV), showed footage of the plume that threw the two crewmembers across the aft deck. That explosive thermal blast was strong enough to damage a metal structure and continued to release its remaining energy out the ventilation stack, and up through the vestibule out onto the main deck above, injuring everyone in its path of discharge. Figure 11 illustrated the explosion, path of discharge, and reported or last known locations of each persons aboard *Kim Thu* at the time of the casualty.

Figure 11. Cut out of Figure 5, plume out of exhaust stack not shown; annotated by the Investigating Officer.
