**REPORT OF THE INVESTIGATION
INTO THE
COMMERCIAL FISHING VESSEL LADY ELLEN
(O.N. 625371) CREWMEMBER LOSS OF LIFE IN
TANGIER SOUND NEAR DEAL ISLAND, MD ON
JULY 23, 2024**

MISLE ACTIVITY NUMBER: 7965695

**FALL OVERBOARD AND SUBSEQUENT LOSS OF ONE LIFE FROM THE
COMMERCIAL FISHING VESSEL LADY ELLEN (O.N. 625371) WHILE FISHING
IN TANGIER SOUND NEAR DEAL ISLAND, MARYLAND ON JULY 23, 2024**

INVESTIGATING OFFICER'S REPORT

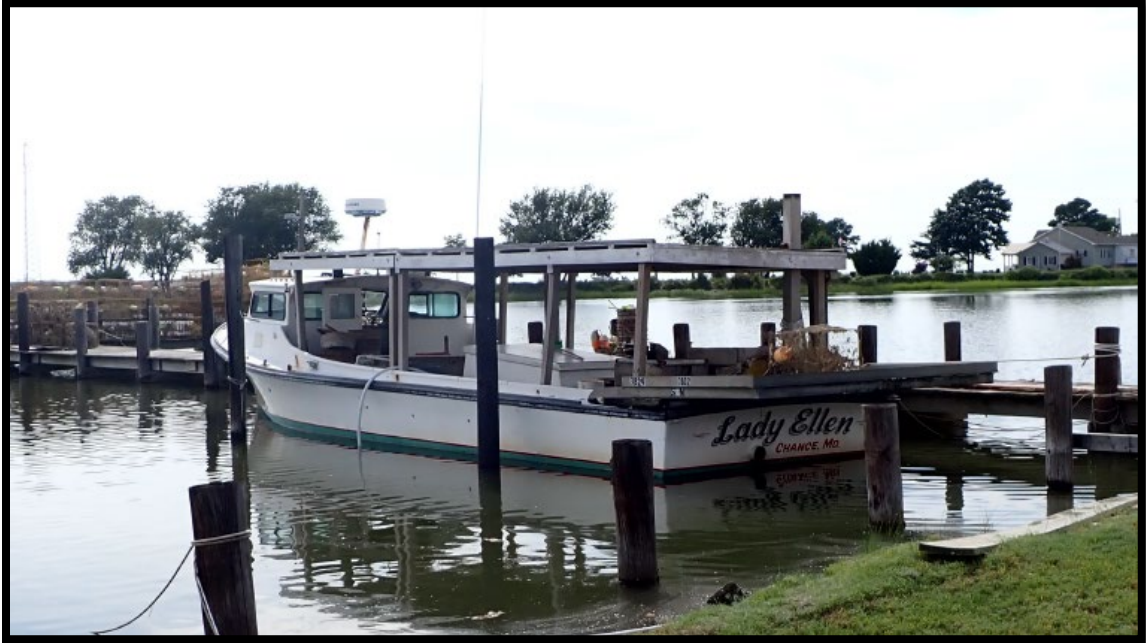
Figure 1. Photograph of LADY ELLEN post-incident moored at Corbin’s Seafood private dock in Chance, MD. This photo was taken by the attending U.S. Coast Guard Investigating Officer on 23Jul2024.

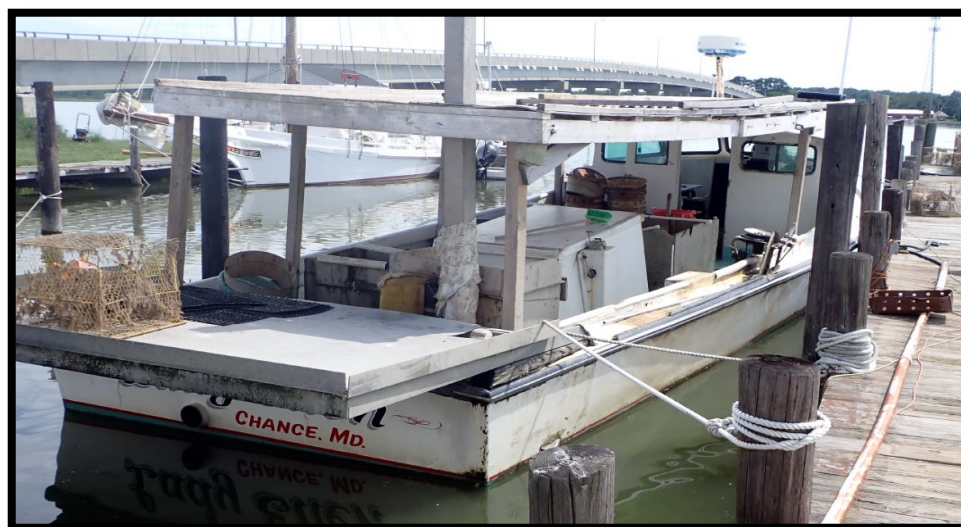
Figure 3. A starboard quarter aspect showing LADY ELLEN's low bulwarks and lack of perimeter railing or courses. The photo was taken by the attending U.S. Coast Guard Investigating Officer on 23Jul2024 at Corbin's Seafood dock in Chance, MD.
