UNITED STATES COAST GUARD

**REPORT OF THE INVESTIGATION
INTO THE
COMMERCIAL FISHING VESSEL LADY NORA
(O.N. 543395), LOSS OF LIFE IN THE GULF OF
MEXICO, NEAR PORT ARANSAS, TX ON
FEBRUARY 6, 2022**

INVESTIGATING OFFICER'S REPORT

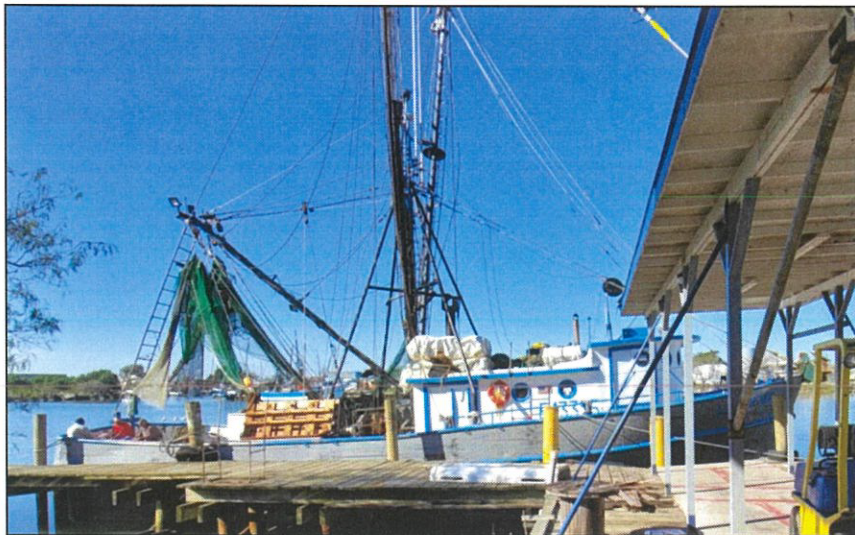
Figure 1. Starboard aspect of the LADY NORA at dock in the Port of Brownsville. (February 7, 2022/USCG)

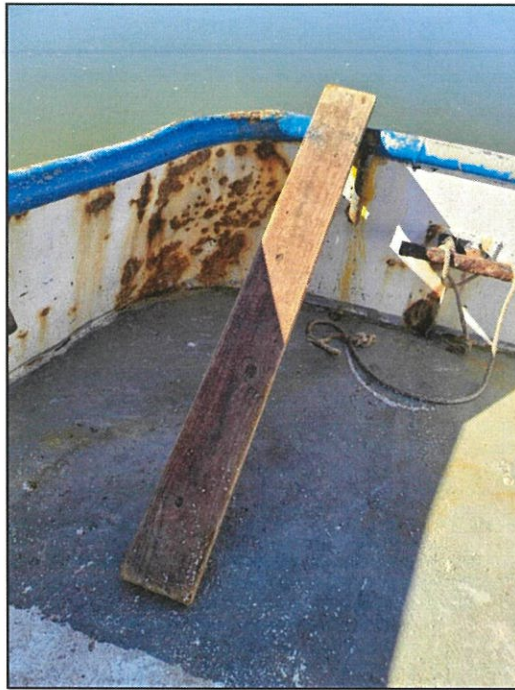
Figure 2. Pala (2" x 8" x 67") found on the LADY NORA in Brownsville Shrimp Basin. (February 7, 2022/USCG)

5.3. *Inadequate equipment for cleaning nets.* Proper equipment should have been provided to avoid using a cumbersome and heavy tool for cleaning the nets. The autopsy report stated he was 5'7" (67 inches) tall. At the time the Header went overboard, he was reaching and leaning over the 30" side of the vessel, cleaning the nets with a 2 x 8" piece of lumber approximately 5 to 6 feet long. Significantly shifting his center of gravity increased the likelihood of losing his balance. This untreated, unpainted piece of lumber was likely soaked with water, weighing over 25 pounds. It lacked any handles for better grip. If a lighter, easier-to-handle tool had been available, it is likely the Header would not have had to lean over the side of the vessel with a heavy piece of lumber to clean the nets and would not have fallen overboard.

6.1.1.1. The use of a heavy, water-soaked scraping tool required the Header to lean over the side of the vessel.
