UNITED STATES COAST GUARD

REPORT OF THE INVESTIGATION INTO THE COMMERCIAL FISHING VESSEL LA 3266 GG (HIN EKHB4665D909) LOSS OF LIFE IN THE VERMILION BAY ON JULY 11, 2023

MISLE ACTIVITY NUMBER: 7756996

FALL OVERBOARD AND SUBSEQUENT LOSS OF ONE LIFE FROM THE COMMERCIAL FISHING VESSEL LA 3266 GG IN THE VICINITY OF BAYOU HEBERT IN VERMILION PARISH, LOUISIANA ON JULY 11, 2023

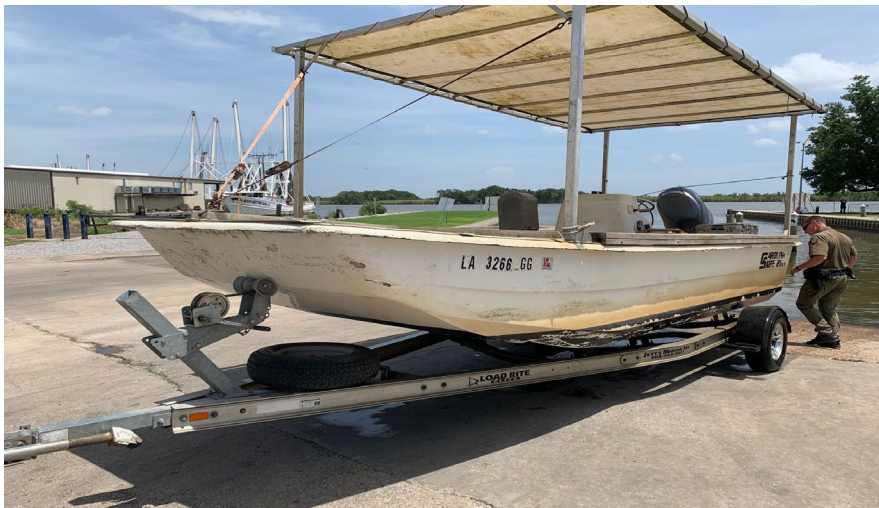
Figure 1 Commercial Fishing Vessel LA 3266 GG taken by the USCG July 12, 2023

Official Name:	LA 3266 GG
Hull Identification Number:	EKHB4665D909
Flag:	United States of America
Vessel Class/Type/Sub-Type	Commercial Fishing
Build Year:	2009
Gross Tonnage:	N/A
Length:	20' 10"
Beam/Width:	N/A
Draft/Depth:	N/A
Main/Primary Propulsion: (Configuration/System Type, Ahead Horsepower)	Outboard Gasoline: Yamaha 150 HP
Owner/Operator:	Matthew M. Montz Maurice, LA, USA

4.2.2. The vessel was a 21-foot flat bottom Carolina Skiff with a 24" gunwale. The gunwale is considered low compared to rail height standards and would put the top of the gunwale just above the knee of the owner, increasing the potential of falling over the side.
