**REPORT OF THE INVESTIGATION
INTO THE
DEATH ONBOARD THE RECREATIONAL
VESSEL LINEDOUT (HIN: JDJ5V303J223) IN
THE GULF OF MEXICO ON MARCH 12, 2024**

MISLE ACTIVITY NUMBER: 7879209

16732/IIA #7879209
12 September 2025

ALLISION OF THE RECREATIONAL FISHING VESSEL LINEDOUT (HULL IDENTIFICATION NUMBER: JDJ5V303J223) WITH FIXED PLATFORM SS-087B RESULTING IN THE LOSS OF ONE LIFE WHILE UNDERWAY NEAR SOUTH MARSH ISLAND BLOCK 69 IN THE GULF OF AMERICA ON MARCH 12, 2024

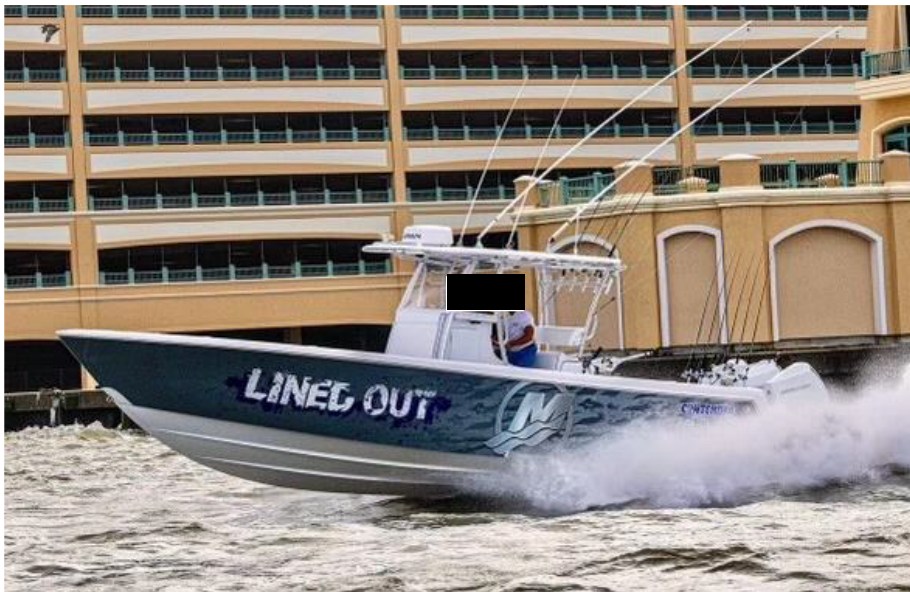
Figure 1. Recreational vessel LINEDOUT, date unknown. Source Instagram.

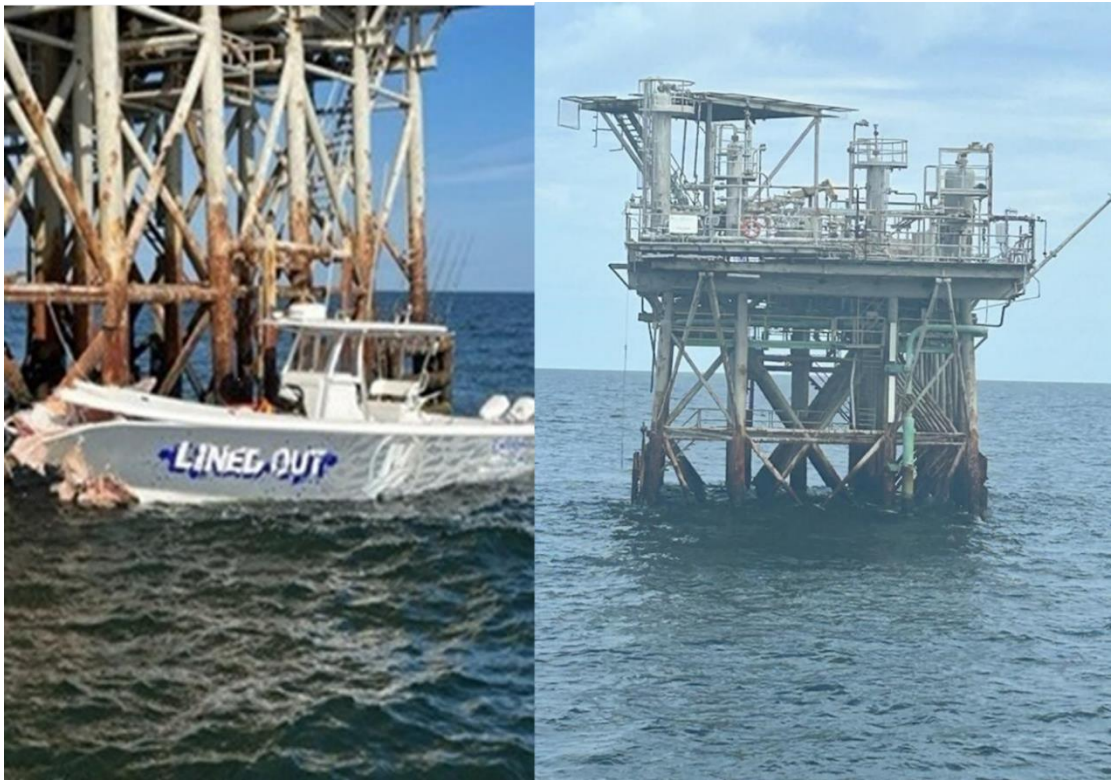
Figure 2 LINEDOUT and Platform Ship Shoal 87B. Taken March 12, 2024. Source Coast Guard.

4.1.6. At approximately 0630, the vessel LINEDOUT allided with the SS-87B platform at the speed of approximately 29 knots.

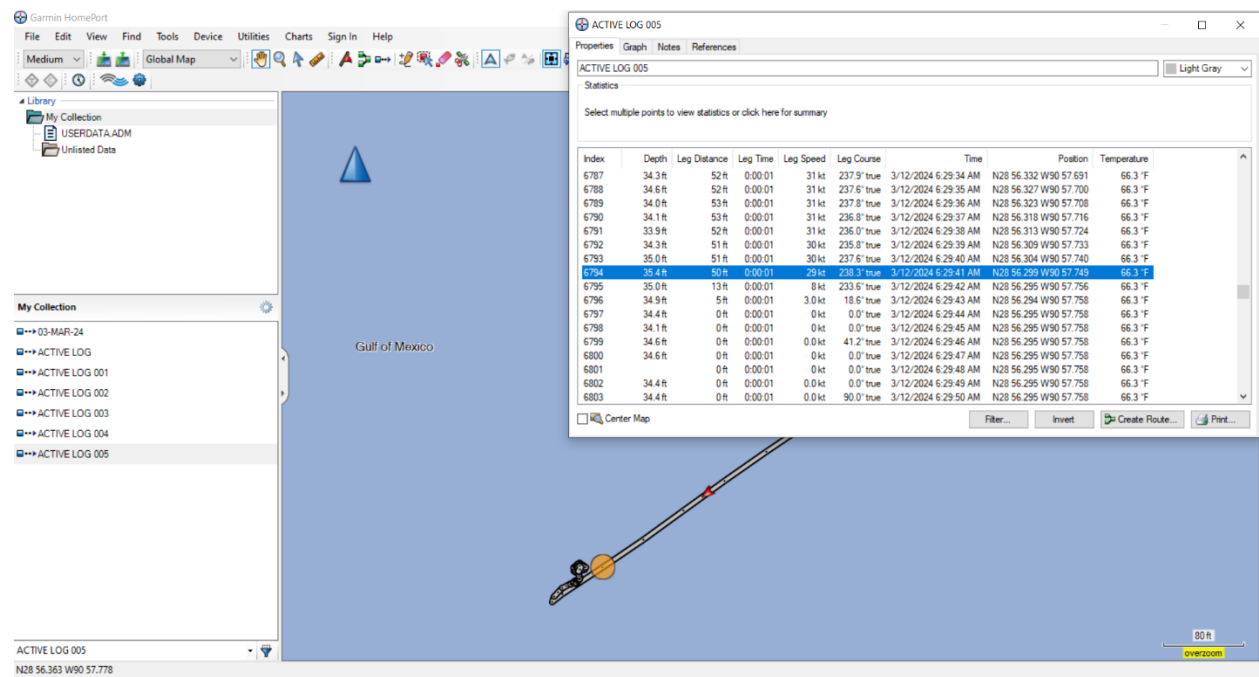
Figure 3. GPS data showing moment of impact speed. Retrieved March 27,2024. Source LINEDOUT GPS.

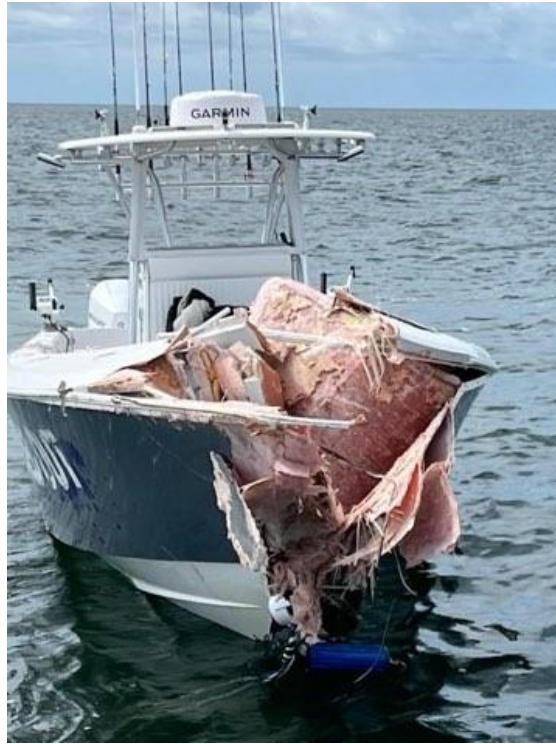
Figure 4. LINEDOUT bow damage from impact, Taken March 12, 2024. Source US Coast Guard.

4.1.8. The vessel LINEDOUT sustained extensive damage to the bow.

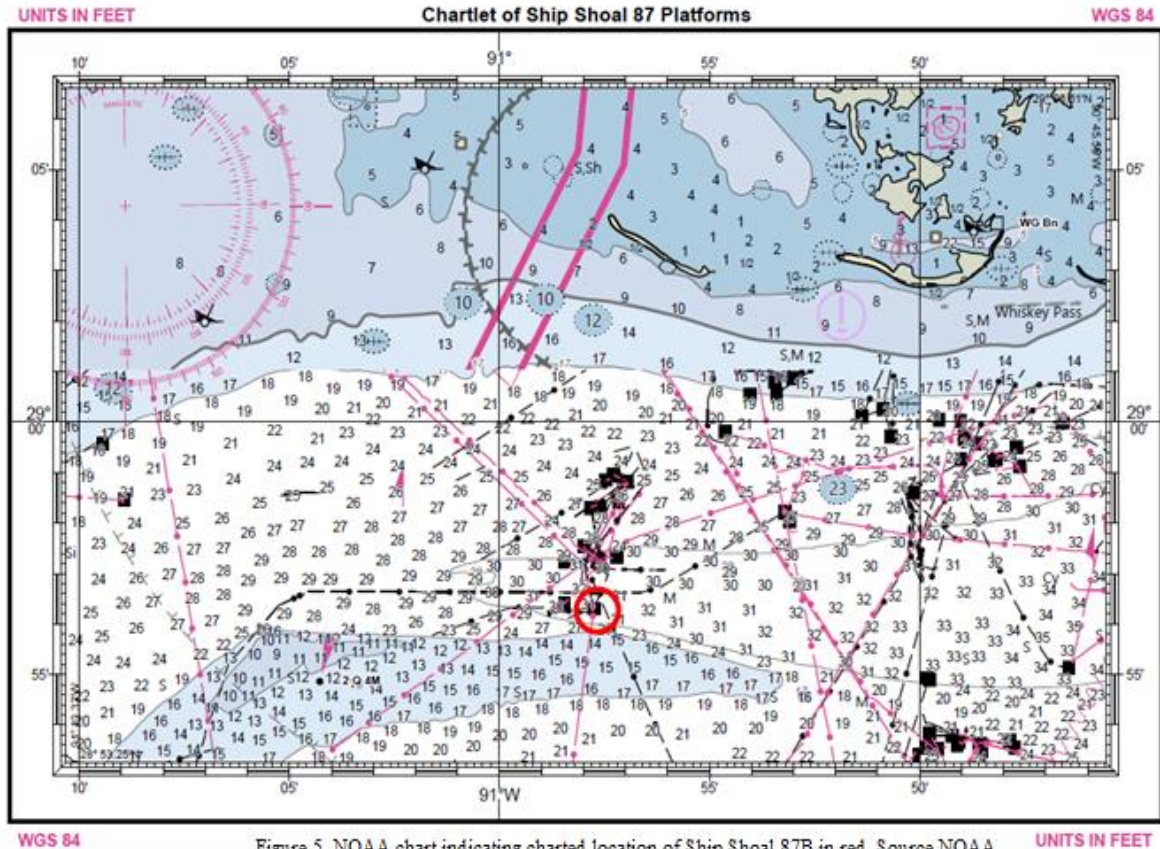
Figure 5. NOAA chart indicating charted location of Ship Shoal 87B in red. Source NOAA.

4.2.5. The Operator was driving the vessel via autopilot, following track lines previously installed. The Operator stated that he didn't see any obstructions, to include the SS-87B platform, in the path of the plotted track line. The Operator was also not sure of which scale the parameters the chart plotter was set for. As seen in Figure 5, the SS-87B platform is a charted object.
