REPORT OF THE INVESTIGATION  
INTO THE  
LOSS OF LIFE ABOARD THE COMMERCIAL  
FISHING VESSEL LISA JEAN (AK9001AR),  
TRANSITING SALISBURY SOUND ON AUGUST  
19, 2024

MISLE ACTIVITY NUMBER: 8095320

**INVESTIGATING OFFICER'S REPORT**

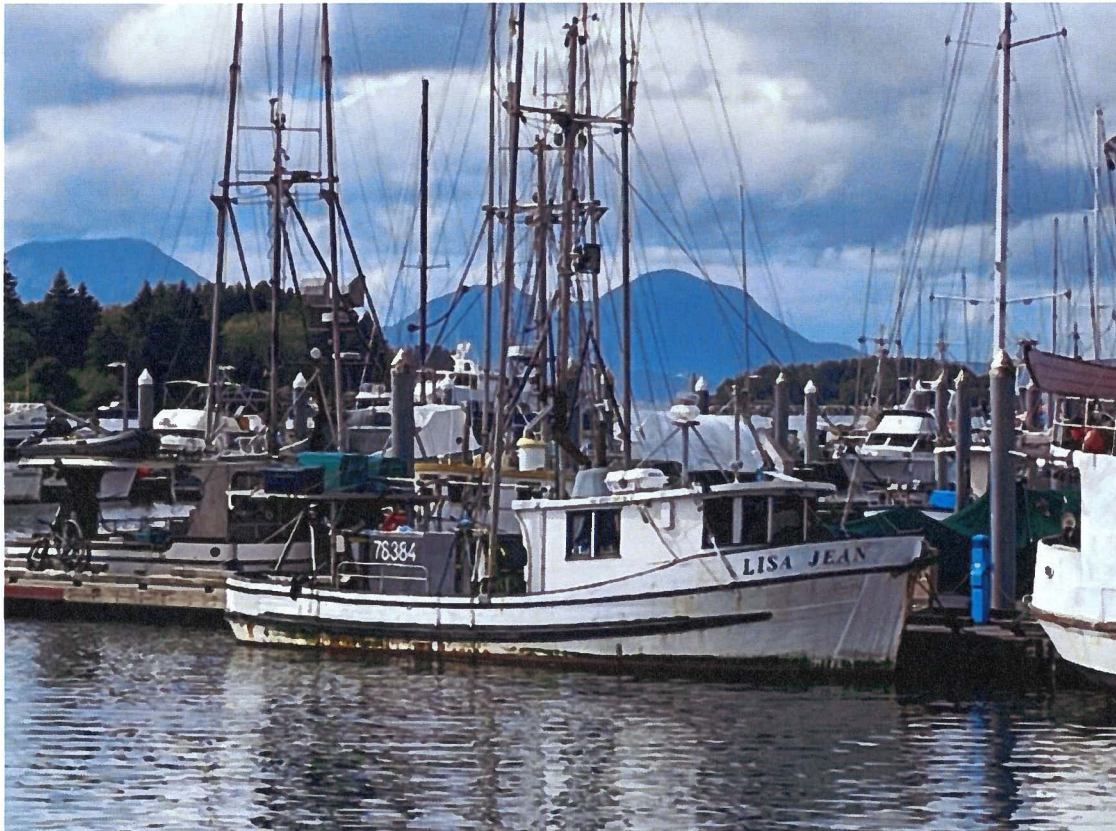
Figure 1. Photograph of LISA JEAN taken by U.S. Coast Guard in Sitka, AK on August 19, 2024.

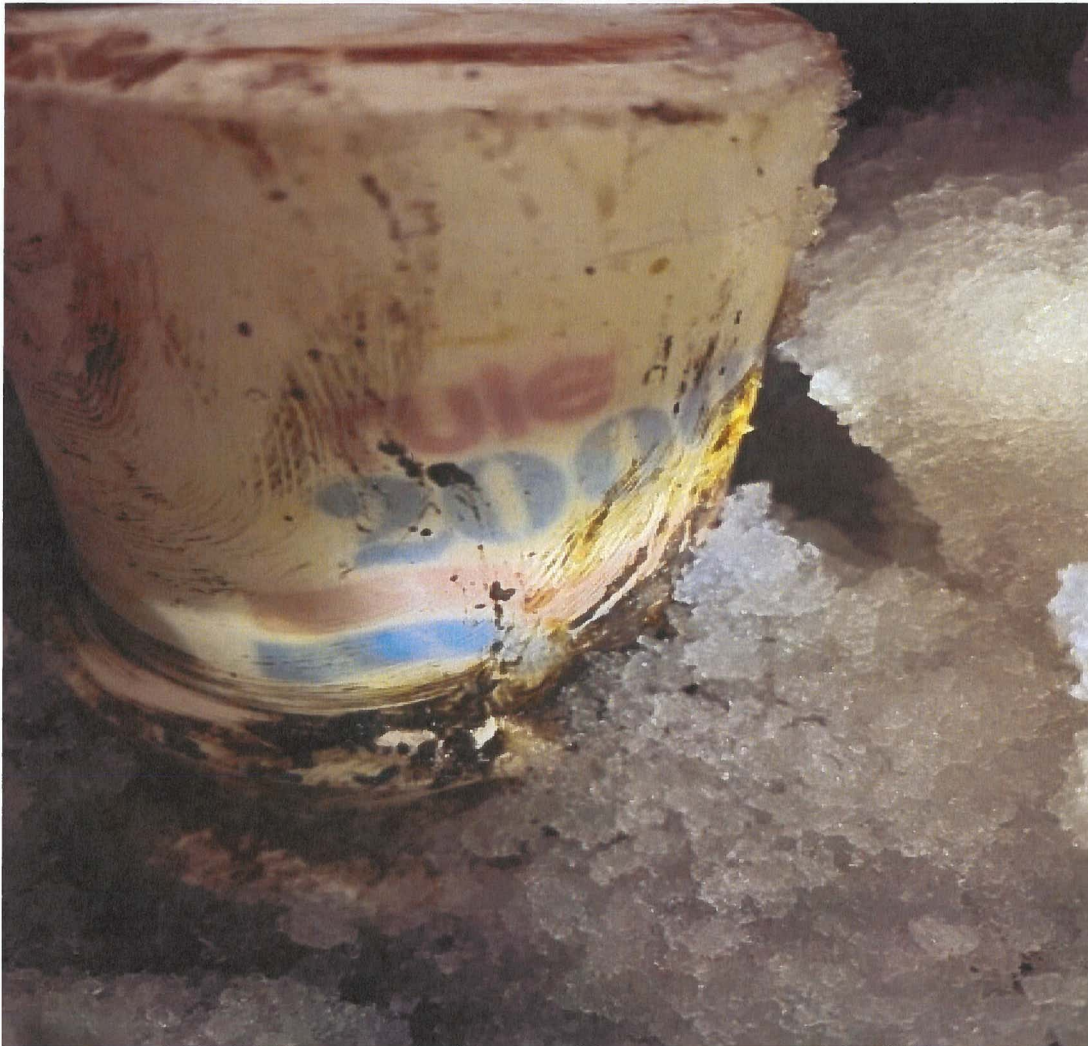
Figure 2. Photograph of Rule 2000 bilge pump installed in shaft alley taken by U.S. Coast Guard in Sitka, AK on August 19, 2024.

5.1. Water ingress. The crew of the LISA JEAN identified what was described as a significant leak. It is unclear how quickly the LISA JEAN was taking on water, and a source of the leak was not determined. The pumps installed aboard the LISA JEAN were Xylem brand Rule 2000 electric pumps rated at 2000 gallons per hour. This particular model was not fitted with an integral automatic activation switch and no external float-activated switches were identified during post-casualty survey of the vessel. The master instructed the deckhand to turn on the pumps every half hour for approximately 15 minutes. It is unclear whether the full 15 minutes were necessary or if the master simply had the deckhand run them extra-long to ensure the water ingress was kept at bay. In any event, the severity of the leak was enough to concern the master, though maybe not enough to prevent him from taking the LISA JEAN out to sea. While at sea, the master was demonstrably preoccupied with his concerns about the leak and finding its source. This sense of urgency likely factored into the master's decision to access the shaft alley while the vessel's engine was clutched into the running gear.

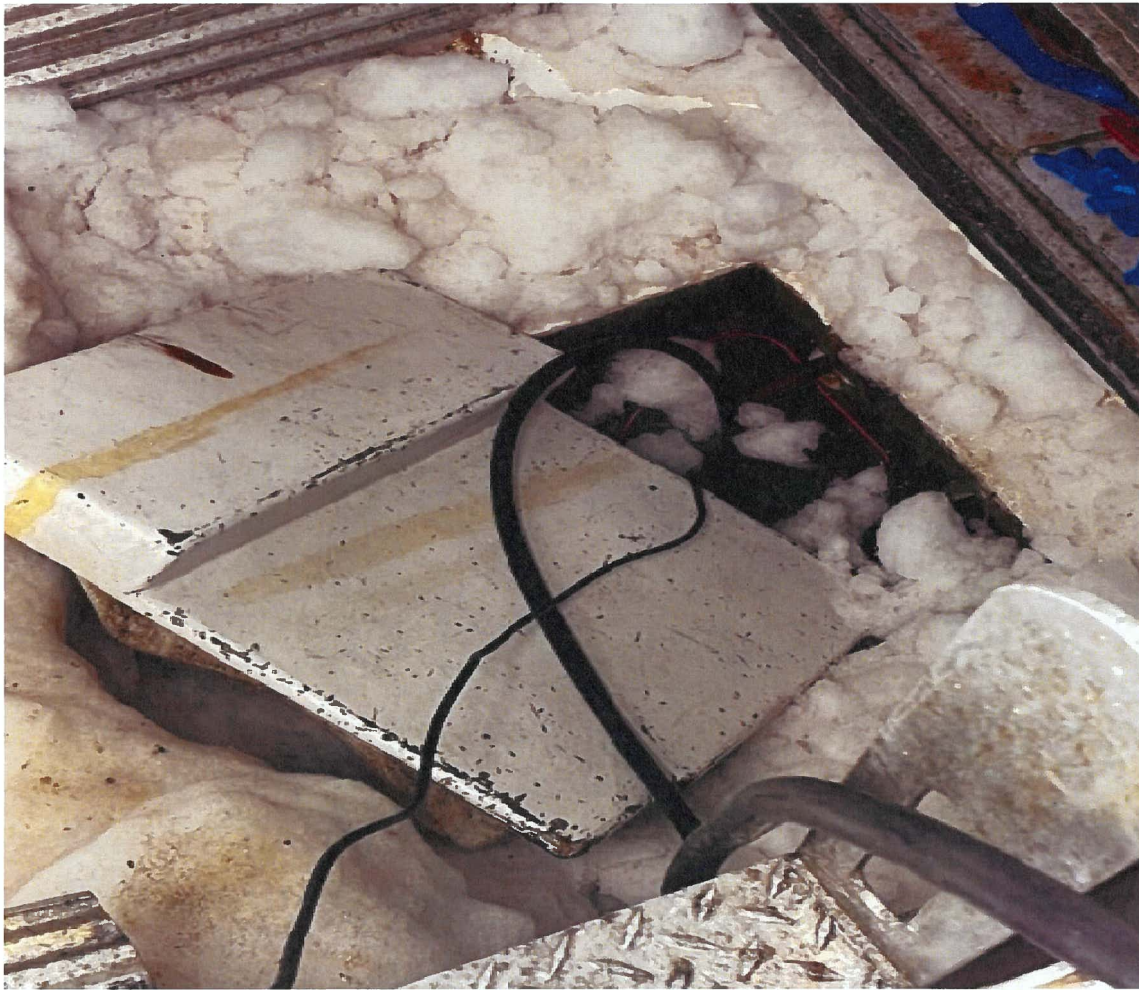
Figure 3. Photograph of shaft alley access hatch taken by U.S. Coast Guard on August 19, 2024.

5.2. The master's decision to enter the shaft alley while the propeller shaft was turning. The deckhand stated that the master had accessed the shaft alley on several prior occasions, all of which while the engine was secured. During the interview, the deck hand stated that he considered opening the shaft alley access hatch while the engine was running to be extremely dangerous. It is unclear whether the master had become complacent or if he intended for the propeller shaft to be turning when he accessed the shaft alley. Considering that the master had checked the shaft alley multiple previous times in search of the leak, it is plausible that the master might have considered a compromised shaft seal as the source of the leak and wanted to observe the shaft seal while the vessel was making way. In any event, this decision exposed the master to unguarded rotating machinery.

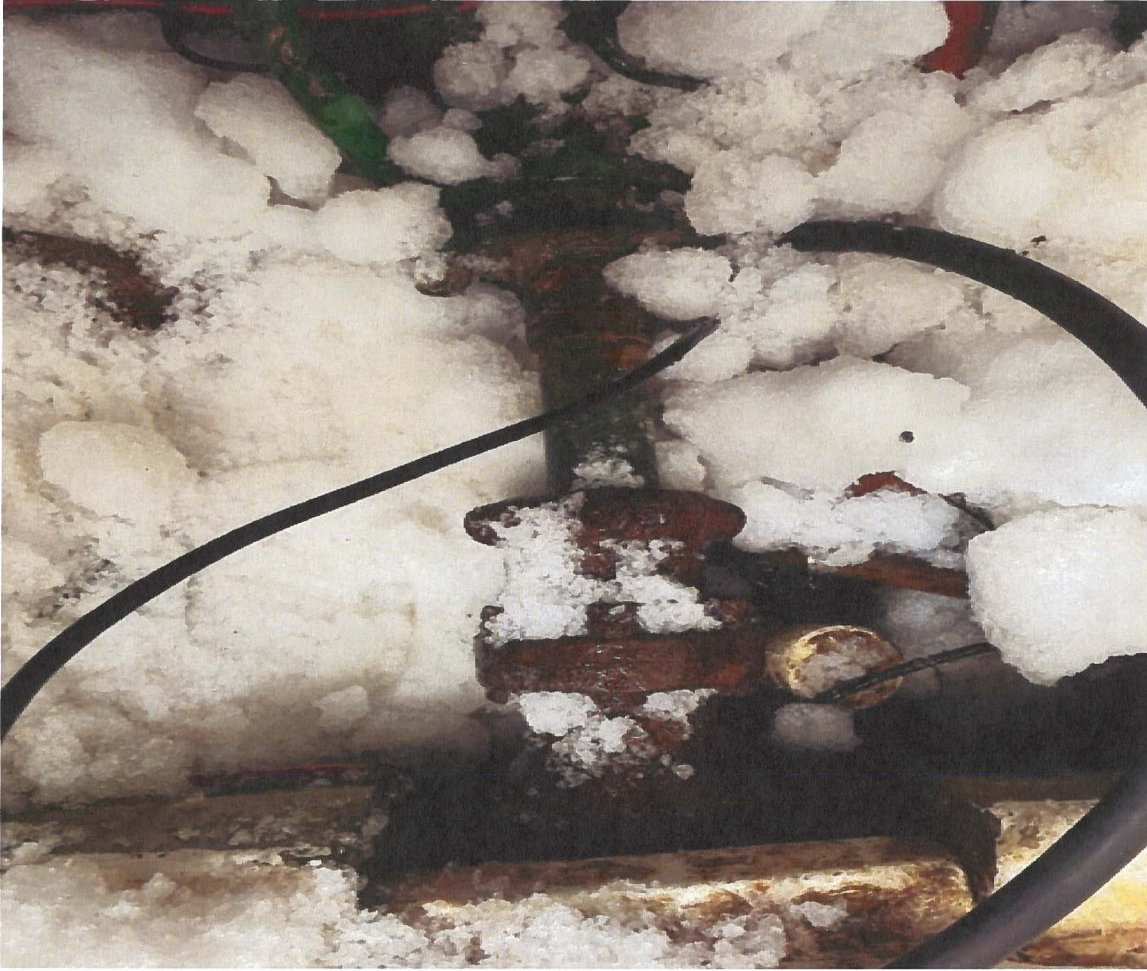
Figure 4. Photograph of propeller shaft taken by U.S. Coast Guard on August 19, 2024.

5.3. Removed machinery guards. The propeller shaft of the LISA JEAN was not fitted with machinery guards. The shaft alley of the LISA JEAN was not a normally occupied space and machinery guards would be both impractical and unnecessary to install. Nonetheless, the proximity of the vessel's fish hold and the shaft ally access hatch served, in the practical sense, as machinery guards and were sufficient to prevent injury during normal vessel operation. In essence, the master removed those defensive structures when he opened the shaft alley access hatch.

5.5. Main engine did not stall quickly enough to prevent fatal injury. The engine of the LISA JEAN was making turns to achieve salmon trolling speed, likely around 3 knots. At this slow speed, the entanglement of the master around the propeller shaft was sufficient to effectively stall the main engine. However, the engine did not stall before the master sustained fatal injuries. Had the engine stalled sooner, it is possible the master could have survived the entanglement. It should be noted that the stalling of the engine was not a designed nor intended safety defense mechanism. It was simply a product of the mechanical principles of internal combustion engine operation that, incidentally, had the potential to prevent or limit bodily injury.
