### LOSS OF LIFE ONBOARD THE WORKBOAT LITTLE G (MC954372) WHILE TRANSITING THE ALABAMA RIVER NEAR CLAIBORNE, AL ON JUNE 16, 2023

**SINKING OF THE UNINSPECTED WORKBOAT LITTLE G (CG1818164) AND  
SUBSEQUENT LOSS OF ONE LIFE WHILE HOLDING A DECK BARGE AGAINST  
THE EAST BANK OF THE ALABAMA RIVER IN THE VICINITY OF MILE  
MARKER 9 NEAR TENSAW, ALABAMA ON JUNE 16, 2023**

### **EXECUTIVE SUMMARY**

### **INVESTIGATING OFFICER'S REPORT**

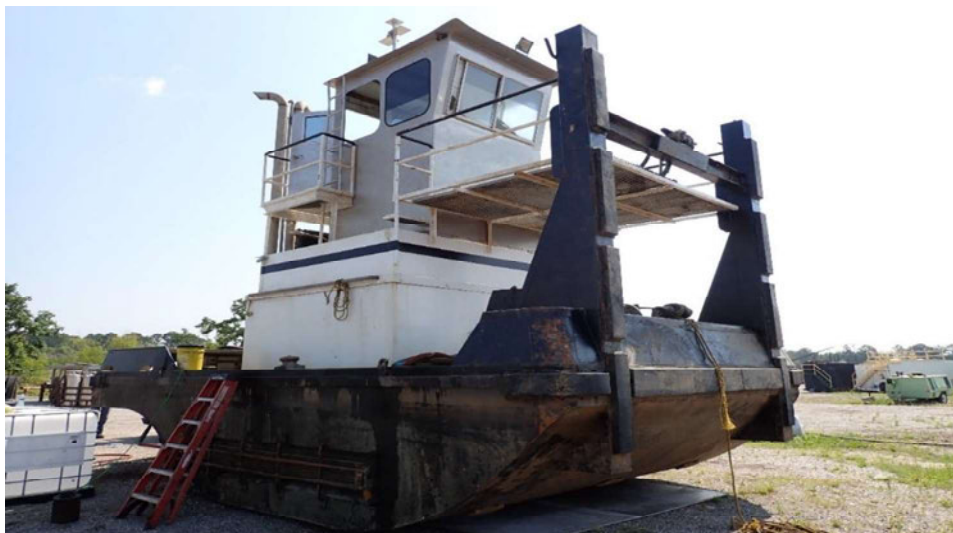
Figure 1. LITTLE G post salvage at MC Marine Shipyard, Chickasaw, AL. (June 30, 2023/Sector Mobile IO)

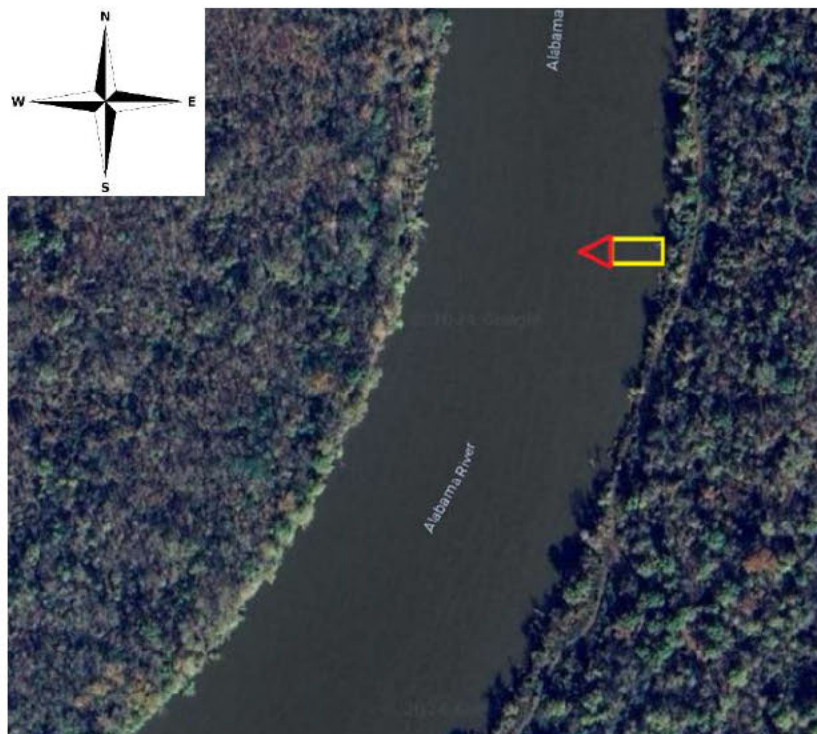
4.1.6. At 0400, June 16, 2023, Deckhand 1 awoke and discovered the vessel and barge shifted perpendicular to the bank, with the stern of the LITTLE G now positioned in the center of the river. Deckhand 1 then went back to sleep. The Master was not notified at this time.

Figure 6. Aerial view of the LITTLE G and barge shifted in a perpendicular position on the Alabama River. (Google Maps)

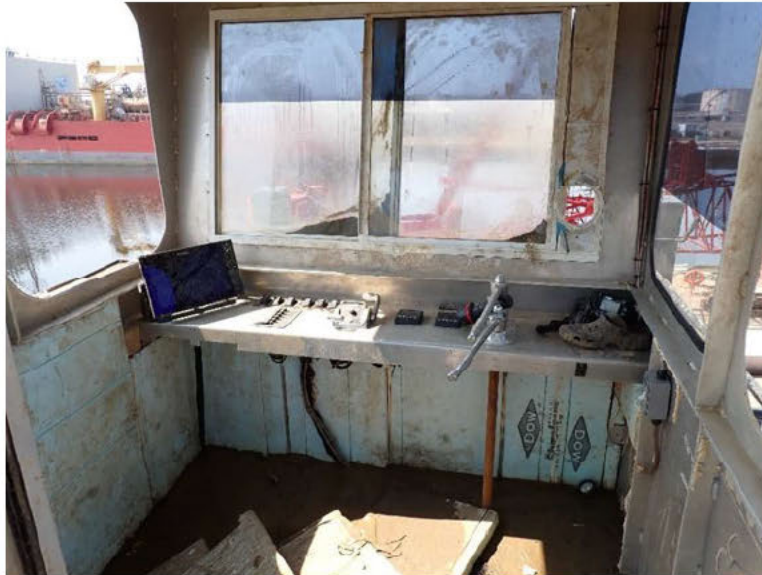
Figure 7. Wheelhouse of the LITTLE G post salvage at MC Marine Shipyard (June 30, 2023/Sector Mobile IO)

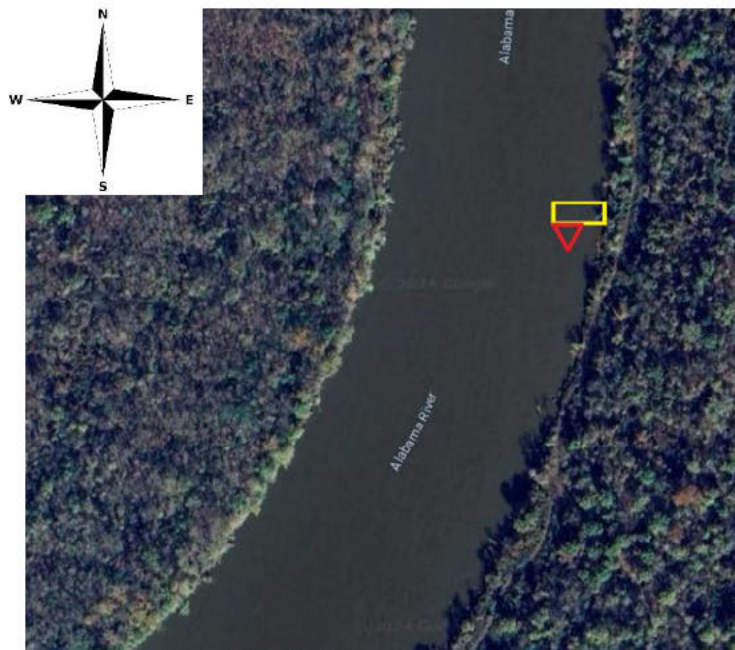
4.1.9. The Master then positioned the LITTLE G to push up against the starboard side (south side) of the perpendicular barge, with the intent of pushing it northward in a clockwise rotation back against the east bank of the river.

Figure 8. Aerial view of the LITTLE G pushing the starboard side of the barge. (Google Maps)

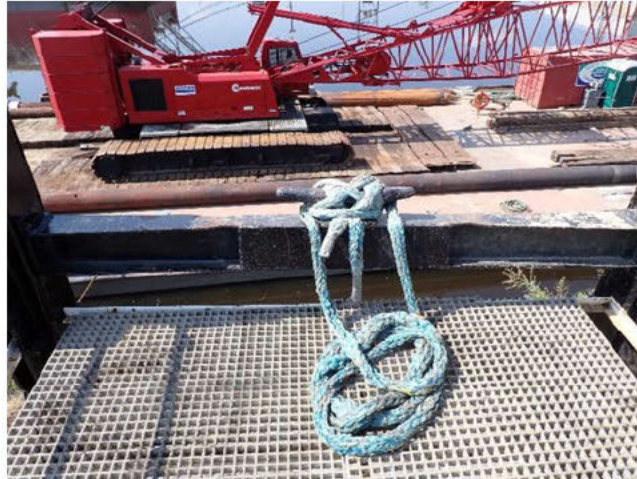
4.1.11. Once the LITTLE G was pushed up against the barge with the port side abreast the east bank, Deckhand 1 secured a towing line from the barge to the forward cleat of the LITTLE G.

Figure 9. LITTLE G forward cleat. (June 30, 2023/Sector Mobile IO)

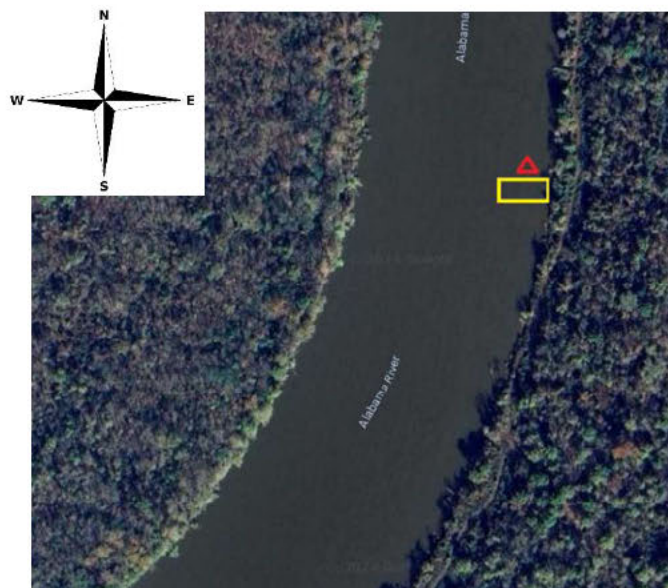
4.1.12. Shortly after affixing the towing line, water began rushing over the stern of the LITTLE G. The Master immediately ordered Deckhand 1 to remove the towline, to which Deckhand 1 replied that he believed it would make matters worse. The Master insisted, and Deckhand 1 eventually obliged.

4.1.13. After removing the towing line, flooding over the stern of the LITTLE G reportedly increased.

4.1.14. As the flooding over the stern of the LITTLE G continued, the barge simultaneously began shifting back to a perpendicular position.

Figure 10. Aerial view of the LITTLE G position to the north of the perpendicular barge. (Google Maps)

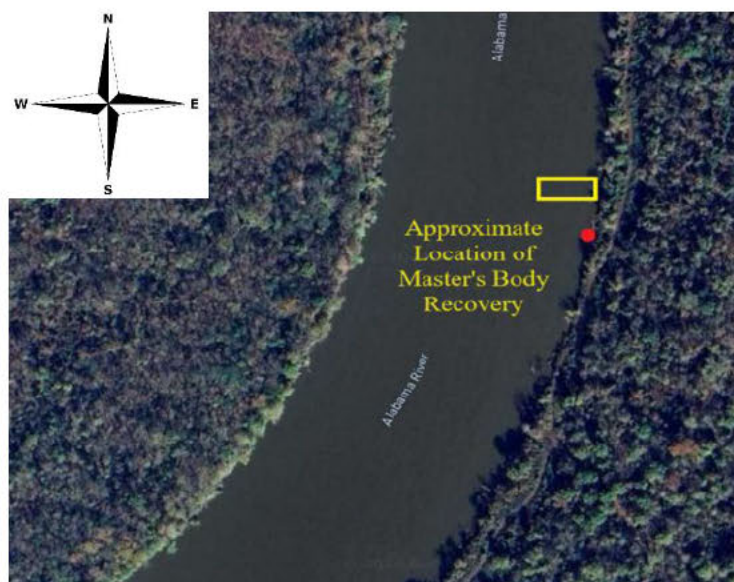
4.1.25. Once the Master's body resurfaced, it drifted approximately 100 yards south of the barge along the riverbank where first responders retrieved his body.

Figure 13. Aerial view of the body recovery in relation to the barge. (Google Maps)

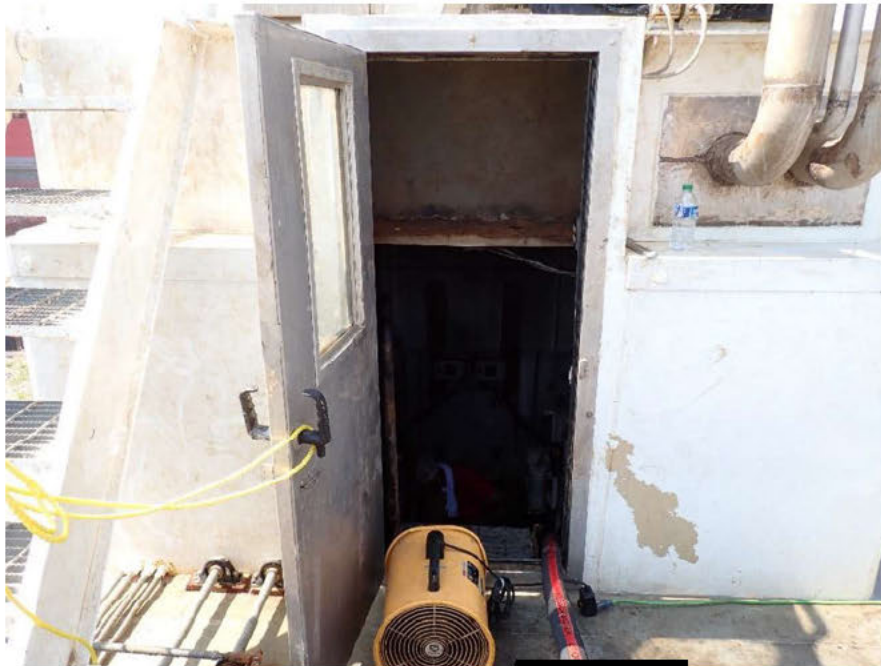
3. The risk of engine room down flooding is significantly increased when non-watertight doors are left in an open position. This office notes similar instances of engine room down flooding due to doors being propped open on inland-certificated towing vessels specifically. Maintaining these closures is a critical safety practice to prevent uncontrollable ingress of water.

4.2.6. The door leading to the engine room of the LITTLE G was not watertight. It is unknown whether the door was secured shut or open during this incident.

Figure 15. LITTLE G engine room door. (June 30, 2023/LT [REDACTED])
