**REPORT OF INVESTIGATION
INTO THE
COMMERCIAL FISHING VESSEL MASTER
KINGSTON (1044386), LOSS OF LIFE IN THE
GULF OF AMERICA
ON OCTOBER 08, 2024**

**FALL OVERBOARD AND SUBSEQUENT LOSS OF ONE LIFE FROM THE
COMMERCIAL FISHING VESSEL MASTER KINGSTON (O.N. 1044386), IN
THE GULF OF AMERICA APPROXIMATELY 6 NAUTICAL MILES SOUTH
OF SHIP ISLAND, MISSISSIPPI ON OCTOBER 8, 2024**

INVESTIGATING OFFICER'S REPORT

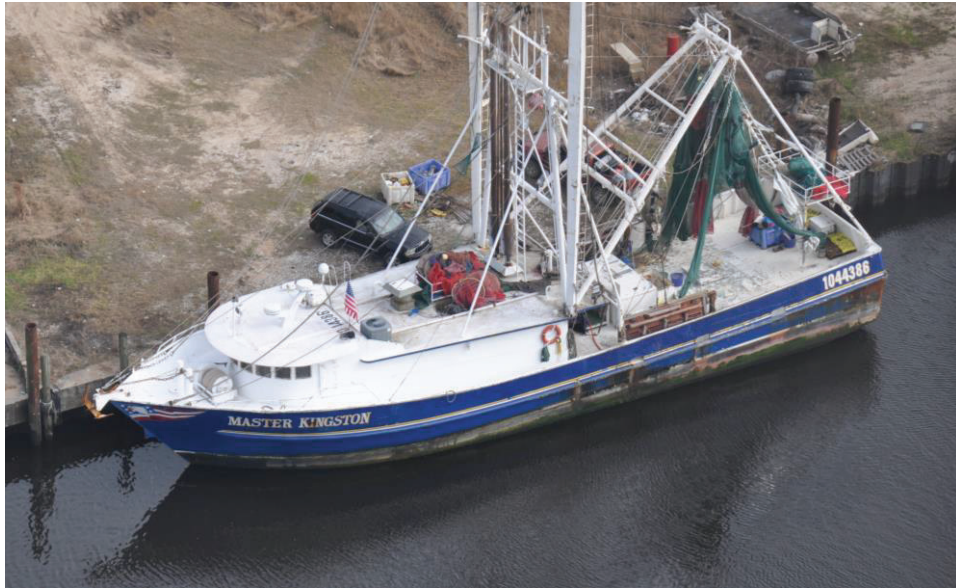
Figure 1. MASTER KINGSTON moored in Bayou La Batre, AL

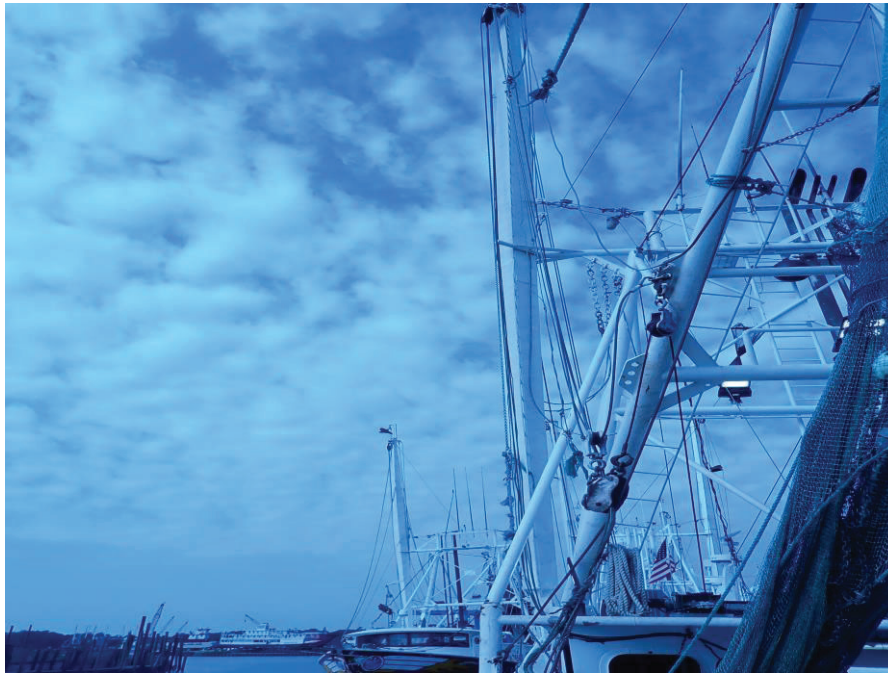
5.1 *Master's decision to climb aloft.* The Master chose to climb aloft on the port-side outrigger while the vessel's shrimping gear remained deployed. The purpose of this was to "bib the cable," a practice in which an auxiliary line is secured to the trawl nets to modify their vertical orientation within the water column. This adjustment is intended to cause the nets to ride higher, thereby targeting larger shrimp species typically located above the depth range of standard trawl operations.

Ascending a deployed outrigger in an attempt to bib the cable presented significant and avoidable hazards. The safer and more appropriate method would have been to recover the deployed gear and conduct the evolution from the working deck, where conditions are more controlled and the risk of falling or entering the water is substantially reduced. By proceeding aloft while the gear remained deployed, the Master introduced unnecessary exposure to environmental forces, vessel motion, and the dynamic strain of the trawl rigging.

It is likely the Master's decision to climb the rigging while underway was influenced by an operational desire to minimize downtime and maintain trawling operations. This decision prioritized efficiency over safety and directly increased the probability of casualty. Had the Master conducted the bibbing procedure from the deck, after recovery of the gear, it is reasonable to assume he would not have climbed aloft and therefore would not have entered the water.

Figure 2. Port side rigging of the CFV MASTER KINGSTON.

6.1.1.1. Master's decision to climb aloft while the port side rigger was extended over the water.

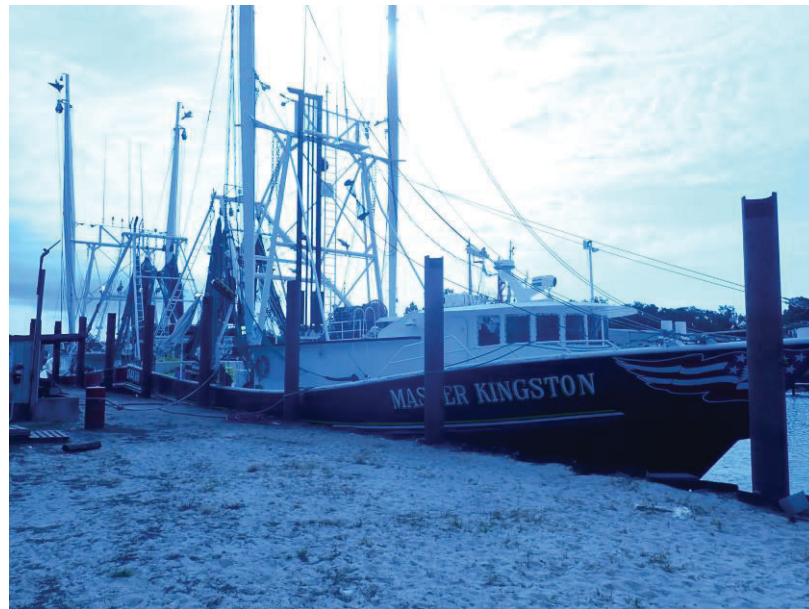
Figure 3. Starboard side of the CFV MASTER KINGSTON moored at homeport in Bayou La Batre, AL.
