# **UNITED STATES COAST GUARD**

**REPORT OF THE INVESTIGATION  
INTO THE  
MICHIPICOTEN (IMO: 5102865) STRUCTURAL  
FAILURE WHILE UNDERWAY ON LAKE SUPERIOR ON  
JUNE 08, 2024.**

**STRUCTURAL HULL FAILURE OF THE CANADIAN FLAGGED BULK CARRIER  
MICHIPICOTEN (IMO #5102865) WHILE TRANSITING WESTERN LAKE  
SUPERIOR 25 NAUTICAL MILES SOUTHEAST OF GRAND MARAIS, MINNESOTA  
ON JUNE 8, 2024**

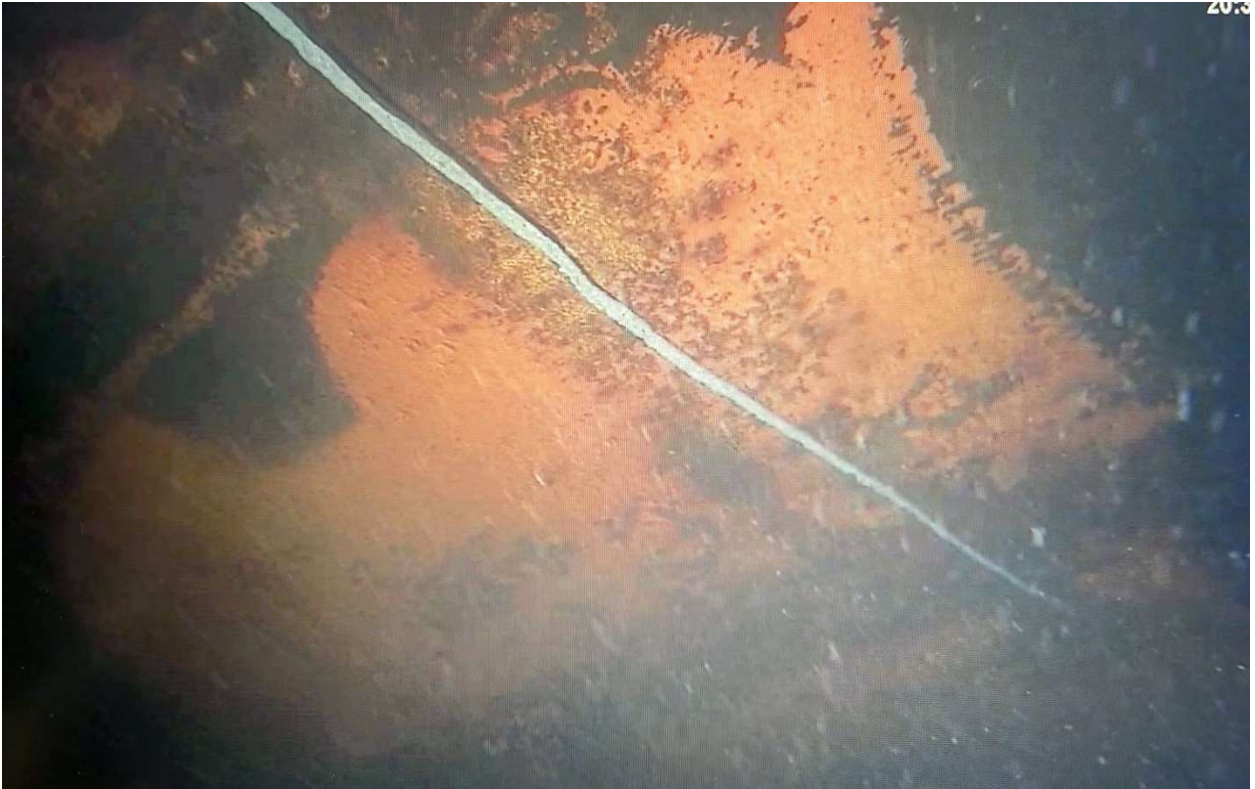
4.2.21. During the post-casualty inspection of the ship while in dry dock, inspectors discovered that the ship suffered a 13-foot crack in the hull plating in the vicinity of frame number 92, which is located within the starboard #4 ballast tank. Additional findings showed that the 13-foot crack extended an additional 55 inches into the inboard longitudinal bulkhead of the #4 ballast tank, and that the #1 inner void was compromised.

Figure 3. Crack in MICHIPICOTEN Hull Plating taken during dive survey.

4.3.4.1. Bay Engineering was hired as a 3rd party engineering consultant for the ship. During their investigation they found indications that a cement box patch had been installed on frame 92 where the structural failure occurred. Cement box patches are temporary repairs typically installed to stop leaks. There is no evidence or record from either the Classification Society or the company of why a cement box patch would have been installed in this location.

5.1. *Chronic Overstressing.* Cargo loading records from the incident voyage (Voyage 021) and the four preceding voyages (Voyage 017 through 020) indicate that the MICHIPICOTEN was loaded beyond the permissible at-sea bending moment limitations as outlined in the cargo loading manual on all five voyages. Voyage 017 was loaded to 102%, Voyage 018 to 112%, Voyage 019 to 109%, Voyage 020 to 112%, and Voyage 021 to 113% of the ship's at-sea bending moments. A Coast Guard Salvage Engineering Response Team (SERT) analysis of these voyage loading plans found that the location of the highest bending moments and tensile stress on the hull bottom plating occurred between 14 and 36 feet from frame 92 (the location of the fracture) during each of these voyages. This repetitive overloading of the ship contributed to cumulative stress on the ship's structural members and hull plating, weakening them to the point of failure. Every loading record reviewed as part of this investigation showed that the ship had been overloaded to excess of 100% its at-sea bending moment. Had the ship adhered to proper loading practices, the stress on the hull would have remained within design specifications, and this casualty may have been avoided.

7.1. Upon safe navigation from Thunder Bay, Ontario, Canada, to Fraser Shipyard in Superior, WI, the MICHIPICOTEN repaired the 13-foot hull crack and the 55-inch crack that extended into the longitudinal bulkhead. All repairs were made to the satisfaction of the Classification Society, ABS. On June 14, 2024, Transport Canada revoked the year of grace approval for the dry docking of the ship, to which Lower Lakes Towing Ltd. appealed. On July 25, 2024, Transport Canada supplied the ABS report detailing the results of the inspection conducted on the internal and external hull structures to Marine Safety Unit Duluth for review. Marine Safety Unit Duluth Inspectors reviewed the report on July 27, 2024, and noted several concerning findings.

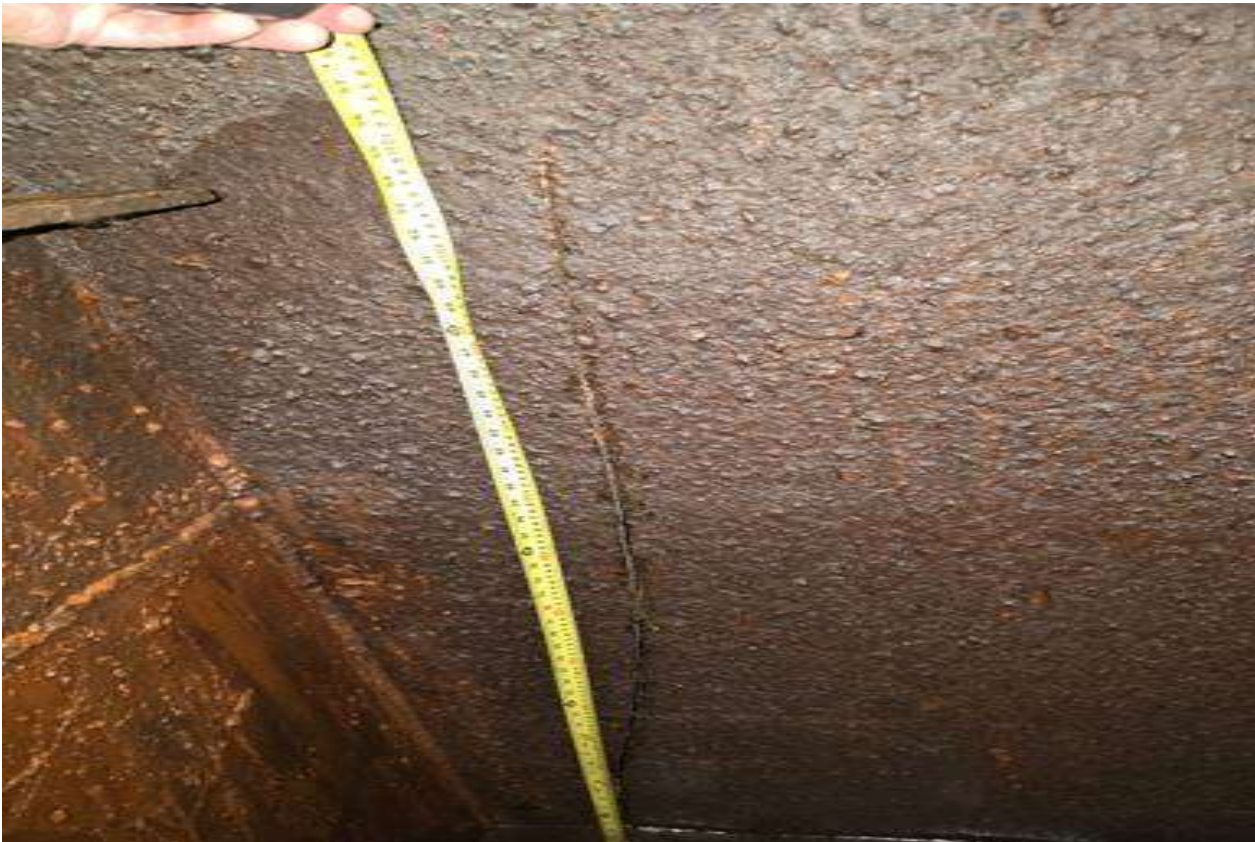
Figure 4. 55-inch crack in the longitudinal bulkhead.
