**REPORT OF INVESTIGATION  
INTO THE  
TOWING VESSEL MILES MADISON (O.N.  
1244647), CREWMEMBER FELL  
OVERBOARD AND LOSS OF LIFE ON THE  
UPPER MISSISSIPPI RIVER IN LOCK  
AND DAM 27 ON SEPTEMBER 20, 2023**

**MISLE ACTIVITY NUMBER: 7796025**

**FALL OVERBOARD AND SUBSEQUENT LOSS OF LIFE INVOLVING THE  
INSPECTED TOWING VESSEL MILES MADISON (O.N. 1244647) IN LOCK AND  
DAM 27 ON THE UPPER MISSISSIPPI RIVER NEAR GRANITE CITY, ILLINOIS  
ON SEPTEMBER 20, 2023**

**INVESTIGATING OFFICER'S REPORT**

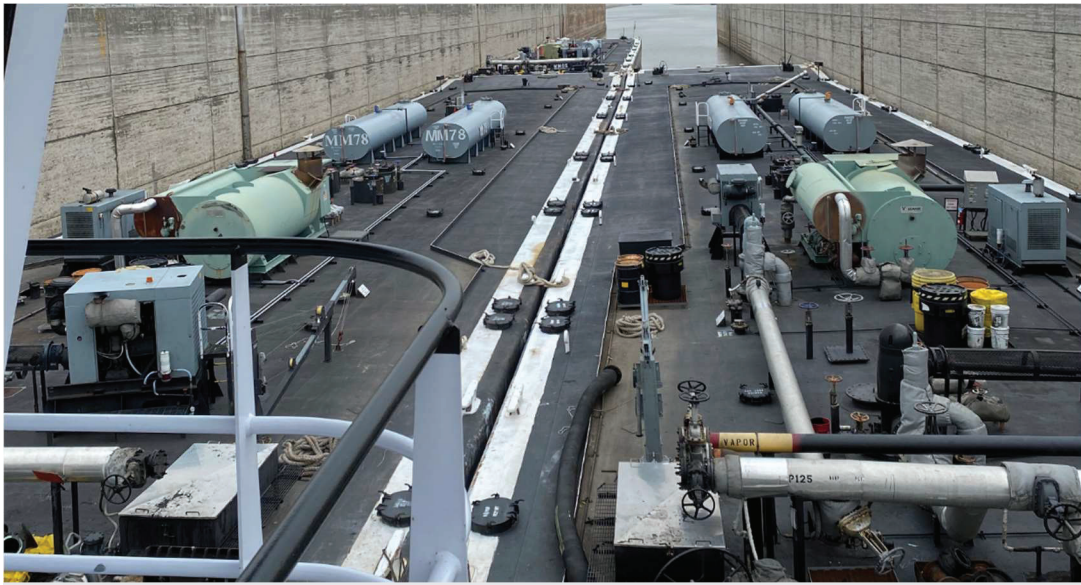
Figure 2. Photograph of MILES MADISON tow arrangement with MM 65, MM 78 and MM 30 in Locks and Dam 27 taken September 20, 2023.

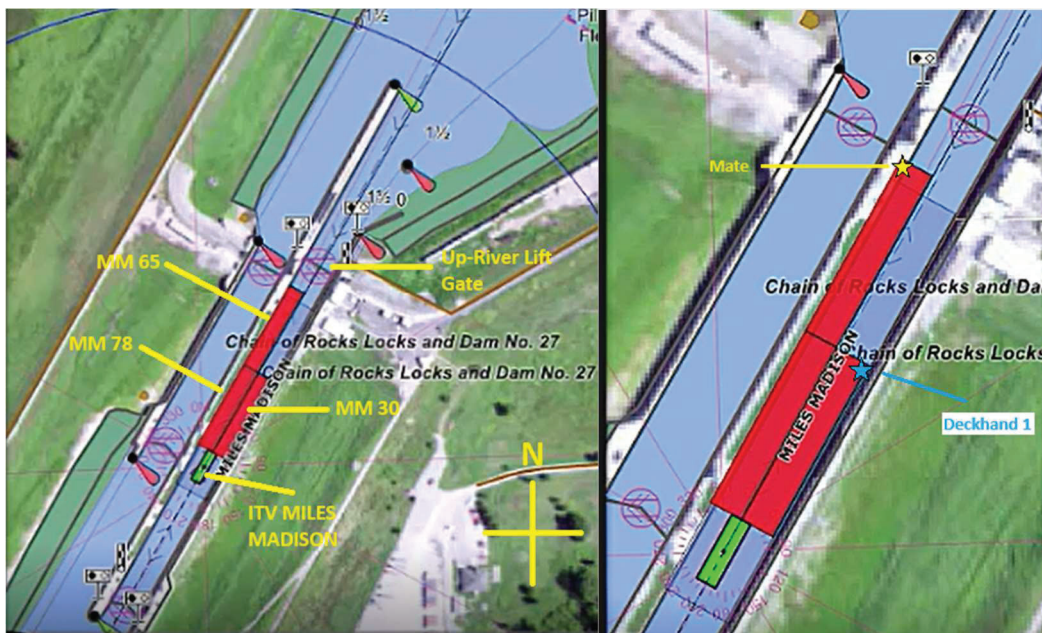
Figure 3. General arrangement of MILES MADISON and tow inside Lock and Dam 27. MILES MADISON is faced-up to the intersection of the two aft barges heading upriver. Vessels to approximate scale. Compiled from the ITV's Rosepoint data and created by the CG Investigation National Center of Expertise.

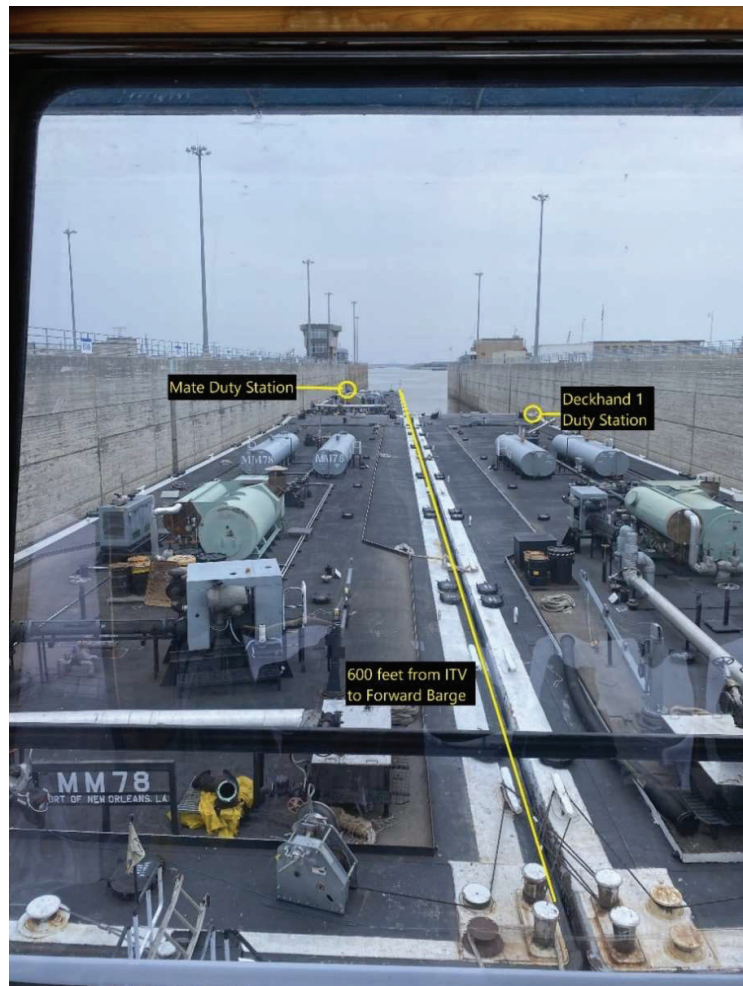
4.2.5.1. The overall distance from the Pilothouse to the head of the port lead barge was over 600 feet. This distance made visual contact for the Master with on deck workers challenging as shown in Figure 4. This is aggravated when considering on-deck obstructions such tanks, boilers, etc. that can obstruct crewmembers transiting the deck.

Figure 4. Photo taken from the Pilothouse of the ITV MILES MADISON looking forward out to the head of the tow. MILES MADISON is faced-up to the intersection of the 2 aft barges heading upriver.

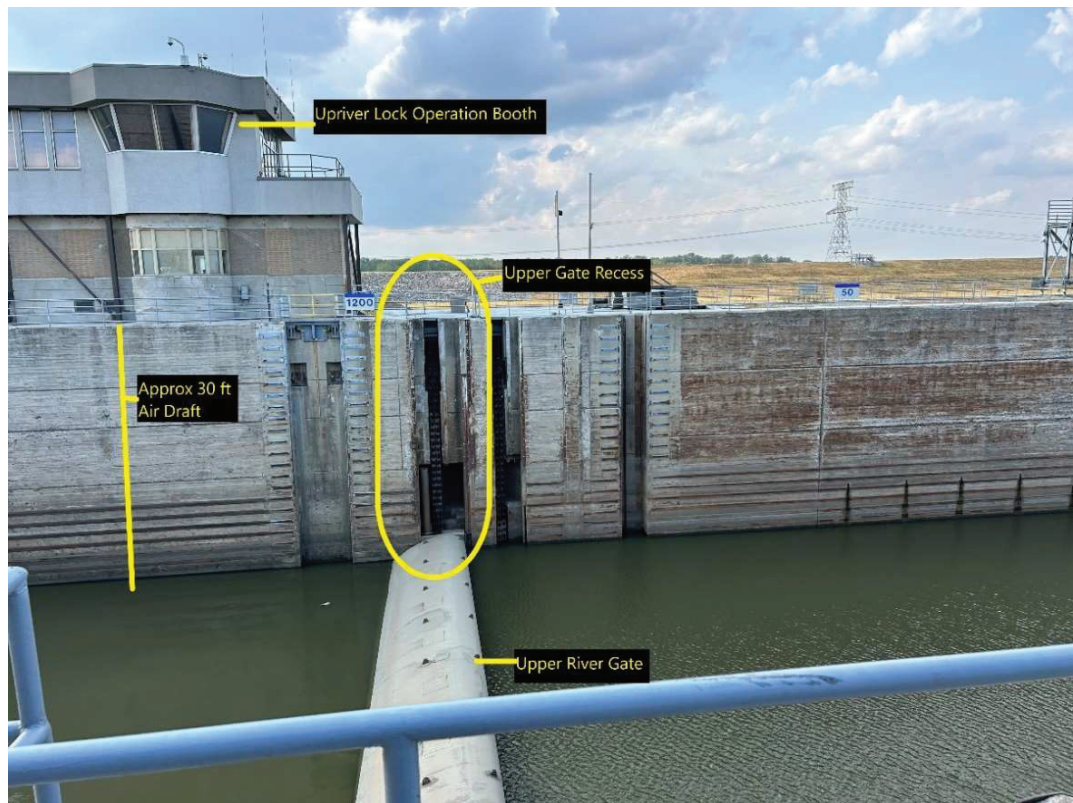
4.2.5.2. At the time of the incident, L&D 27 did not have any barriers, safeguards or warnings in way of the recesses that house the appurtenances that are responsible for lowering and raising both the downriver and upriver gates. These appurtenances include, but are not limited to, the gate chain. Figure 5 depicts the upriver gate as seen from the top of the eastside lock chamber wall looking across to the west (the area where the entanglement of the bumper occurred). The steep angle of visibility from the Upriver Lock Operation Booth to the port bow of the MM 65 created a blind spot to any emergency or danger that may be occurring in the lock chamber below.

Figure 5. Photo taken from the top of the eastern chamber wall looking across to the west lock chamber wall. River conditions at the time of the incident afforded approximately 30 ft of air draft from the river level to the top of the chamber
