# **UNITED STATES COAST GUARD**

## **REPORT OF THE INVESTIGATION INTO THE**

### **LOSS OF LIFE FROM THE COMMERCIAL FISHING VESSEL NC3250BW IN CEDAR ISLAND BAY ON AUGUST 20, 2024**

### INVESTIGATING OFFICER'S REPORT

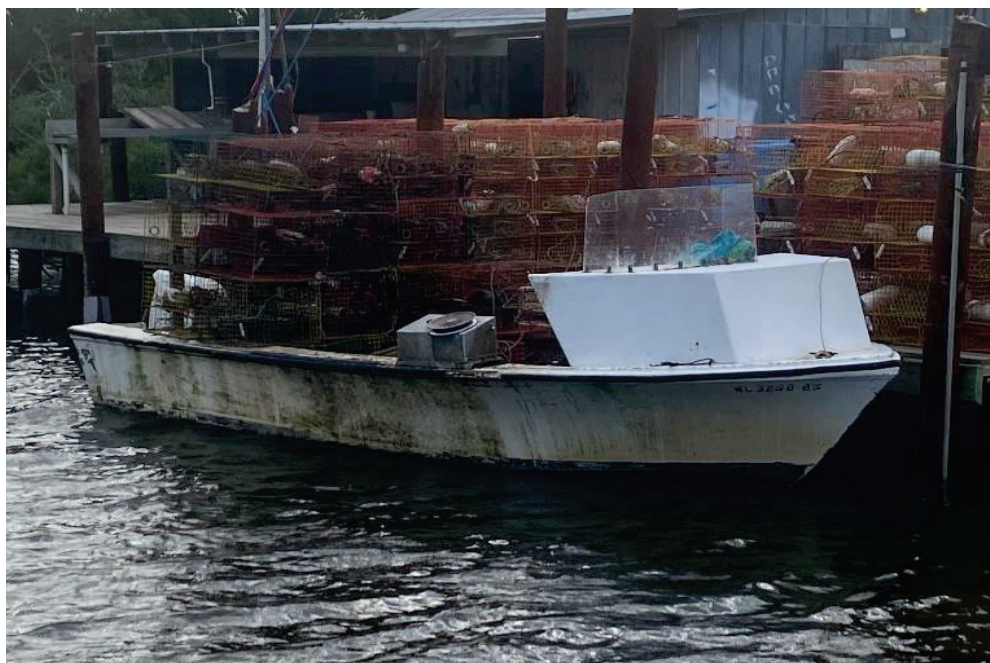
Figure 1: Photograph of Commercial Fishing Vessel NC3250BW. Photo sourced from USCG Investigating Officer.

4.2.1. The 22-foot, fiberglass-hull, downeaster-style commercial fishing vessel, registration # NC3250BW, has been registered to its owner/operator since 1998. It is equipped with a single outboard engine and modified for crabbing with a forward remote steering station and a starboard-mounted crab pot puller. NC3250BW was modified to steer its single gasoline outboard engine from the bow using a system of pulleys, lines and a wooden tiller.

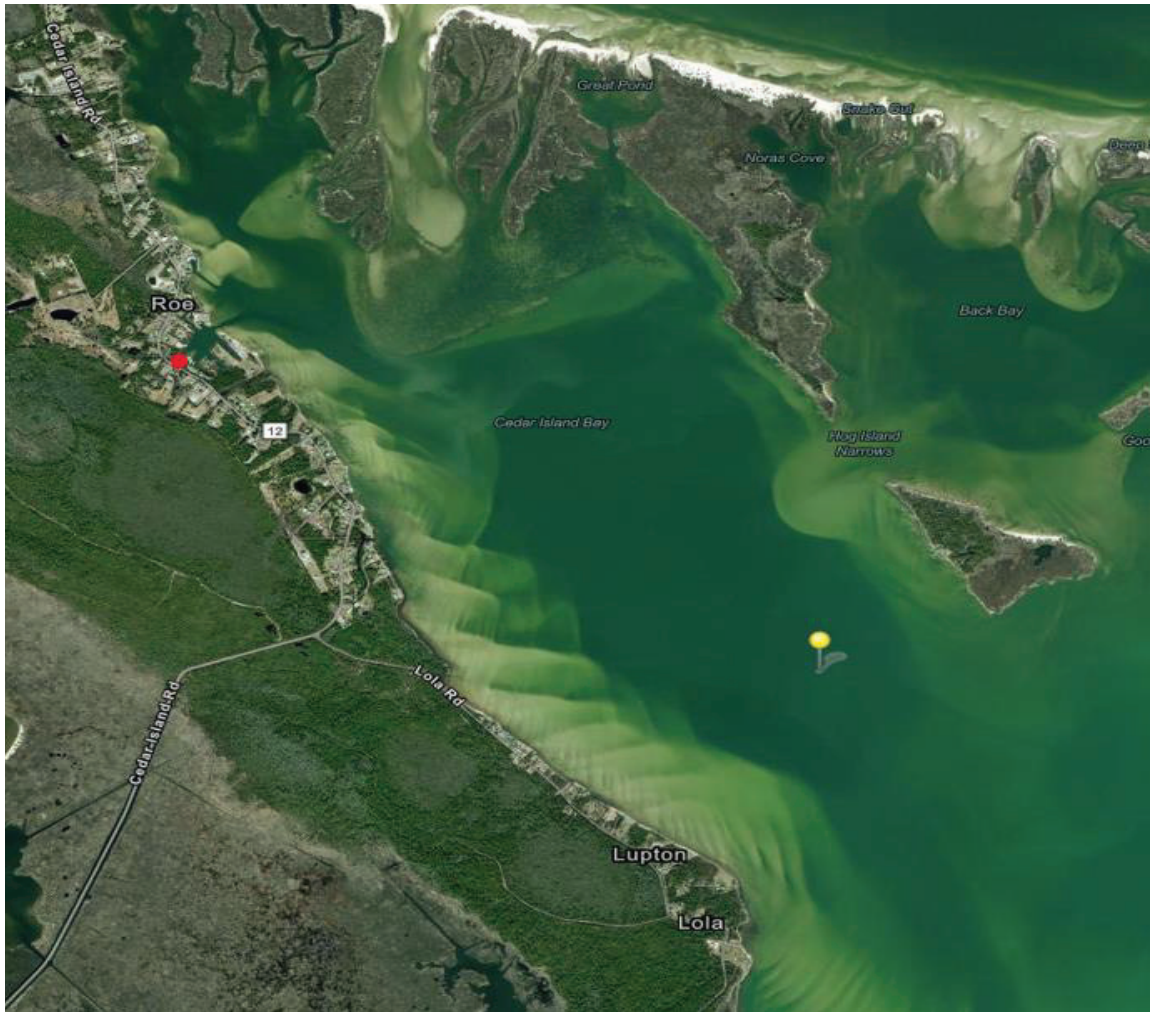
4.1.9. NC3250BW was found unmanned, with its clutch engaged in forward gear and the helm fixed hard to starboard, causing it to circle in Cedar Island Bay.

Figure 3: Satellite image of Cedar Island Bay from MISLE GIS Map Point Picker. The yellow pin marks the approximately location where NC3250BW was found making circles, while the red dot indicates the location of the fish house.

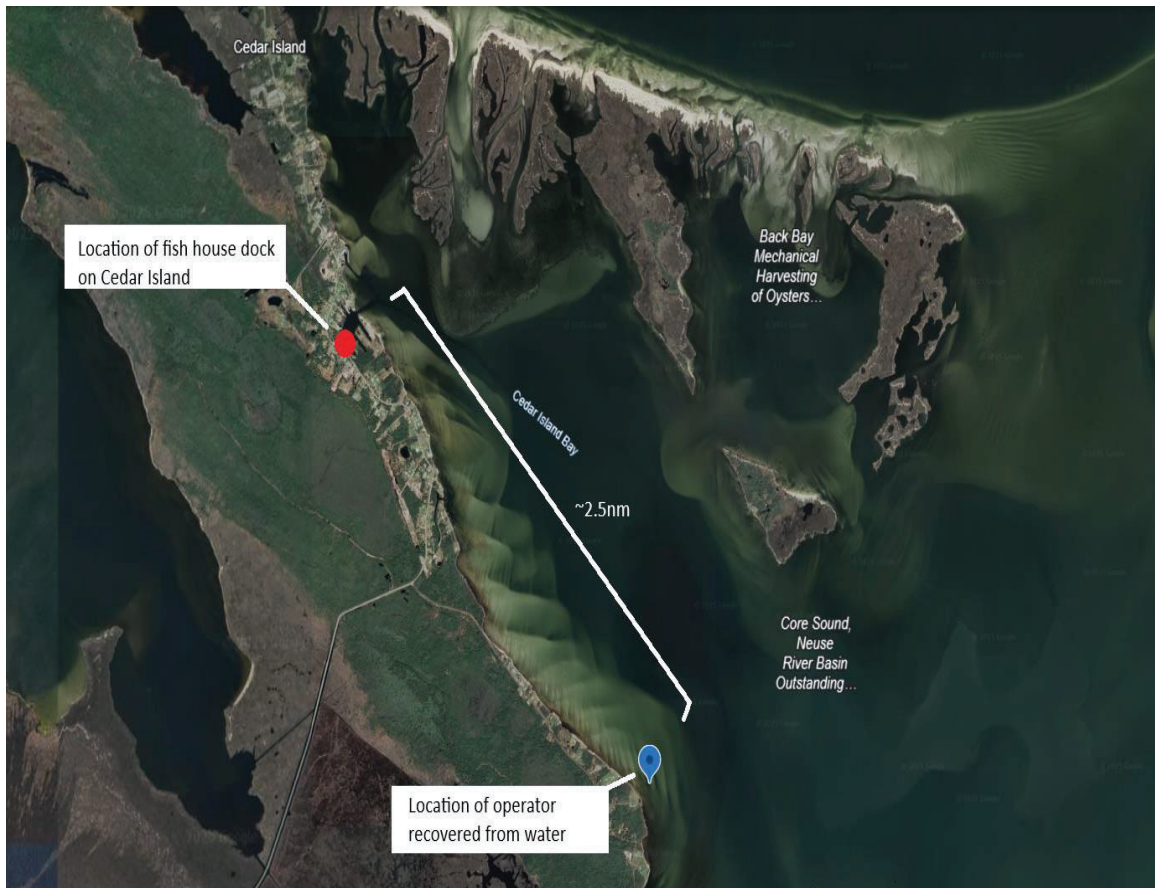
4.1.15. At 1450, CG 6018 was alerted by a Good Samaritan to an unresponsive person in the water at position 34-57.416N / 076-16.385W.

Figure 4: Satellite image of Cedar Island Bay showing the approximate location of the unresponsive operator marked by a blue dot, in relation to the fish house and its estimated distance, captured from Google Maps.

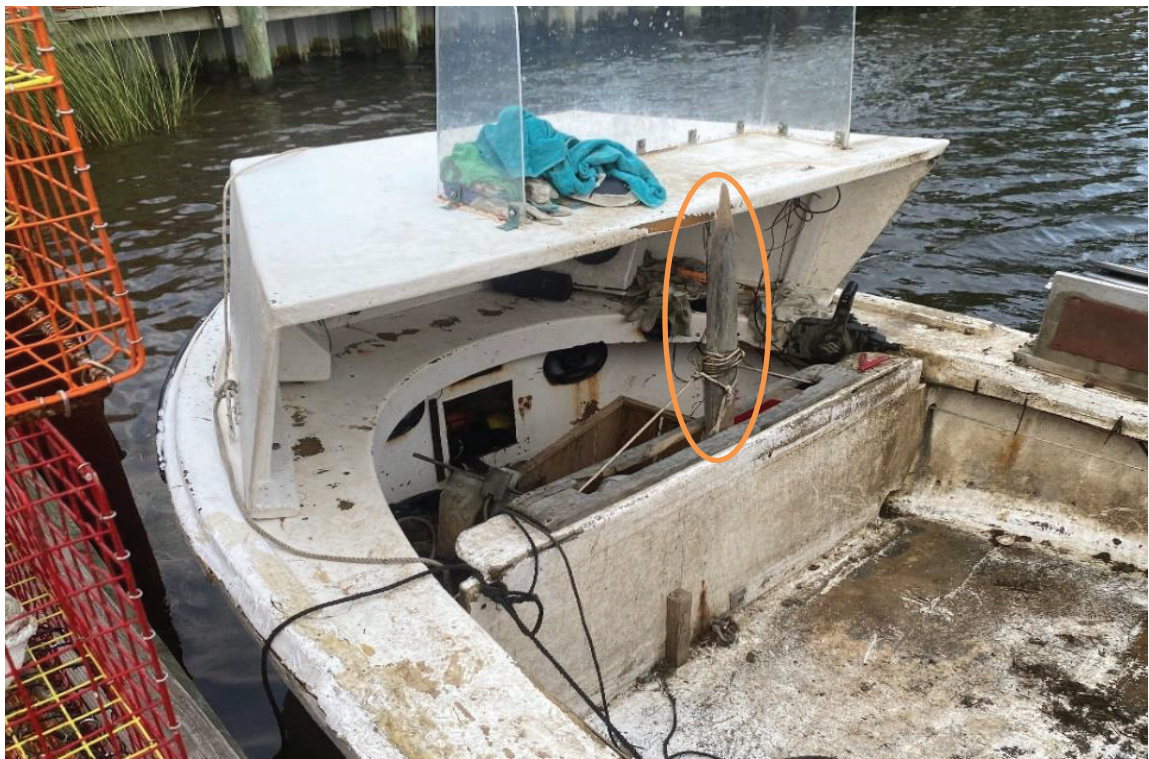
Figure 5: Photograph of the operating area in the bow of NC3250BW. The oval highlights the tiller handle used for steering from the forward position of vessel. Photo sourced from the USCG Investigating Officer.

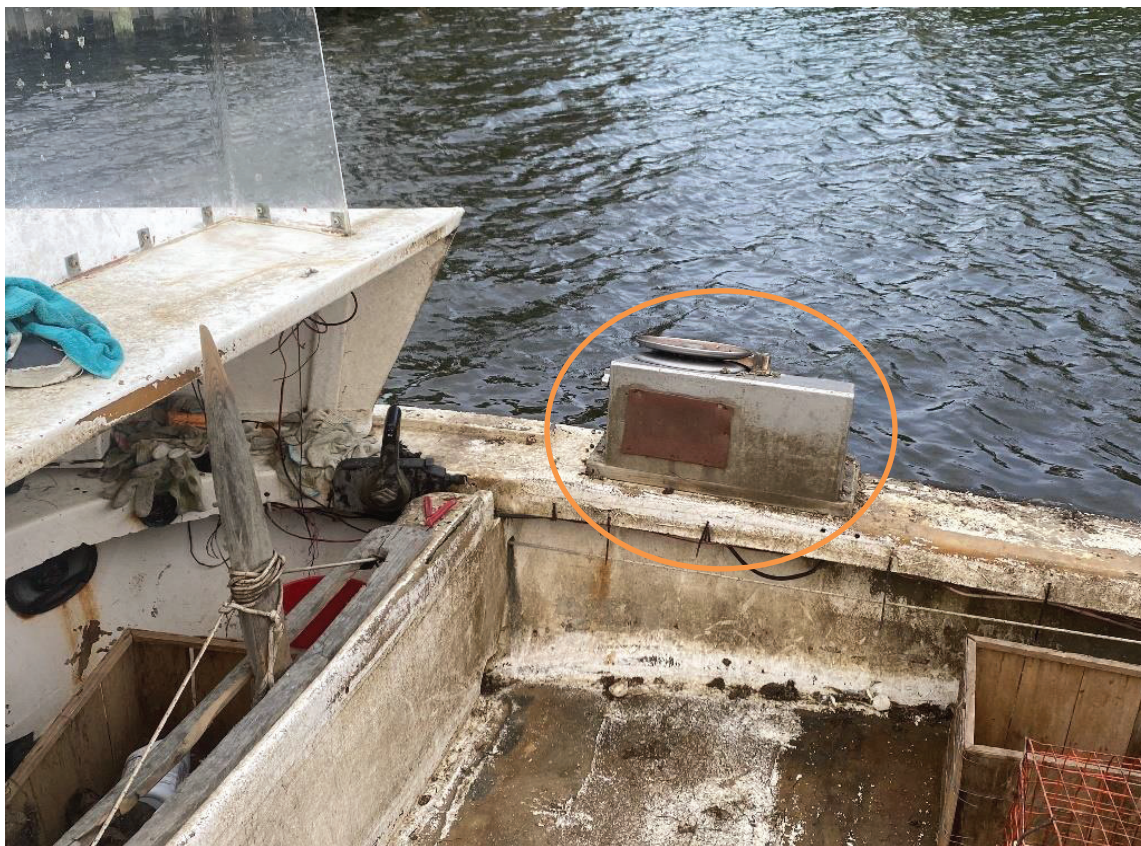
4.2.2. Crabbing operations onboard NC3250BW typically involved the use of a handheld catch hook to retrieve trap lines, which were then fed into a pot puller. The pot puller utilized the vessel's propulsion to lift traps from the water, a process that often required the operator to lean against or over the starboard gunwale. No evidence of malfunction or tampering was found on the pot puller or any other vessel equipment that would account for the operator's entry into the water. Notably, the catch hook was missing from the vessel.

Figure 6: Photograph of operating area of NC3250BW. The circle highlights the “pot puller” mounted on the starboard gunwale. Photo sourced from the USCG Investigating Officer.
