**REPORT OF THE INVESTIGATION
INTO THE
COLLISION BETWEEN THE PROWLER (O.N.
294465) AND THE ATTESSA IV (IMO 9179830)
SOUTH OF THE U.S./MEXICO MARITIME BOUNDARY
LINE
ON OCTOBER 26, 2018**

**MISLE ACTIVITY NUMBER:
6572770**

COLLISION BETWEEN THE SMALL PASSENGER VESSEL PROWLER (O.N. 294465) AND THE CAYMAN ISLANDS FLAGGED YACHT ATTESSA IV (IMO #9179830) RESULTING IN THE LOSS OF ONE LIFE WHILE TRANSITING APPROXIMATELY NINE MILES SOUTHWEST OF IMPERIAL BEACH, CALIFORNIA ON OCTOBER 26, 2018

INVESTIGATING OFFICER'S REPORT

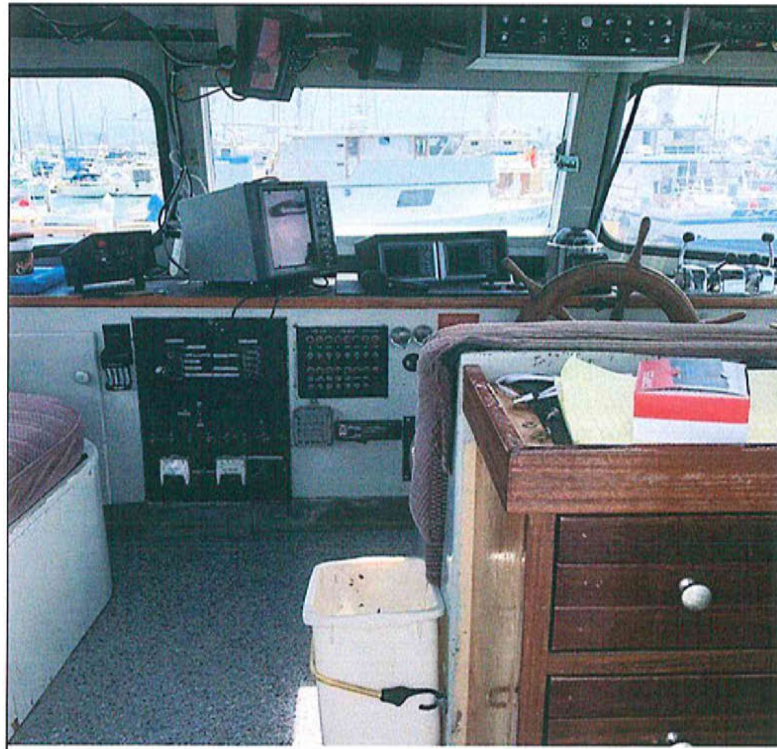
Above: Photograph of PROWLER's operating station prior to collision, provided by the owner.

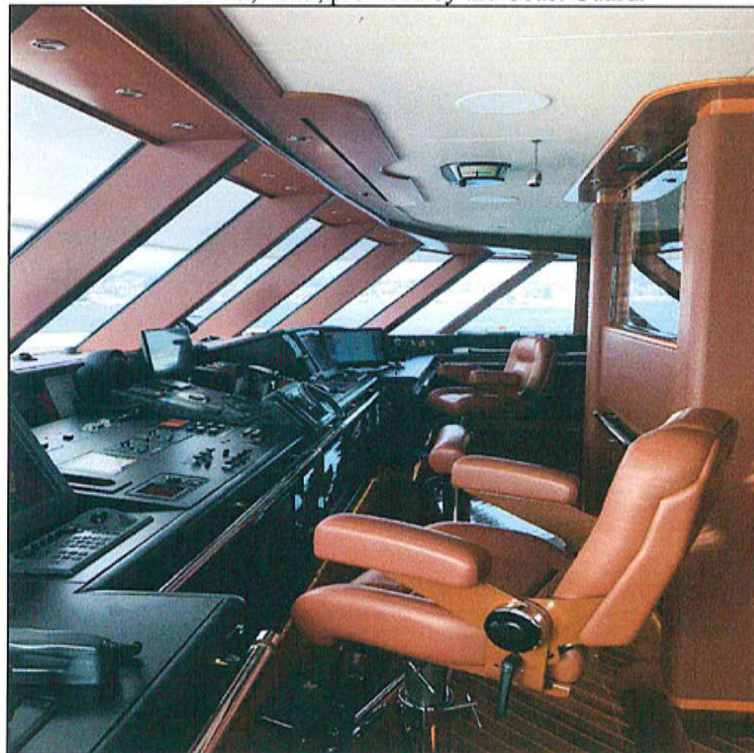
Below: Photograph of the ATTESSA IV's operating stations taken on October 29, 2019, provided by the Coast Guard.

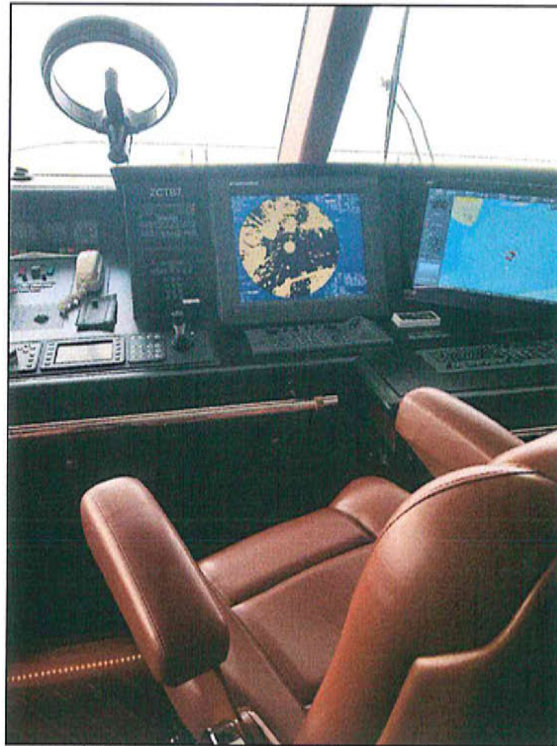
Above: Photograph of the ATTESSA IV's starboard side operating station taken on October 29, 2019, provided by the Coast Guard.

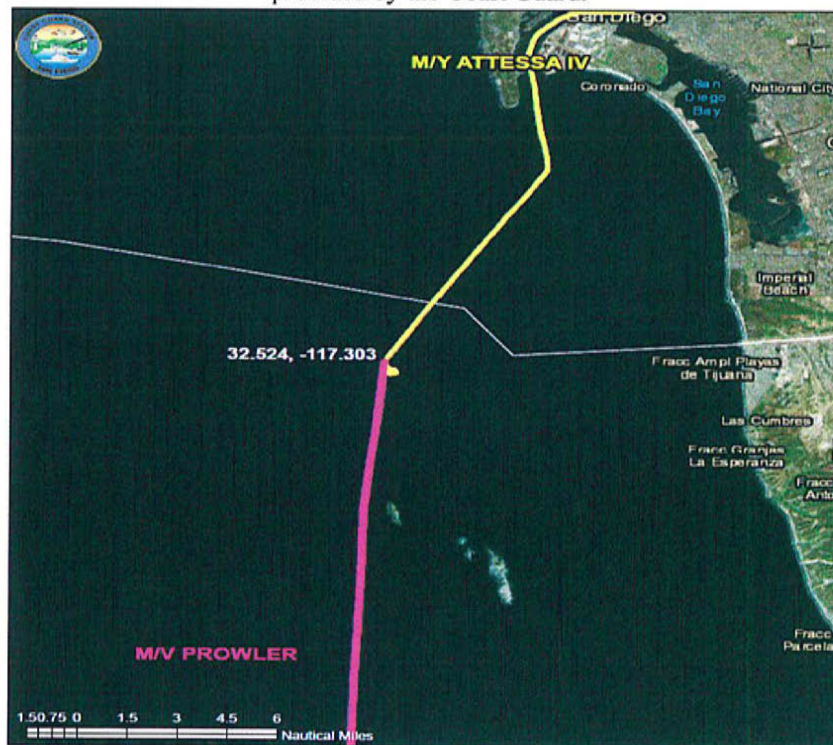
Below: Location of the collision with the vessel tracklines on October 26, 2019 provided by the Coast Guard.

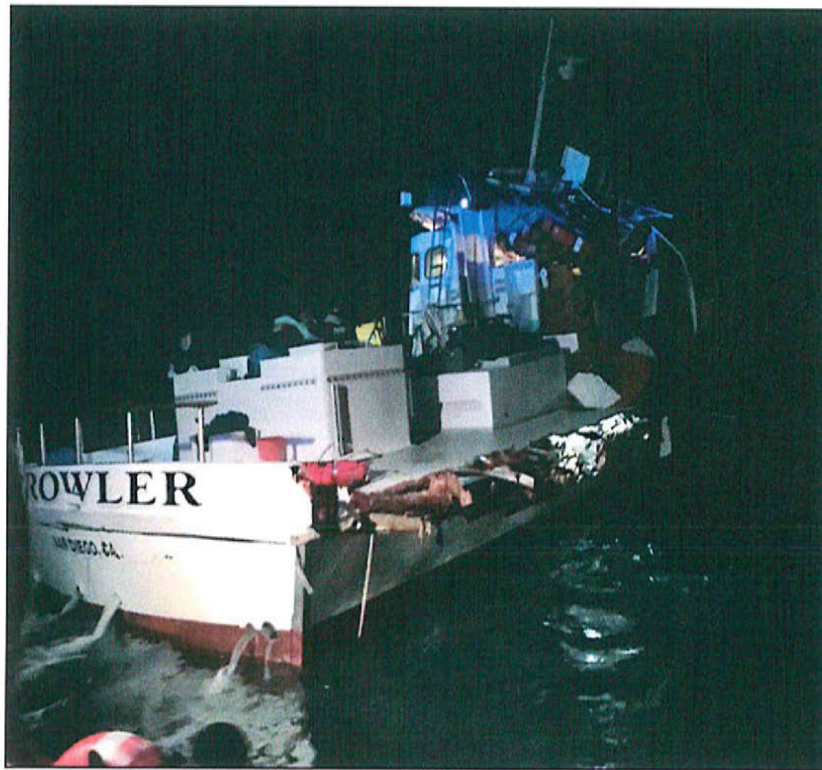
On October 26, 2019, at approximately 1915, the starboard bow of the ATTESSA IV collided with the PROWLER's starboard bow, resulting in a large protrusion in the hull of the PROWLER with an eventual determination as total constructive loss of the vessel, a passenger death, and multiple injuries. The collision occurred approximately nine miles southwest of Imperial Beach, California and two miles south of the United States and Mexico maritime boundary line, estimated at 32°.524N, 117°.303W.

4.1.2.3. The collision resulted in a total constructive loss of the PROWLER, one death, and multiple injuries.

Above: Photograph of the PROWLER's starboard side after the collision taken on October 26, 2019, provided by a person on the Prowler.

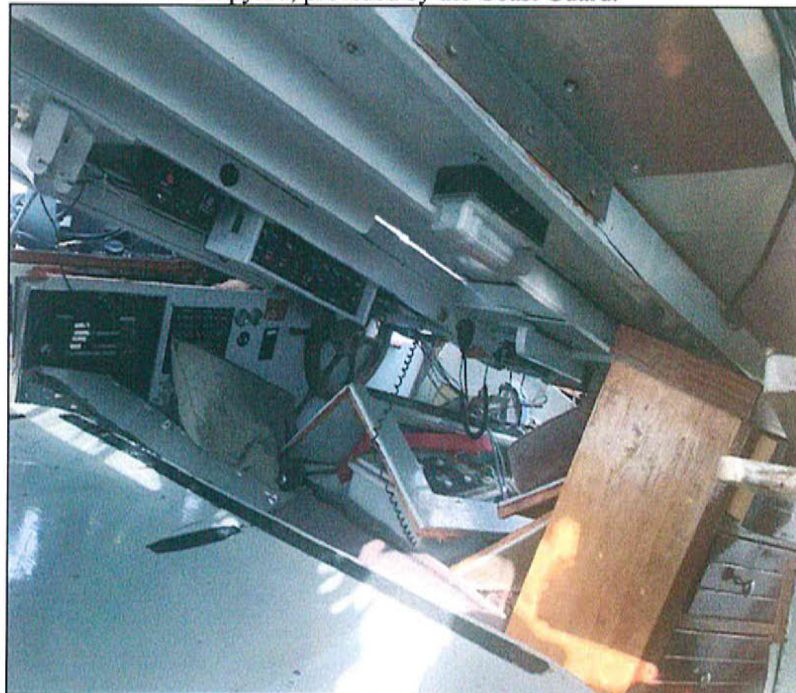
Below: Photograph of PROWLER operating station taken on October 28, 2019 while the vessel was in the shipyard, provided by the Coast Guard.

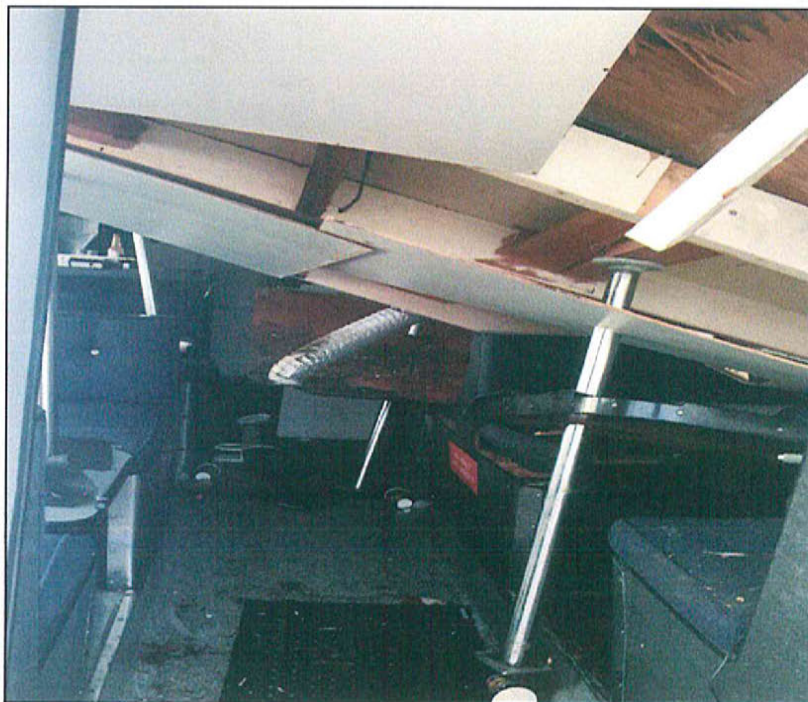
Above: Photograph of PROWLER's galley taken on October 28, 2019 while the vessel was in the shipyard, provided by the Coast Guard.

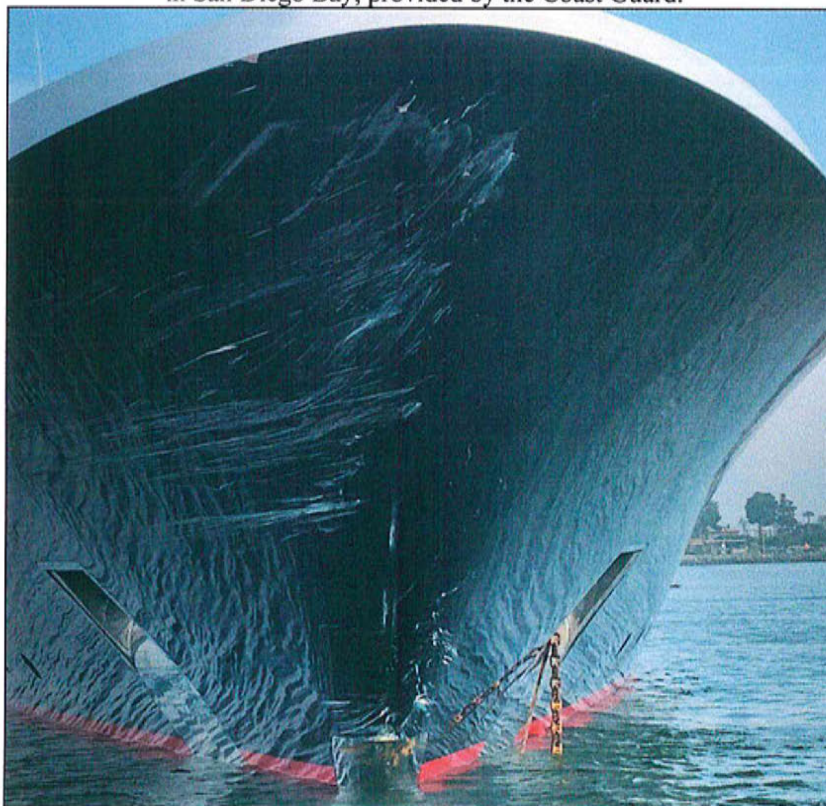
4.1.3.4. The ATTESSA IV sustained minimal damage to the hull as a result of the collision and no injuries were reported from the crewmembers.

Below: Photograph of ATTESSA IV's bow taken on October 29, 2019 in San Diego Bay, provided by the Coast Guard.

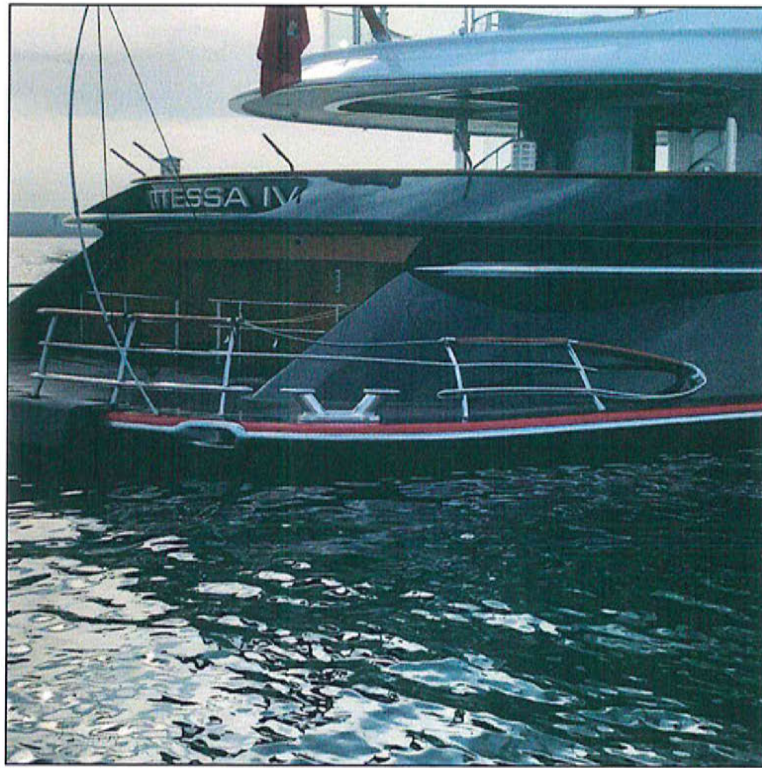
Above: Photograph of ATTESSA IV's stern taken on October 29, 2019
in San Diego Bay, provided by the Coast Guard.
