## INVESTIGATION INTO THE CIRCUMSTANCES SURROUNDING THE ALLISION OF THE

### P/V RACHEL MARIE

WITH THE WASHINGTON STREET PUBLIC BOAT  
LANDING IN SEATTLE, WASHINGTON ON  
SEPTEMBER 26, 2010

Subj: ALLISION OF THE P/V RACHEL MARIE IN SEATTLE, WASHINGTON ON  
SEPTEMBER 26, 2010.

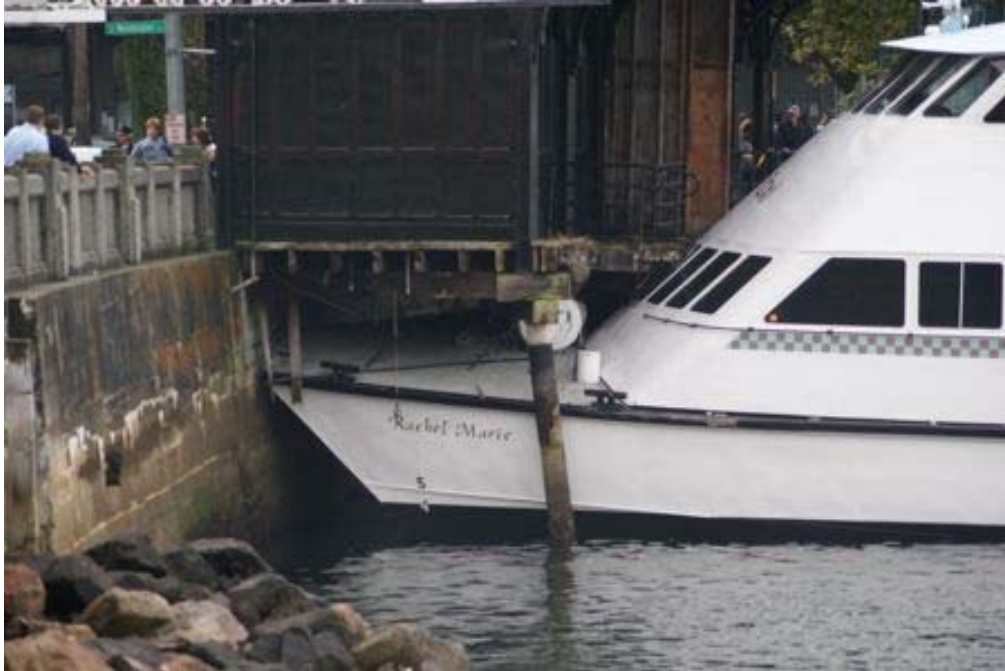
13. The RACHEL MARIE's forward momentum continued, and at 1115 the vessel allided with the Washington Street Public Boat Landing while traveling at approximately six knots. The vessel's hull was damaged, several windows shattered, a life raft container was damaged, and several of the passenger bench seats were dislodged as a result of the allision. The Washington Street Public Boat Landing sustained minor damage from the allision.

*(Photo shows the RACHEL MARIE wedged underneath the Washington Street Public Boat Landing after the allision.)*

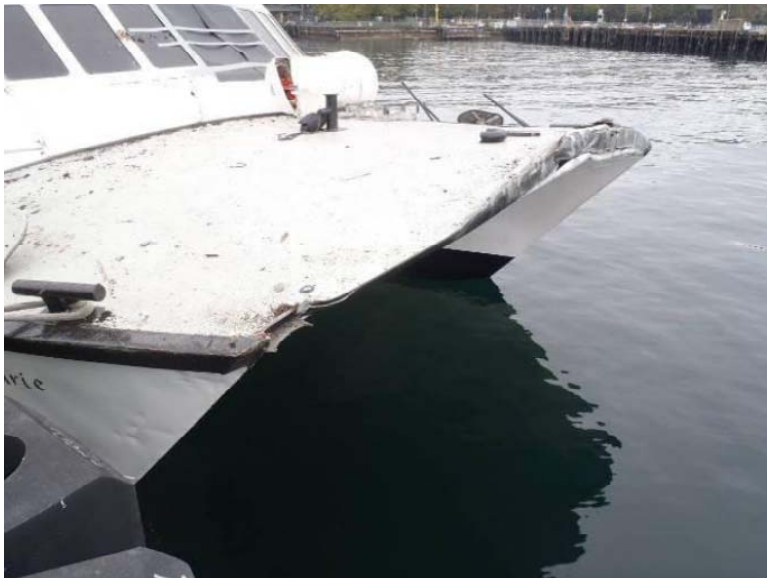
Six passengers, one crewmember, and one bystander on the Landing were injured, and the vessel's hull, two forward main deck windows and several main deck passenger seating benches were damaged as a result of the allision. Coast Guard and Seattle Police and Fire units were on-scene within minutes to assist.

*(Photo shows damage to the bow of the RACHEL MARIE as a result of the allision.)*

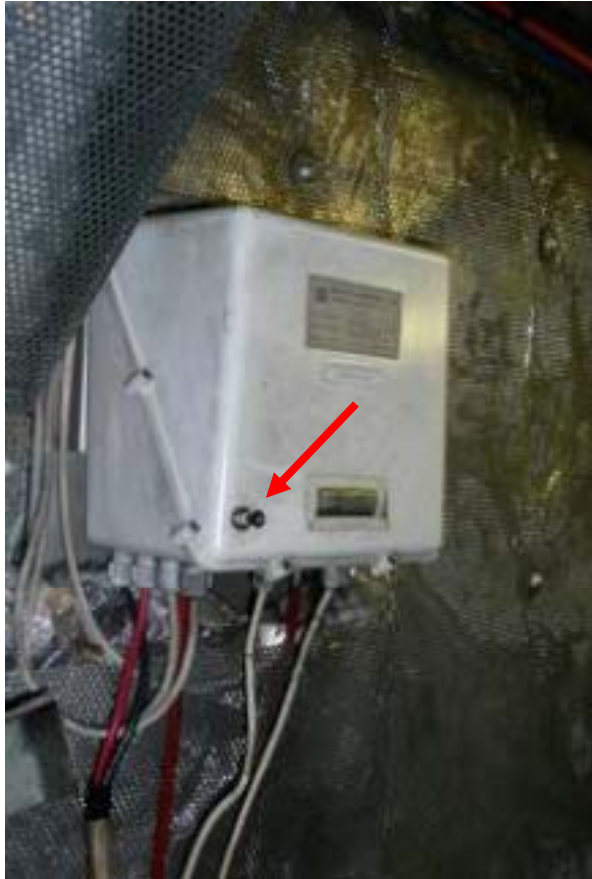
In addition, the circuit breaker was located in a position prone to being tripped accidentally. The outlined conditions represented a latent unsafe condition on September 26, 2010.

*(Photo shows the location of the port engine throttle control system circuit breaker. The manufacturer of the system recommends against placing the breaker on the box itself.)*

1. *Vessel Engineering:* The circuit breaker for the port and starboard engine throttle control system was mounted in a location inside the unmanned port engine compartment that made it difficult for the crew to detect a tripped condition. It was also mounted on the outside of the system's control box, which was not recommended by the manufacturer. The cause or reason that the port engine throttle control box circuit breaker tripped was never discovered; however, extensive testing conducted and attended by King County, ZF Controls, and the Coast Guard revealed that the tripped breaker was the most likely cause of the loss of throttle control.

A certified marine electrician conducted a thorough investigation of the vessel's electrical system. Several bad connections and shorts were discovered; however, none of these problems were shown to have caused, or have given reason, for the circuit breaker to trip. The vessel's throttle control system was installed in such a manner that it did not provide the master with an audible indication that power to the port throttle control system had been lost. The location of the circuit breaker also made it virtually impossible for the master to visually detect the tripped condition

Recommend that King County Marine Division move the RACHEL MARIE's throttle control system circuit breaker to a location that will prevent accidental breaker tripping, and is easily accessible to the master and crew so that it can be seen and reset quickly in an emergency situation.
