UNITED STATES COAST GUARD

**REPORT OF THE DISTRICT FORMAL INVESTIGATION
INTO THE
SMALL PASSENGER VESSEL SPIRIT OF BOSTON (O.N.
954835) FIRE IN BOSTON HARBOR, BOSTON,
MASSACHUSETTS ON MARCH 24, 2023**

**FIRE ABOARD THE SMALL PASSENGER VESSEL SPIRIT OF BOSTON
(O.N. 954835) WHILE MOORED AT THE COMMONWEALTH WHARF IN
BOSTON HARBOR, MASSACHUSETTS ON MARCH 24, 2023**

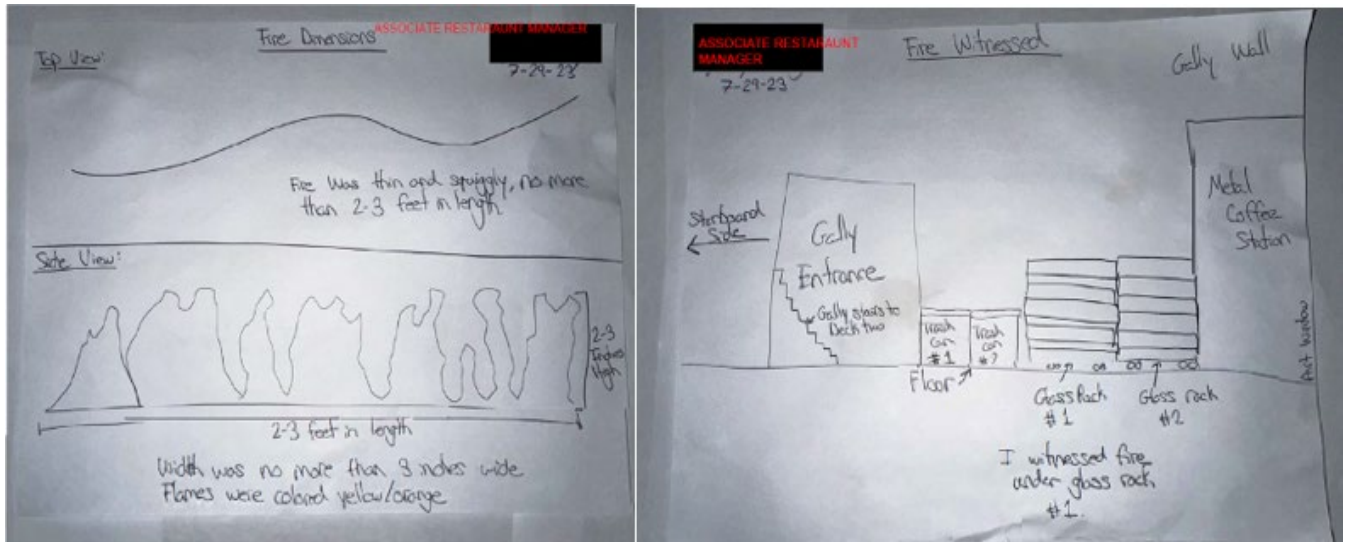
Figure 8-The Associate Restaurant Manager was asked to draw a diagram of the fire as he saw it. Left: the size and extent of the fire witnessed. Right: the location of the fire in relation to the after bulkhead of the main deck wait station. (Source: CG 028 Supplemental Email to Associate Rest. Manager Fire Diagram and Other Info-Redacted)

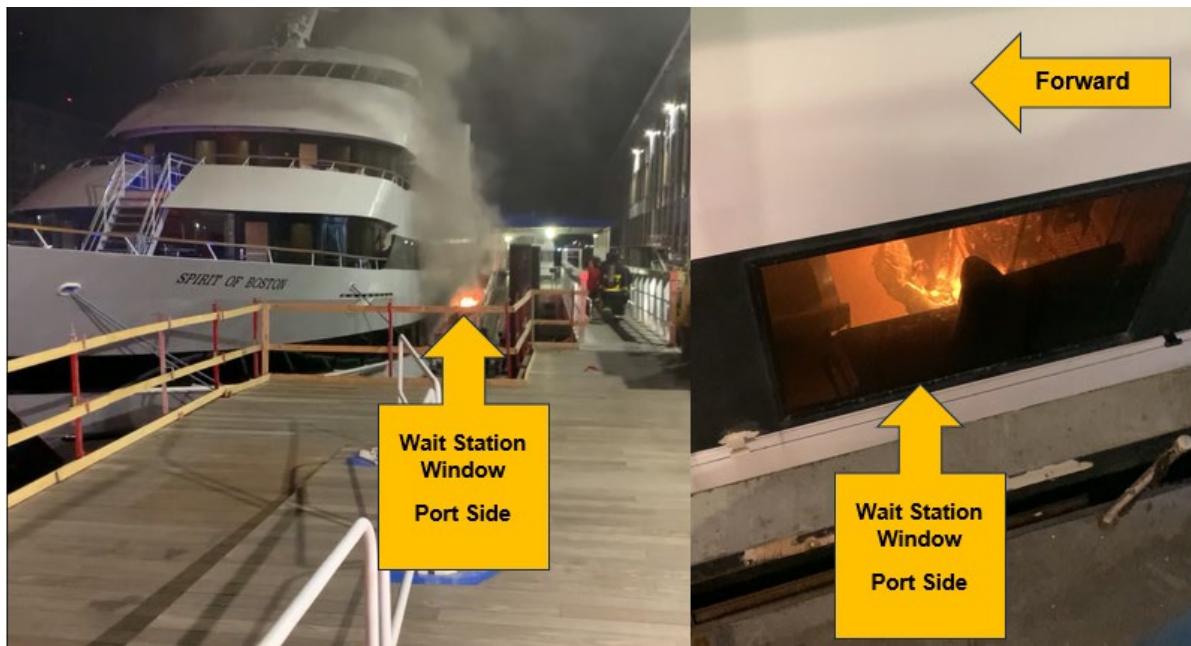
Figure 12- **Left:** The *Spirit of Boston* with smoke and flames and Boston Fire Department personnel arriving on the scene.

Right: The window on the port side looking into the main deck wait station showing the fire on the after portion of that space. (Source: *Spirit of Boston* Crew)

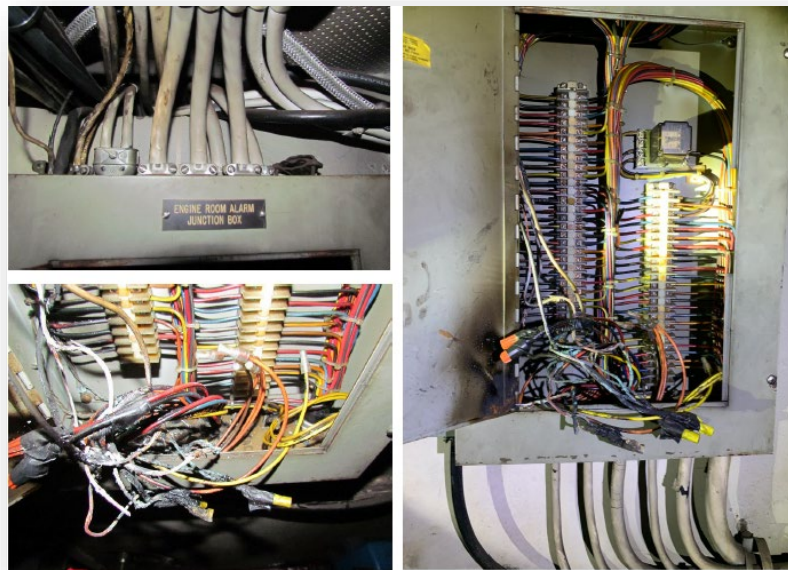
- 4.4.2.2. During the investigation onboard the *Spirit of Boston*, a 24V DC electrical circuit box was found in the vessels engine room to be in the condition indicated in Figure 14. The investigation requested that the company provide the name(s) of the individuals who worked on the circuit shown in this figure to determine when and why these connections were made and to determine if the connections and electrical work conformed to applicable code or regulations. The company was not able to provide responsive information.

Figure 14- Images showing the *Spirit of Boston* 24V DC engine room alarm junction box panel with twisted, wire nutted and taped wire terminations in the bottom of the box. This box was in the lowest deck of the vessel. Some of the corrosion shown may have been caused by firefighting water on the main deck above seeping down. (Source: USCG)

- 4.4.2.3. During an interview with the National Director of Marine Engineering to identify the issues in the circuit panel in Figure 14 above, he stated that a fuse (circuit protection) was required on the windshield wiper wire circuit that ran from vessel's battery as means to reduce the potential for a fire if the circuit was overloaded or shorted. The regulations required circuit protection on that circuit. After his review of the circuit in question, he identified that there was no required circuit protection on the circuit that left the battery. In his interview he testified,

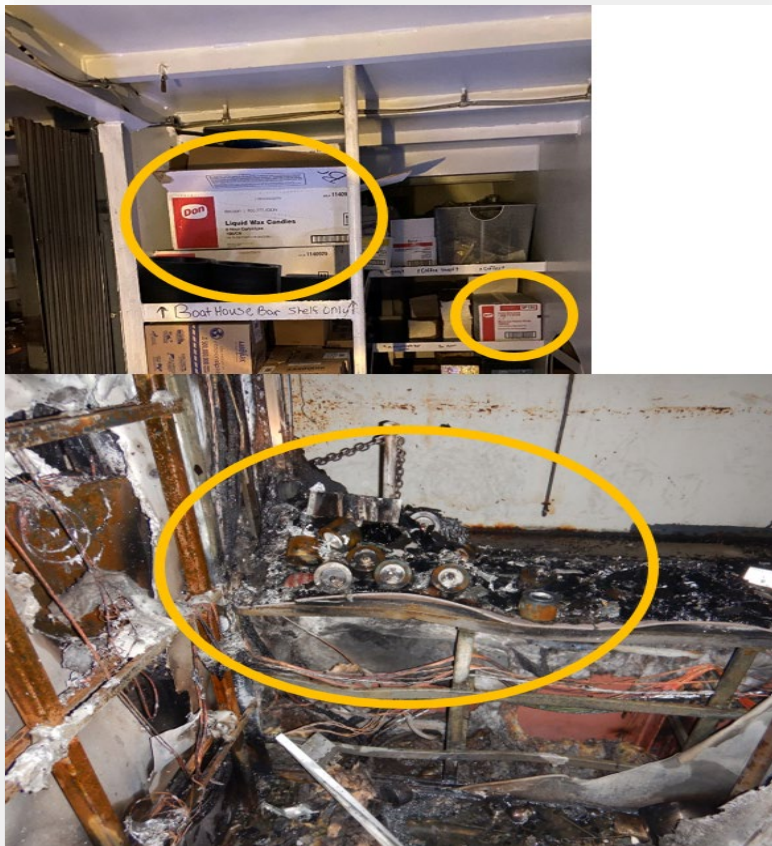
4.4.3.1. The company used three types of open flames on the vessel, two of which were flammable liquids. Those were paraffin liquid candles in glass table sconces, food warming flammable fuel canisters heating sources for food, and beverage and birthday candles for celebrating guest occasions such as birthdays. The company also stored the paraffin candles and heating fuel canisters in storage racks and on the wide windowsill in the wait station area. Long-handled lighters with liquid butane-type fuel (fuel which turns to a gas when it leaves the lighter and is ignited) were also used to ignite the various types of flames in the candles and food warming flammable fuel canisters.

Figure 15 -**Top:** paraffin candles stored in racks near the galley area.
Bottom: Fire-damaged canister fuel heating cans stored on the wide windowsill running fore and aft in the main deck wait station. (Source; USCG)

- 4.4.3.2. The company did not have a policy in place directing employees on how to store these types of flammable fuels onboard nor did the company require proper storage locations. There were no flammable storage lockers and containers for either the paraffin candles or the heating fuel canisters. Both fuel sources are known flammable substances and are potential fire sources. The food warming flammable fuel canisters were stored in the wide fore and aft running windowsill in the wait station area. Paraffin candles and canisters for use under chaffing dishes were also stored in racks in the galley. The company had no written safety policies to ensure the safe use of open flames for paraffin candles, fuel in canisters to heat chaffing dishes, long-handled lighters or birthday candles. Some manufacturers²² have detailed procedures for the safe use of chaffing dish fuel containers to mitigate the possible dangers posed in using this potential fire source.

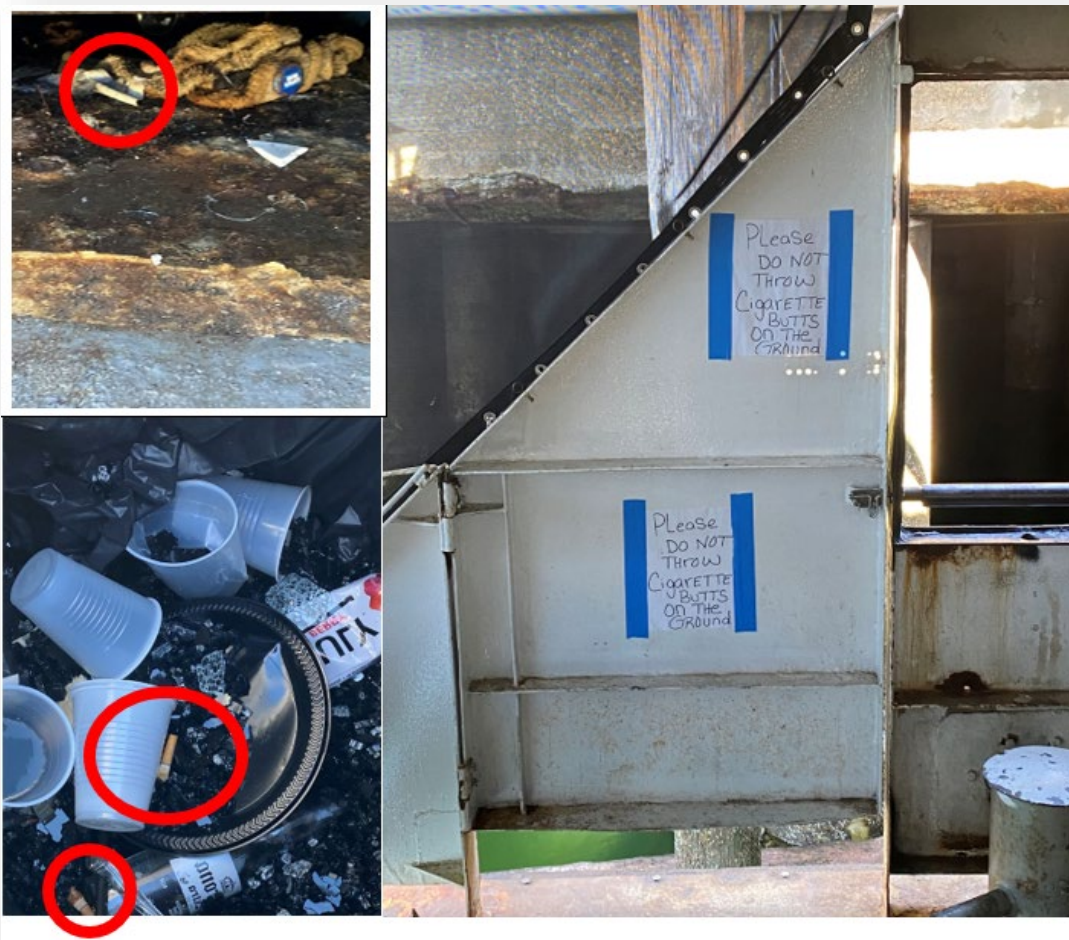
Figure 21 - Red circled objects are cigarettes located after the fire on the main deck and in rubbish from the vessel.
Right, signage on the inside of the port main deck bulkheads indicating shipboard policy regarding cigarette butts. (Source: Coast Guard)

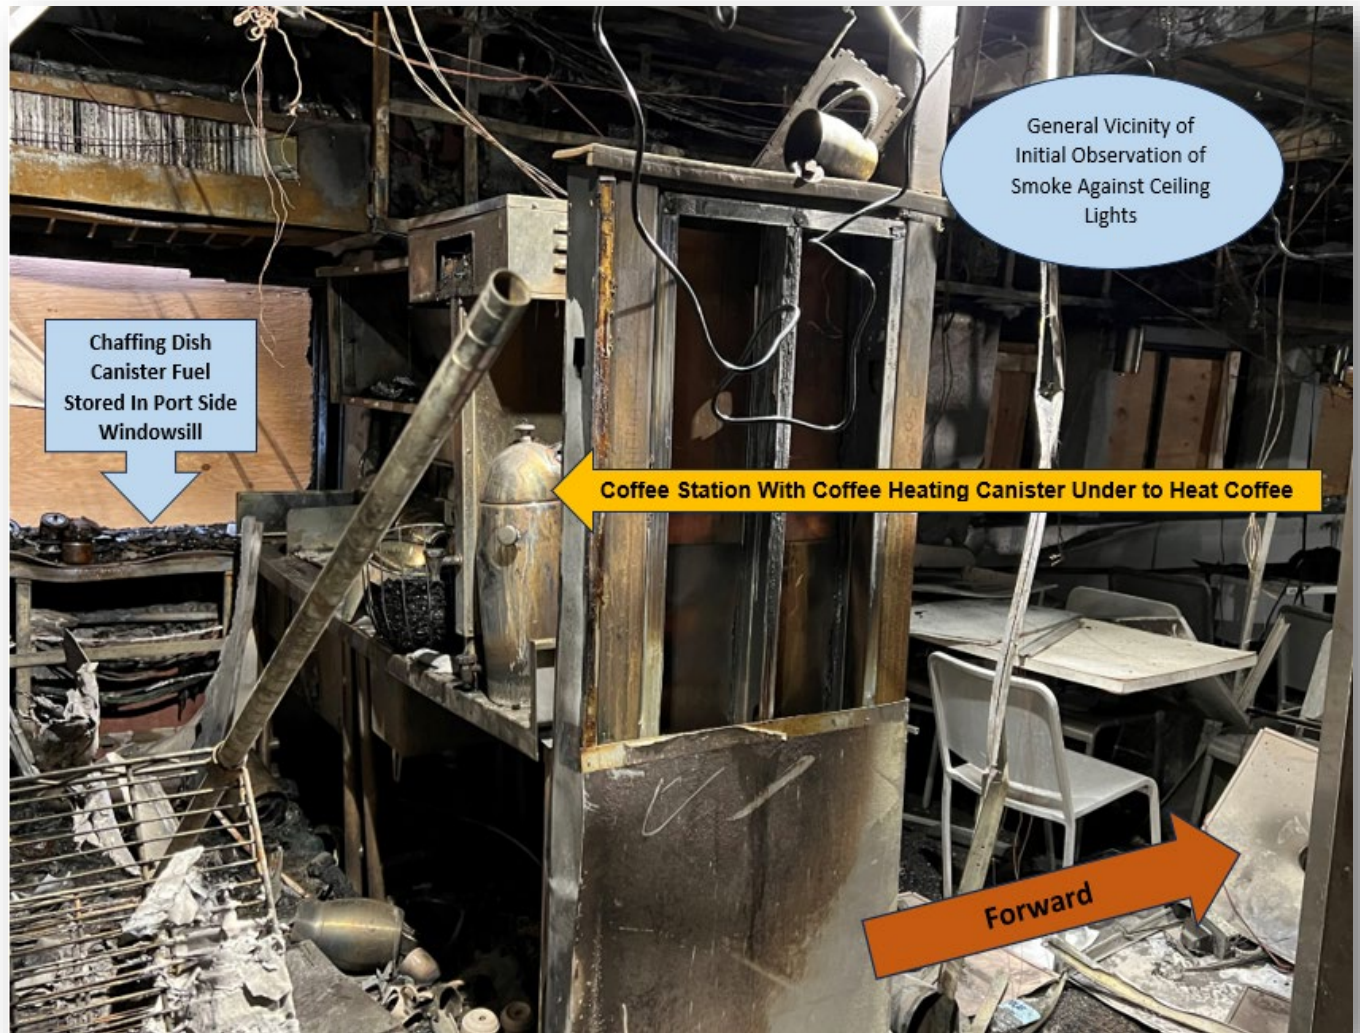
- 4.4.21.3. On the evening of March 24, 2023, the restaurant staff set up the coffee station in the wait station. The coffee station was usually set up in the dining area, in a self-service style. Server Assistant 2 stated they set up the coffee station in the wait area that evening, due to the high volume of young children on the prior dinner cruise. When diners requested coffee, they would bring the cups of coffee to the table. The coffee pot was kept warm by a lit canister flammable fuel heating source.

Figure 24 - Coffee station setup in the wait station on the evening of March 24, 2023. Image has labels applied by the investigation. (Source: ATF)

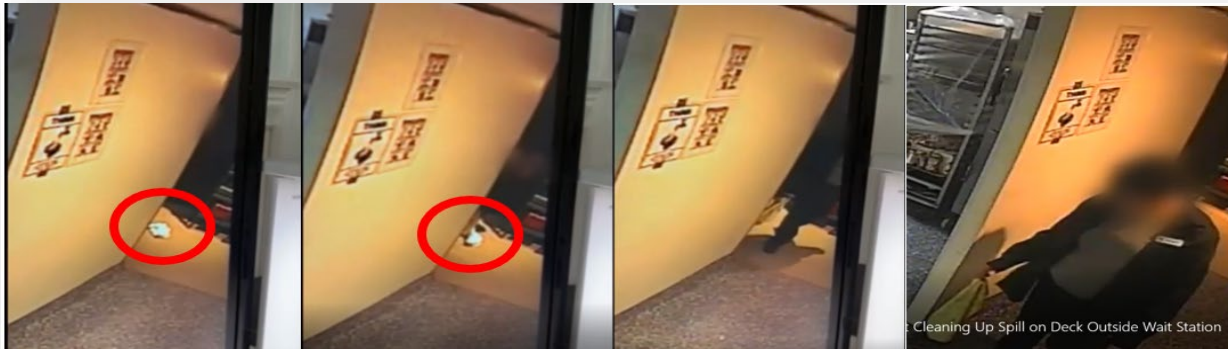
Figure 25 - Closed circuit TV footage of the vicinity of the wait station deck (red oval) showing Server Assistant 1 cleaning up an unknown substance spilled on the deck in the wait station before the fire. Far right, shows the server with a rag in hand walking towards the area where she disposed of the rag used for cleanup in a linen bag aft of the wait station. (Source: City Cruises, with CG markups)

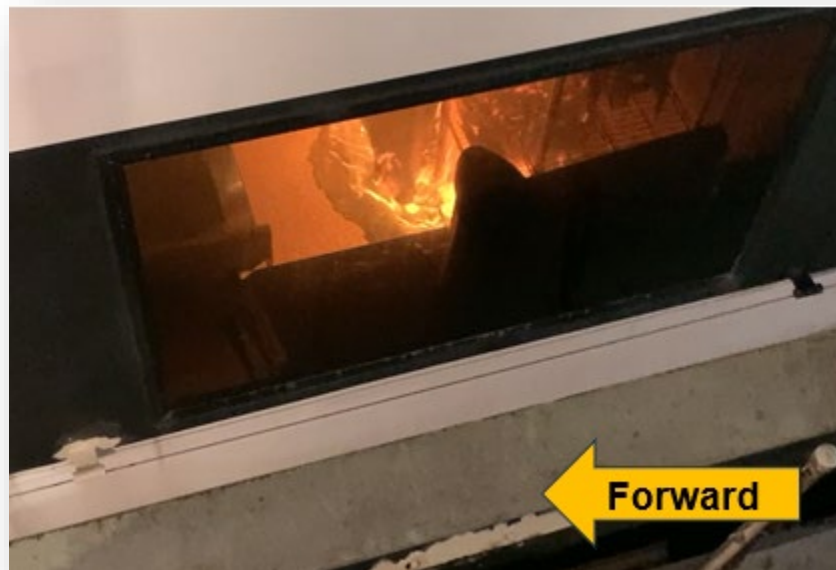
Figure 26 - Looking into the wait station window and downward to the main deck, to the right in this image the vertical storage racks along the after bulkhead of the wait station. (Source: Vessel Crew)

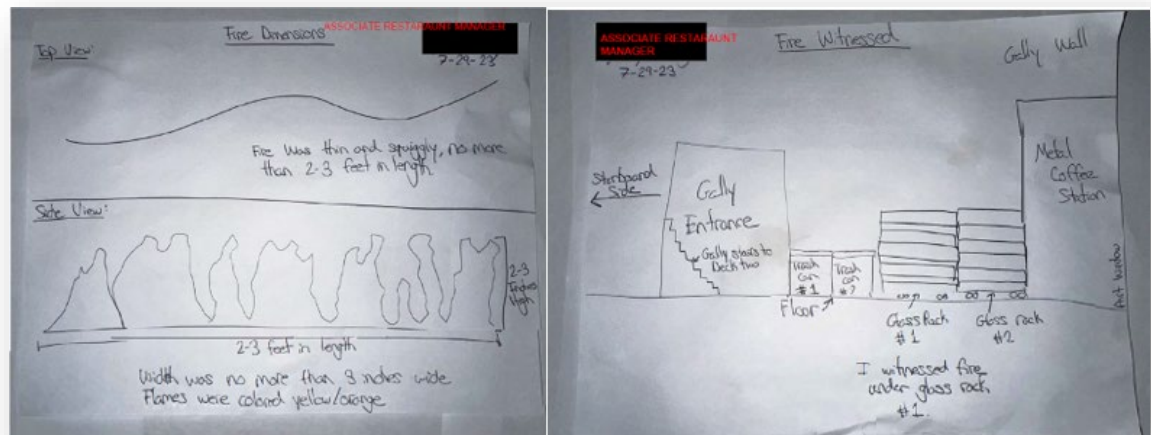
5.2.2.6. He was subsequently asked to provide a diagram showing the location of the fire and size and shape of the fire on the wait station deck.

Figure 27 - Left, A diagram showing the shape of the fire and the length, width and height of the flames observed.

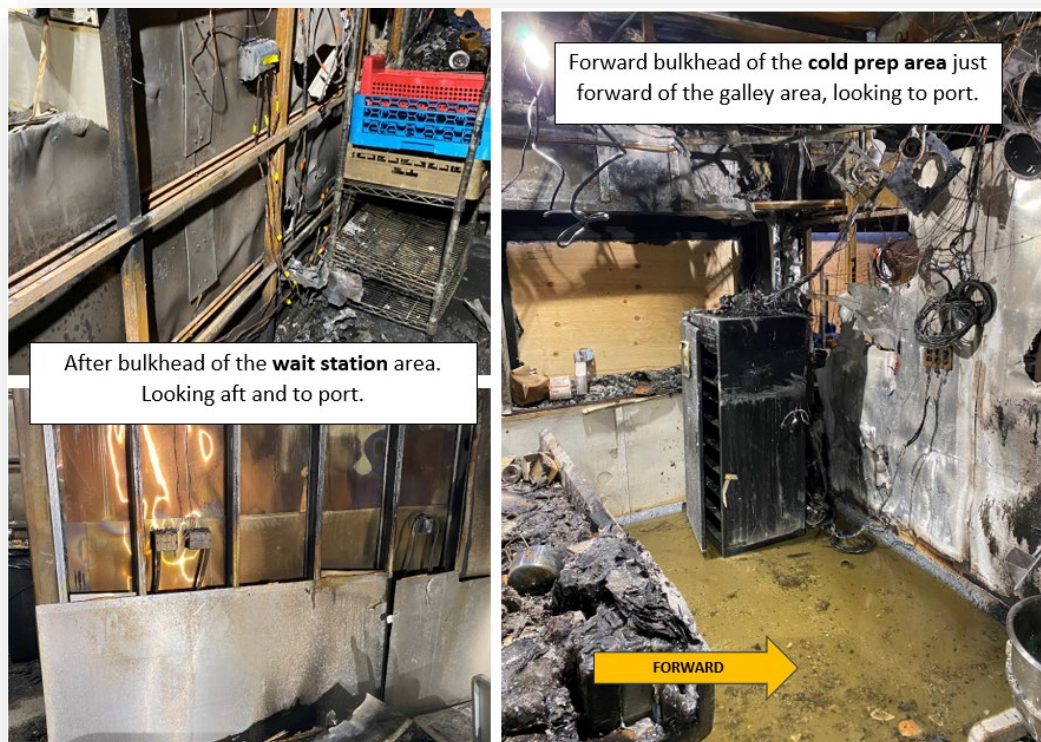
- 5.5.2.1. The area of the initial fire was located in the vicinity of the aft section of the deck on the port side near a partial bulkhead in the wait station. The bulkhead had several electrical circuits that ran along the bulkhead, between aluminum panels, in at least one case going to an electrical outlet. This partial bulkhead separated the cold prep area from the wait station and the partition was not a complete bulkhead from floor to ceiling. The fire damage in the vicinity of that area and the overhead of the space was extensive. Investigators examined the damage and debris and attempted a reconstruction of the area where the fire was reported. In Figure 28, yellow marking tape was used by investigators to recreate the circuits for the electrical system.

Figure 28 - **Left**, Images of the wait station area showing the structure and electrical circuits in the area identified as where the fire started. The yellow tape in the top left, are the result of forensic examination of the wiring conducted by investigators. **Right**, Image of the damage to the cold prep area just behind the wait station area. In both these images, material has been removed from the scene to facilitate examination of the scene. (Source: USCG)

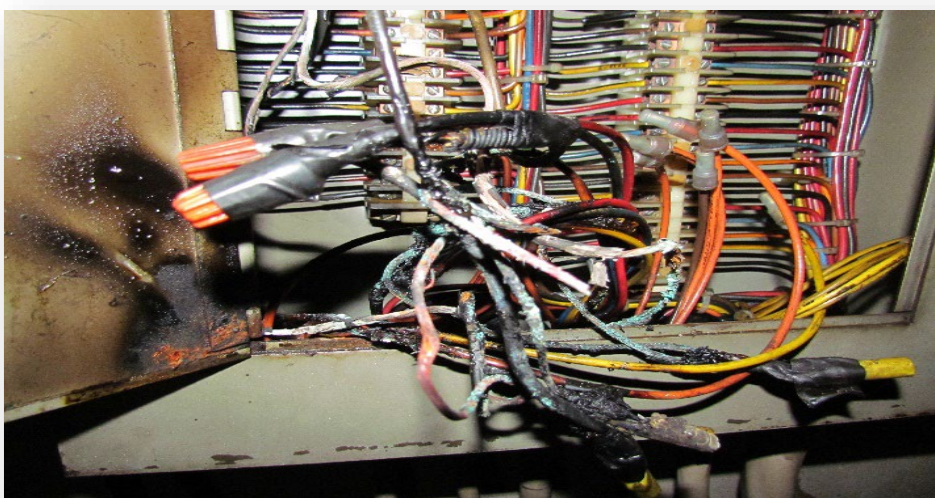
5.5.2.2. In 2020, the company sent out a fleetwide email to examine vessels for electrical safety issues. After the fire on the *Spirit of Boston*, investigators identified this 24V DC junction box and discovered non-standard wire terminations and splices.

Figure 29- Image showing the condition of the 24 V DC engine room alarm panel junction box on the engine room bulkhead of the *Spirit of Boston*. Some of the corrosion and arcing on this junction box may have been the result of firewater seeping down from the main deck above. (Source: USCG)
