**REPORT OF THE INVESTIGATION  
INTO THE  
FIRE ONBOARD PANAMA-FLAGGED  
CONTAINER SHIP STRIDE (IMO 9149835),  
BAYPORT CONTAINER TERMINAL IN HOUSTON,  
TX, RESULTING IN THE LOSS OF TWO LIVES ON  
JANUARY 8, 2024**

**MISLE ACTIVITY NUMBER: 7847385 MISLE**

**INVESTIGATING OFFICER'S REPORT**

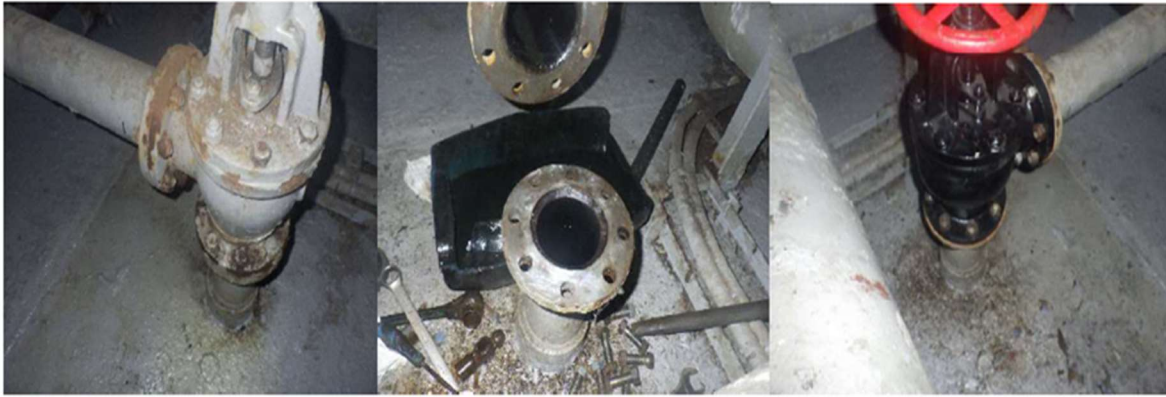
4.2.10. On November 24, 2023, a new screw-down check angle valve, was installed on the port double bottom diesel oil tank to replace the previous valve.

Figure 2: Images of the port double bottom diesel oil tank valve replacement from the 20-26 Nov-2023 Weekly Engine Jobs. Provided by Danaos Shipping Co. Ltd.

5.1. The correct valve was not verified prior to installation. It should have been verified that the valve ordered and received was the correct type needed for the port double bottom diesel oil tank. The fuel oil transfer and purifying system drawing shows that the port double bottom diesel oil tank should have an angle stop valve. The previous valve was an angle stop valve, allowing fuel to flow into and out of the tank. The new check valve was installed so that it would only allow oil to flow from the storage tank when it was opened.

8.2.2. Recommend an internal audit to verify that the Safety Management System is being properly implemented regarding supply and maintenance procedures, ensuring that the crew is ordering the correct spare parts for the ship machinery systems and that those spare parts are properly installed.

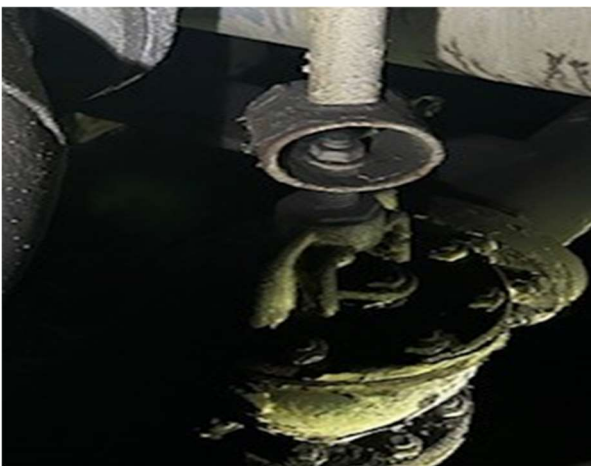
4.2.11. Both the port and starboard valves for the double bottom diesel oil tanks were located below the deck plate on the 4<sup>th</sup> deck. Each valve had a reach rod accessible from the deck plate. During the investigation, it was discovered that the reach rod was not attached to the port valve. A reach rod is used to operate valves that are in hard-to reach areas.

Left- Figure 3- Starboard double bottom diesel oil storage tank valve with attached reach rod. Right- Figure 4- Port double bottom diesel oil storage tank with reach rod hanging down but not attached. Images taken on January 13, 2024, by U.S. Coast Guard.

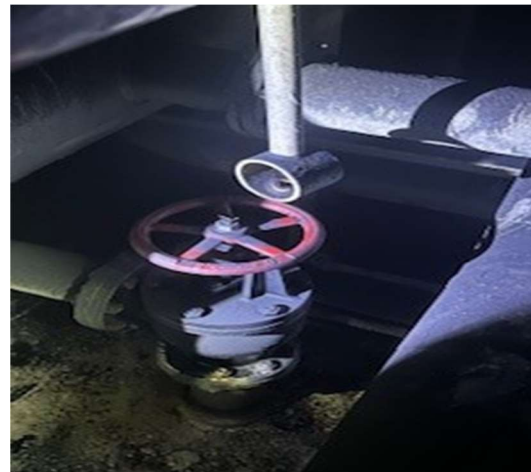
4.2.12. When the U.S. Coast Guard had the crew remove the port valve, it was observed

5.2. Improper installation of reach rod: When the check angle valve was installed for the port double bottom diesel oil tank, the reach rod was not connected to the valve. The reach rod, located at the deck plate, was tied off to piping using rags. The valve was located below the deck plates in between multiple pipes, which would be difficult to close in the event of an emergency.

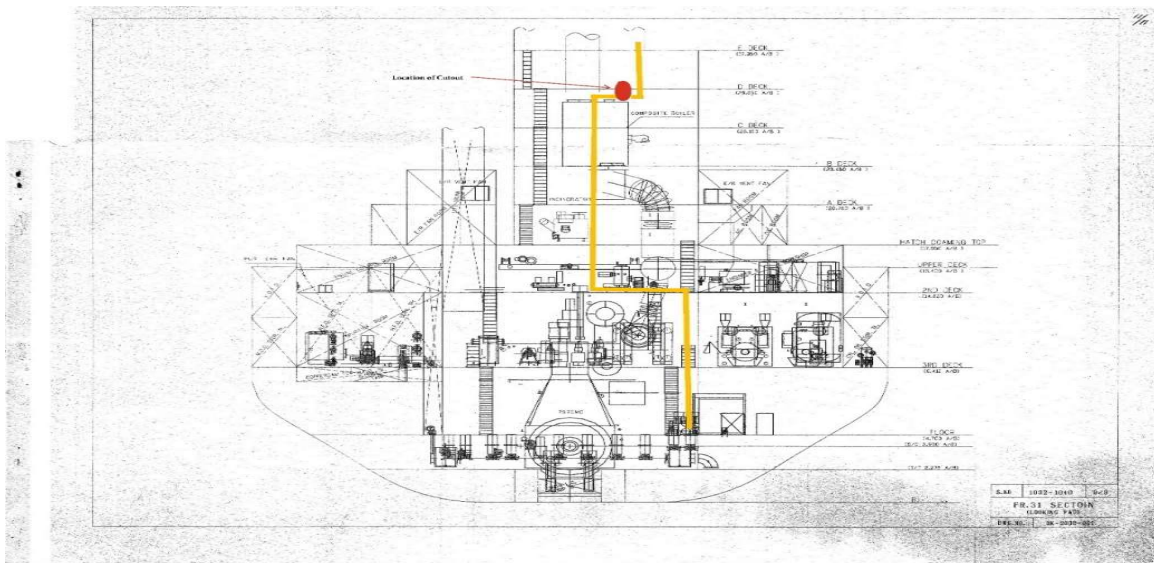
4.2.15. Several fuel tanks, including the port and starboard double bottom diesel oil tanks, heavy fuel oil overflow tank, sludge tank, double-bottom diesel oil service tank, and heavy fuel oil service tank, were fitted with a vent pipe that connected to a 12-inch steel pipe. The 12-inch pipe ran from the 4<sup>th</sup> deck in the engine room up to the compass deck, ending in a gooseneck; total length of the vent pipe was approximately 125 feet in length.

Figure 5- Diagram of engineering spaces looking forward. The yellow line is the vent pipe. The red circle is the location of the cutout. Diagram provided by Danaos Shipping Co. Ltd .

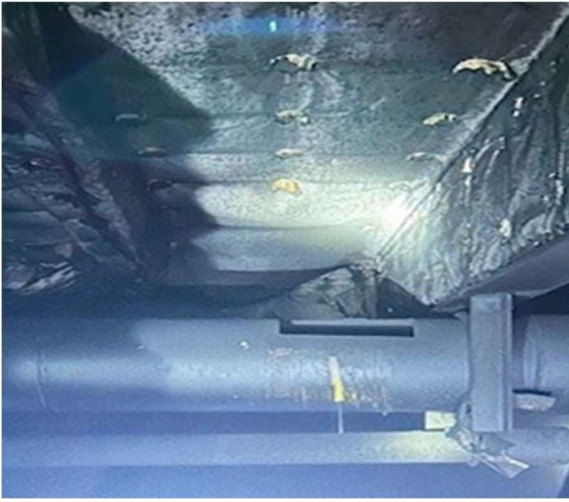
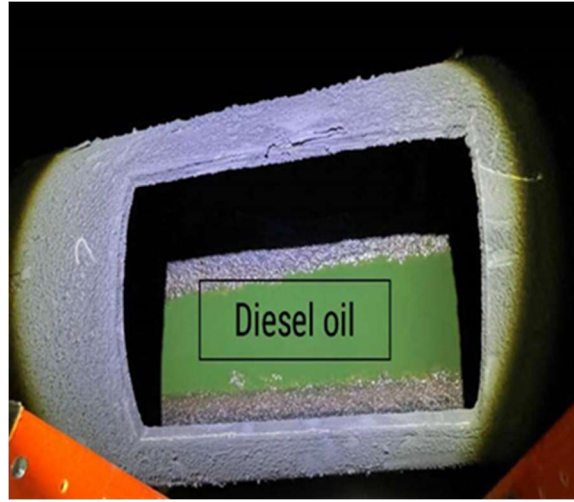
4.2.16. On January 10, 2024, Coast Guard and National Transportation Safety Board investigators discovered a 7-inch by 11-inch cutout on a horizontal section of the vent pipe. The cutout was located approximately 98 feet above the double bottom diesel oil tanks, in the overhead of D Deck, above the boiler. Investigators observed standing oil throughout the interior of the vent piping.

Left- Figure 6: Horizontal vent pipe section with cut out. Right- Figure 7: Diesel oil inside the vent pipe. Both images taken on January 11, 2024, by U.S. Coast Guard.

7.2. The STRIDE’s Classification Society attended the seven sister ships of the STRIDE and discovered three of them had a similar cutout installed on the vent pipe. The three vent pipes have been restored to their original condition.

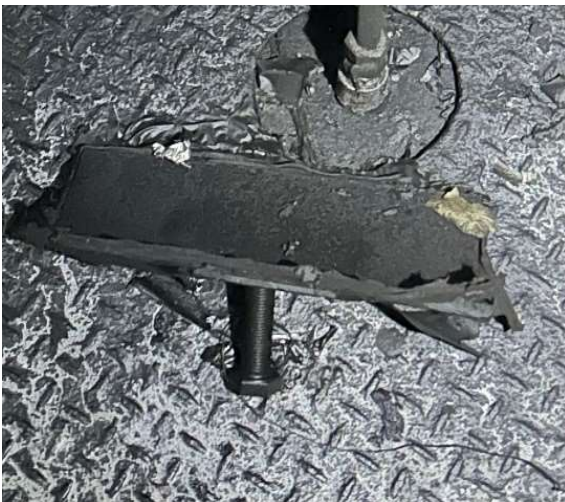
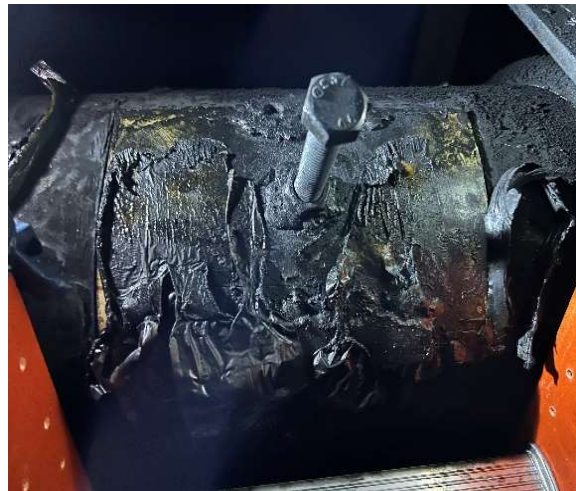
4.2.17. Below the cutout, on the boiler's deck, investigators discovered the missing section of the vent pipe along with remnants of tape and a flexible adhesive. The removed section of the vent pipe had a bolt threaded into a nut that was welded onto the removed section.

Left- Figure 8: Vent pipe section found on the deck of the boiler. Right- Figure 9: The removed section fits perfectly into the cutout section of the vent pipe. Both images taken on January 11, 2024, by U.S. Coast Guard.

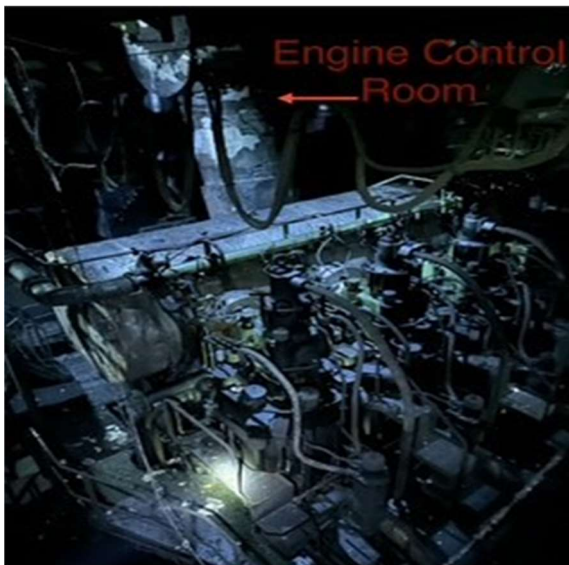
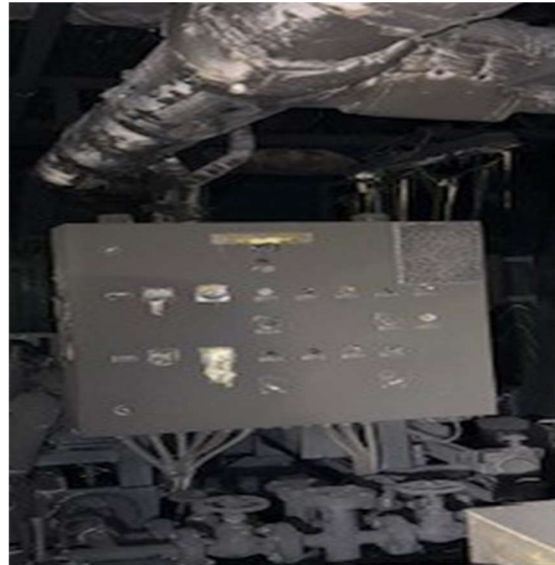
4.2.27. The fire on the STRIDE caused substantial damage to the engine room. Fire, heat, and soot damage were observed throughout the engine room. Numerous electrical panels and visual alarms were burned beyond recognition.

Left- Figure 10: Main engine. Right- Figure 11: Electrical Panel. Both images were taken on January 11, 2024, by the U.S. Coast Guard.

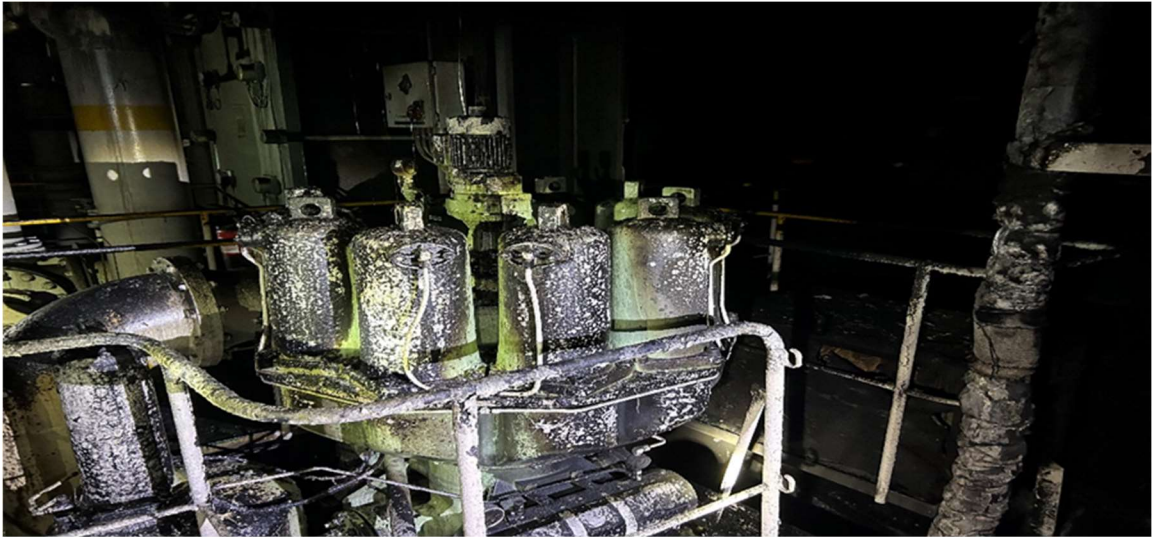
4.2.28. The National Transportation and Safety Board fire and explosion specialist observed an area on the 4<sup>th</sup> deck that showed evidence of a high-temperature exposure on

the starboard side of the main engine. This area had steep gradients of thermal damage over short distances and sharp demarcation between charred and undamaged surfaces. A lube oil filtration system was centered within this area.

Figure 12: Lube oil filtration system located within the high-temperature exposure area. Images taken on January 11, 2024, by U.S. Coast Guard.

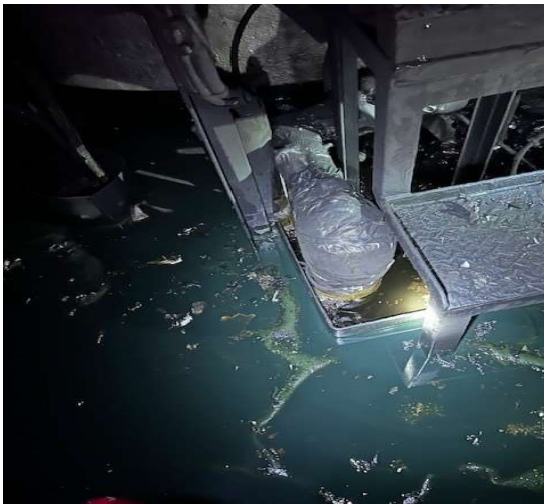
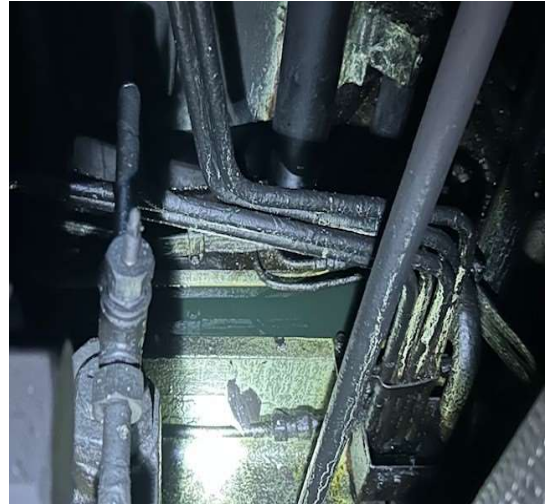
4.2.30. Pools of unburned marine diesel oil were discovered on all decks, starting from the top of the D deck down to the 4th deck. The bulkheads had visible oil streaks throughout the funnel casing and engine room.

Left- Figure 13: Unburned marine diesel oil on D deck. Right- Figure 14: Unburned marine diesel oil at the main engine. Images taken on January 11, 2024, by the U.S. Coast Guard.

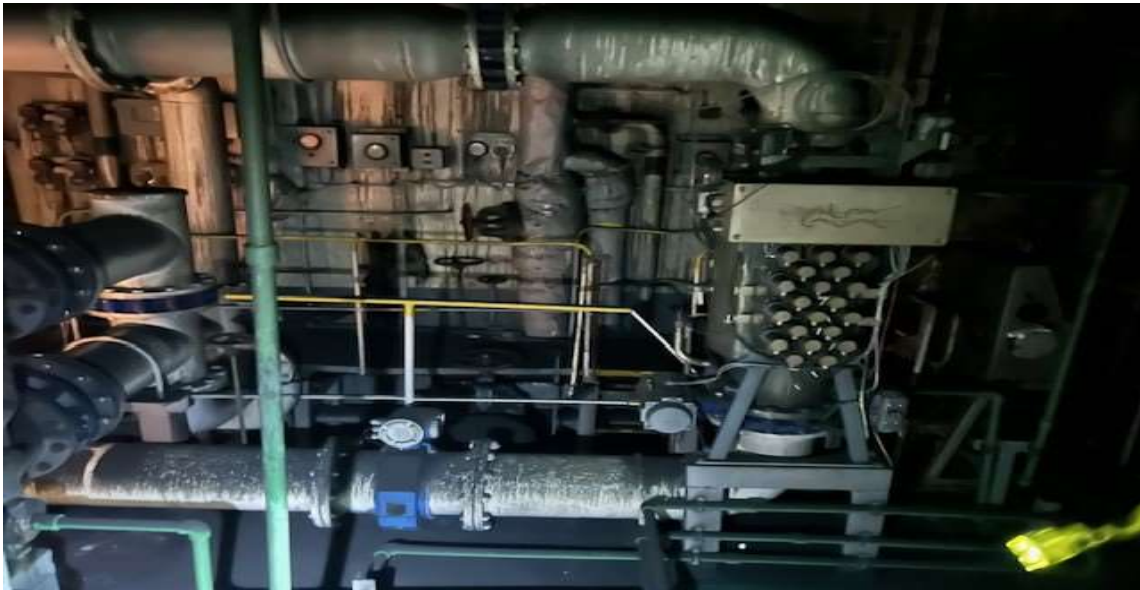
- 4.1.13. At 0325, the wiper observed oil flowing down the forward bulkhead in the engine room coming from several decks above, near the incinerator and boiler.

Figure 15- Oil streaked down the forward bulkhead in the engine room on two decks. Images taken on January 11, 2024 by the U.S. Coast Guard.

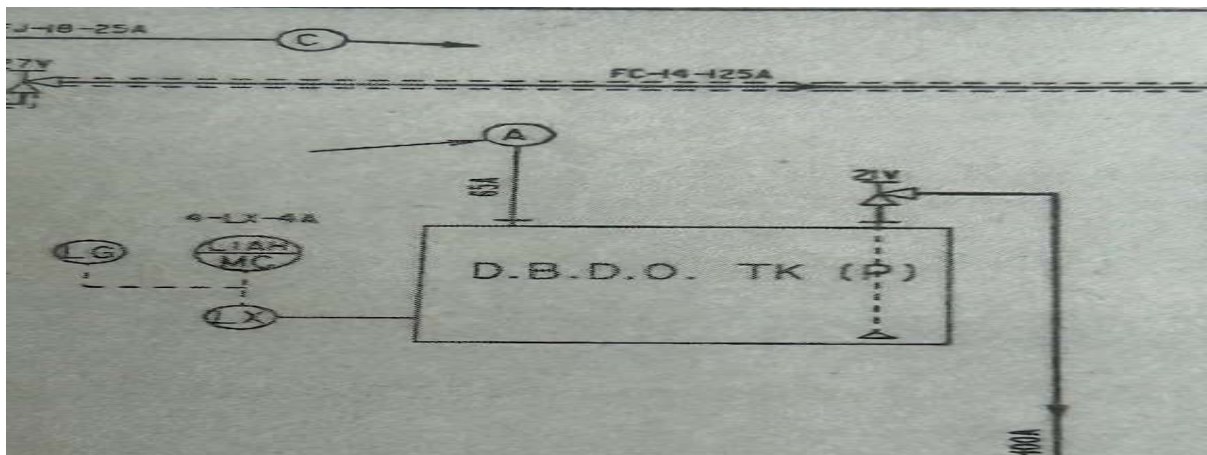
Figure 16: Fuel oil transfer and purifying line drawing showing the port double-bottom diesel oil tank and the required valve.
