**REPORT OF THE INVESTIGATION  
INTO THE  
CHARTER VESSEL TOO SHORT (O.N. 1224367)  
LOSS OF LIFE IN WHITEHALL BAY NEAR  
ANNAPOLIS, MD ON JUNE 16, 2024**

**MISLE ACTIVITY NUMBER: 7943023**

**INVESTIGATING OFFICER'S REPORT**

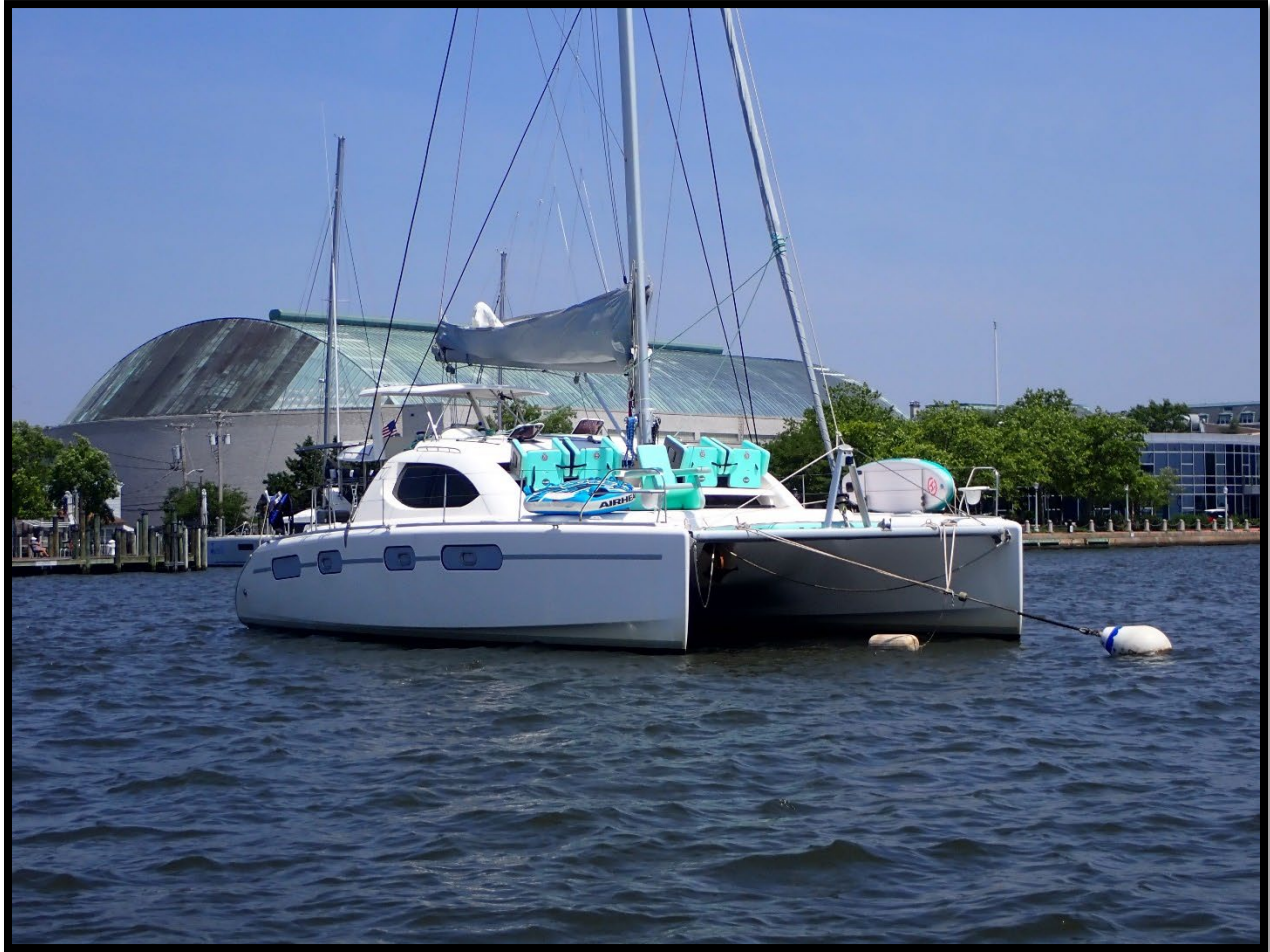
Figure 1. Photograph of TOO SHORT post-incident tied to mooring ball no. 1 in Spa Creek, Annapolis, MD on 18Jun2024. The photo was taken by the lead U.S. Coast Guard Investigating Officer.

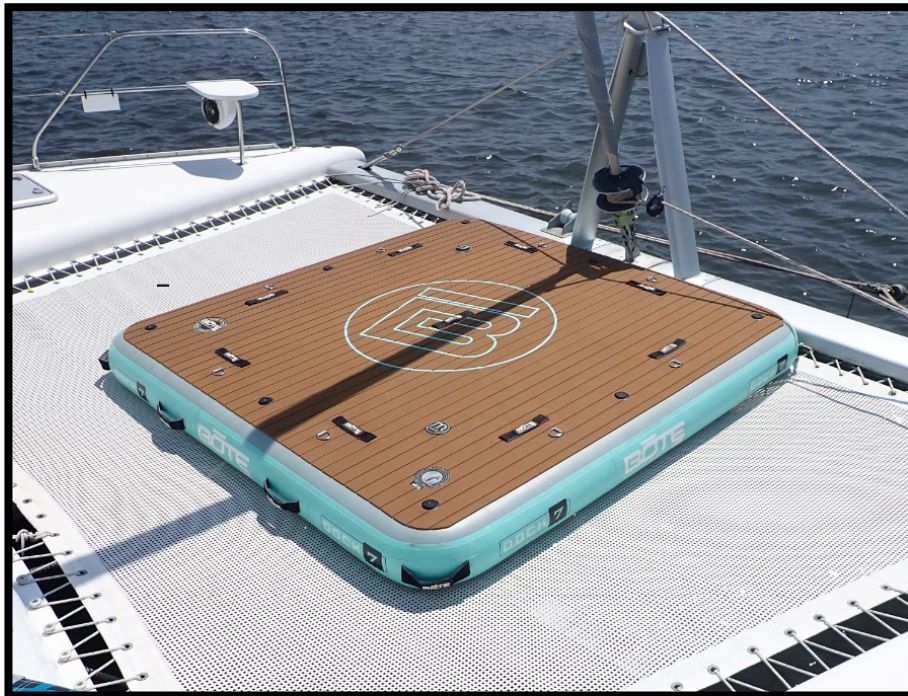
Figure 3. An overall view of the Bote floating dock platform utilized by the swimming passengers. On the day of the incident, the platform was in the water, as opposed to on the deck of the vessel.

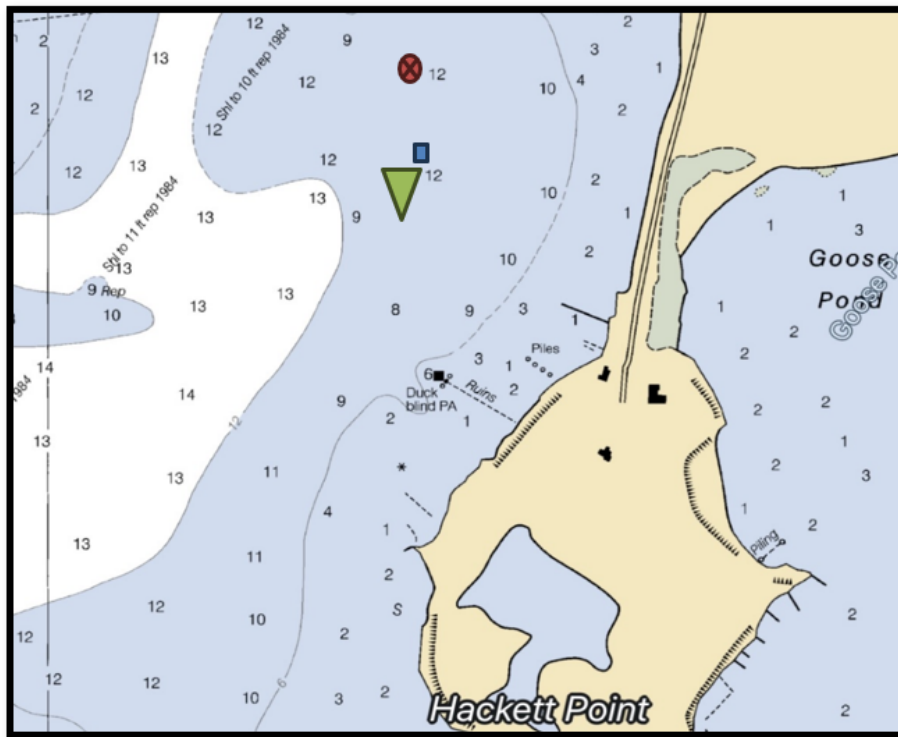
Figure 4. An image showing the charted water depths in Whitehall Bay. A depth of 12 feet was indicated where the TOO SHORT was anchored when the incident occurred. The approximate location of TOO SHORT is represented by the green triangle; the Bote floating platform is the blue square, and approximate drowning location is indicated by the red and black circle.
