**REPORT OF INVESTIGATION INTO THE LOSS
OF FOUR LIVES ONBOARD THE
RECREATIONAL VESSEL TRIUMPH
(NY 1883MS), NEAR BREEZY POINT, QUEENS,
NY, ON FEBRUARY 23, 2025**

MISLE ACTIVITY NUMBER: 8085695, MISLE CASE NUMBER: 1429725

LOSS OF FOUR LIVES ONBOARD THE RECREATIONAL VESSEL TRIUMPH (NY1883MS), NEAR BREEZY POINT, QUEENS, NY, ON FEBRUARY 23, 2025

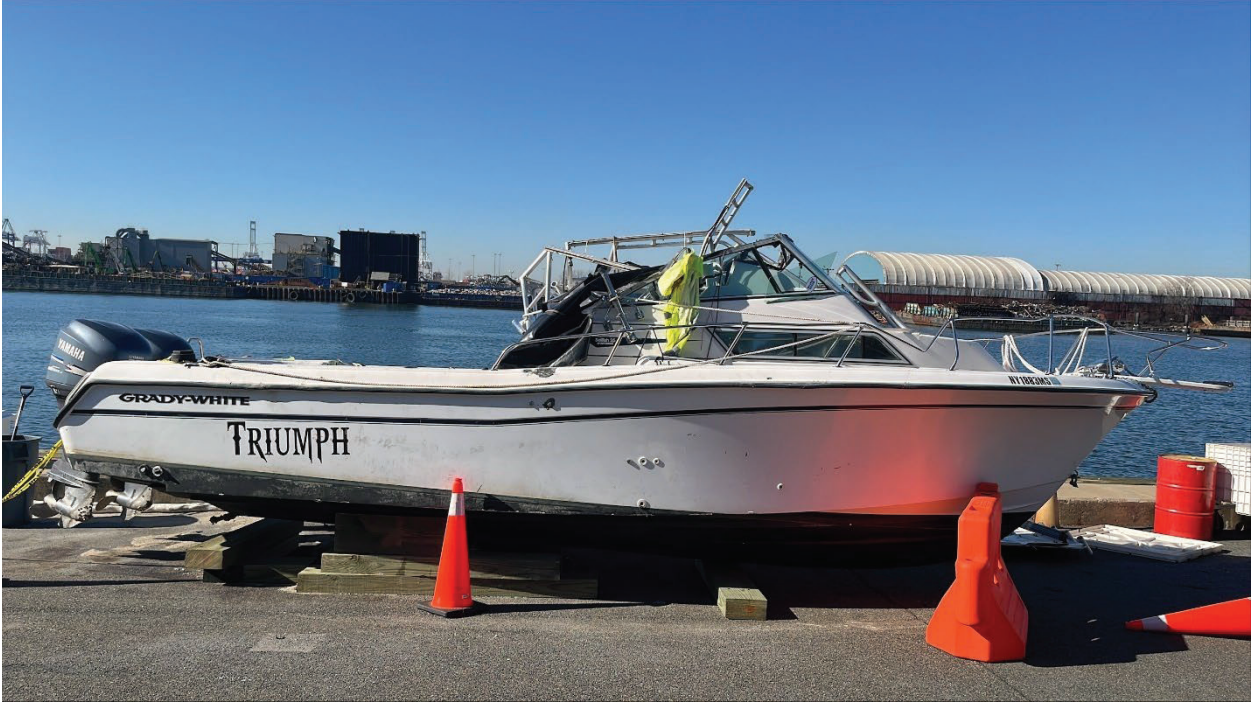
Figure 1. Photo of TRIUMPH on March 10, 2025, taken at the Army Corp of Engineers facility in Jersey City, NJ by USCG.

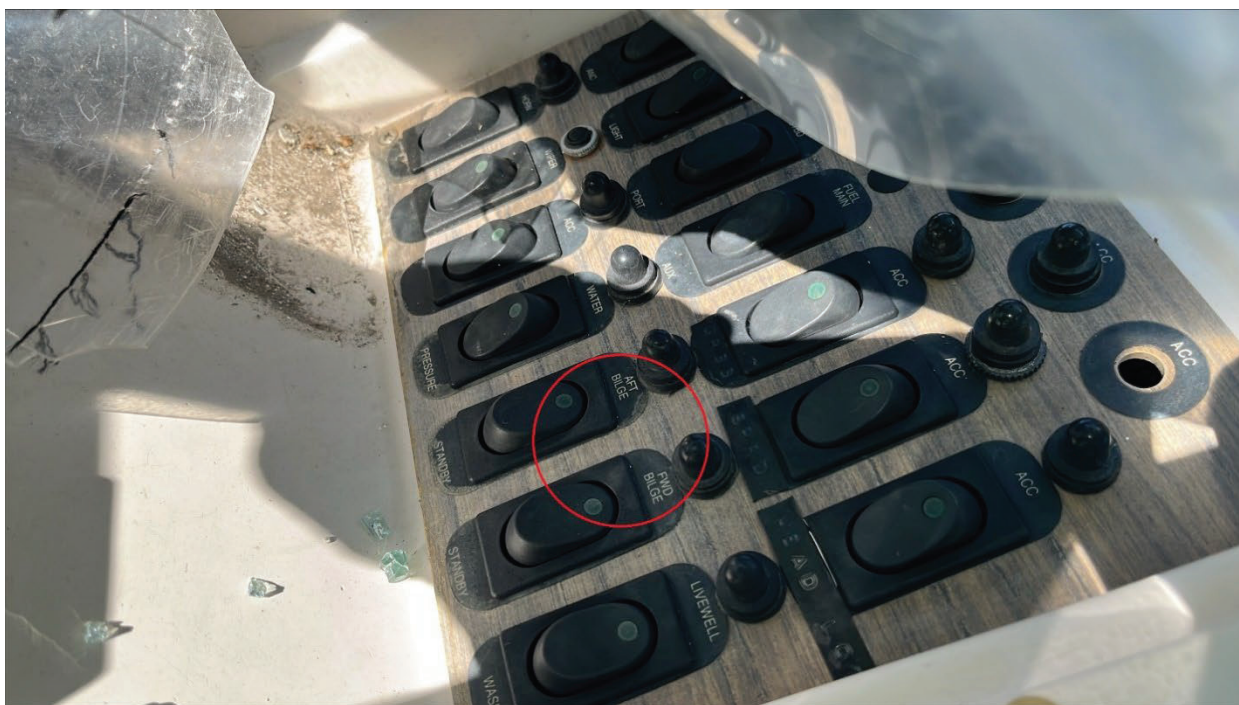
4.1.6. At 1157, Passenger 1 attempted to restart the engines and the bilge pump system, but nothing would start. Passenger 1 stated that at this point the engines and batteries were submerged in the water as the stern of the boat began to sink. Passenger 1 dialed 911 to report the situation, while another passenger distributed life jackets and life rings. There were no VHF calls made by anyone onboard the boat. Meanwhile, two passengers attempted to bail water from the hull of the boat using buckets.

Figure 3: Photo of the main console taken by USCG. Showing both bilge pumps were in the on position.

4.2.9. The vessel was equipped with a manual, rather than automatic bilge pump system that activates at the detection of water.

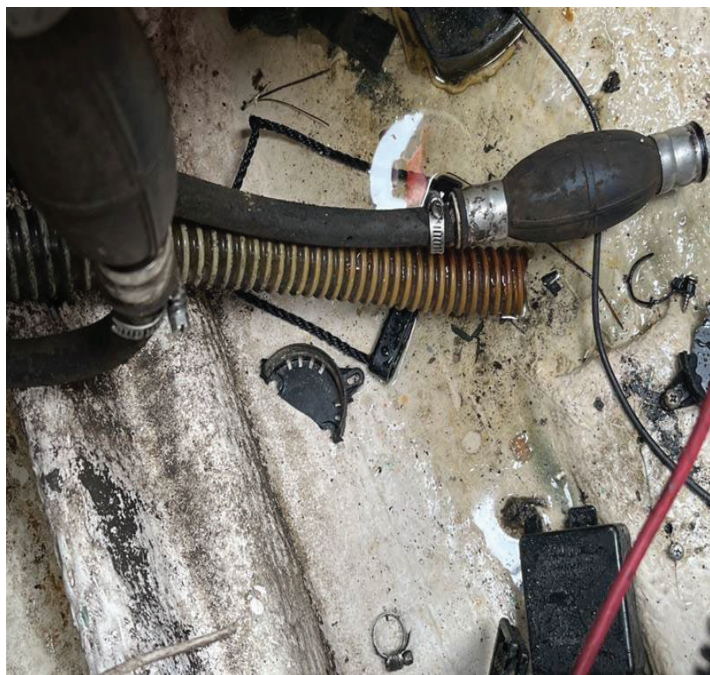
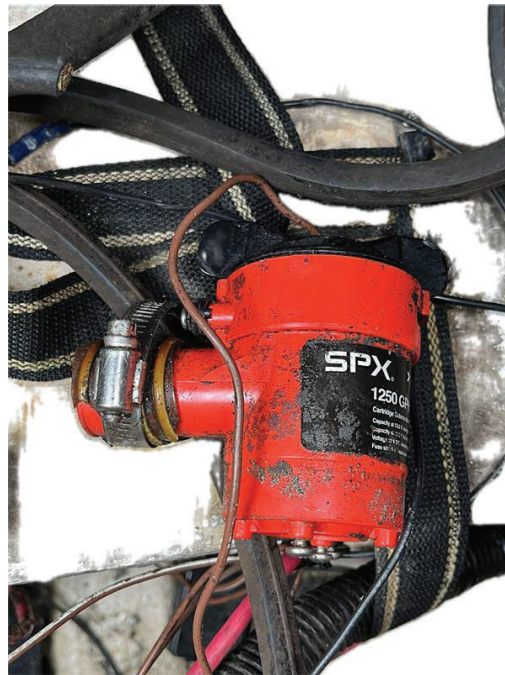
4.2.8. The recovered vessel also showed that the aft bilge hose was cracked and disconnected from the bilge pump. Additionally, the forward bilge pump hose was not connected to the hull fitting.

Figures 4 & 5: Photos of the aft bilge pump and hose taken by USCG.

5.1.1 During the investigation, it was observed that the bilge hose in the aft bilge compartment was cracked and disconnected from the bilge pump. Bilge hoses function by channeling water from the lowest point of the boat to a discharge point outside the hull, typically via an electric bilge pump. Similar to the stern, the hose in the forward bilge compartment was not attached to the hull fitting for proper discharge. Additionally, the port-side drain hose scupper was missing. The scupper allows water to drain while the boat is moving but stop water from entering the vessel when it is stationary. The fact that all of the passengers were fishing near the stern of the vessel with no scupper to stop water ingress is a likely reason that the seawater was able to enter the vessel and drain to the bilge compartment. It remains unclear whether these disconnections occurred prior to the incident or as a result of the boat capsizing, but it is reasonable to assume that if the port side drain scupper was missing, and if the bilge hoses were not connected to overboard discharge, it could have significantly accelerated the rate of water accumulation in the bilges. Additionally, for this case, the bilge pump was not automatic and required manual activation. According to Passenger 1, he was unable to operate the bilge pump due to a complete loss of electrical power, as the batteries were in an aft compartment that had flooded. This electrical failure also stopped the engines from re-starting and possibly allowing the vessel to self-rescue. Although it was not required by law, the boat didn't have a high-level bilge alarm system, which might have alerted the crew of the flooding sooner.

6.1.1.1. Water ingress and accumulation in the bilge compartment.
