**REPORT OF THE INVESTIGATION
INTO THE
PARASAILING VESSEL (TX5126HF),
PASSENGER LOSS OF LIFE ON AUGUST 8,
2015**

**LOSS OF LIFE OCCURRING ON THE UNINSPECTED PASSENGER VESSEL
TX5126HF WHILE CONDUCTING PARASAILING OPERATIONS IN THE VICINITY
OF PIER 19 ON THE LAGUNA MADRE, SOUTH PADRE ISLAND, TEXAS
ON AUGUST 8, 2015**

Subj: LOSS OF LIFE ABOARD THE TX5126HF ON 08/08/2015, INVESTIGATING
OFFICER'S REPORT

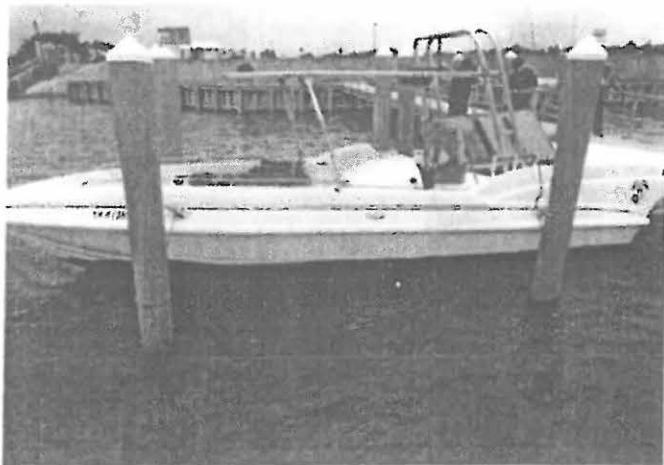
Photo of the TX5126HF at South Padre Island August 2015

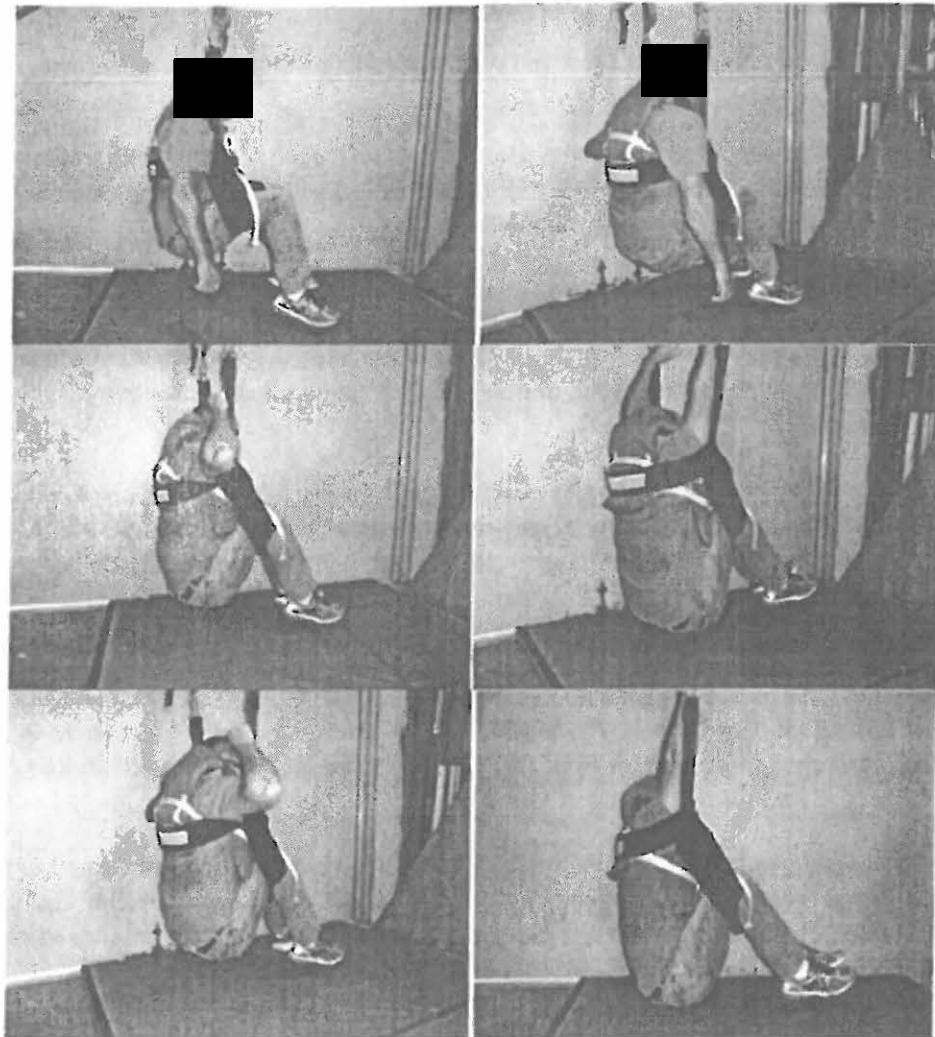
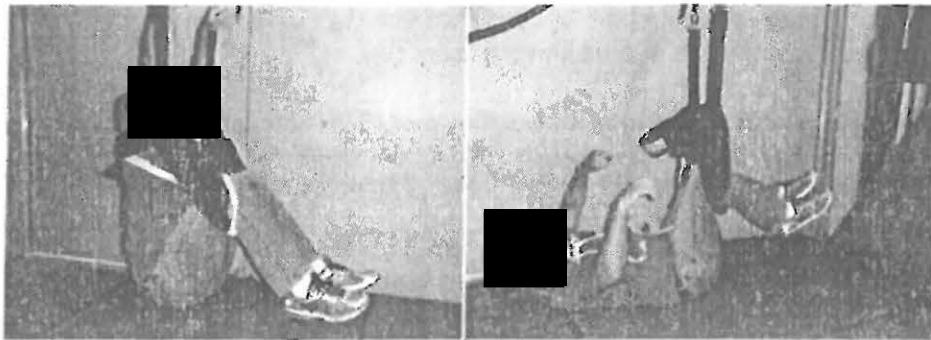
The following series of pictures were taken during the investigating officer's recreation of [REDACTED] fall and best helps to illustrate what witnesses observed. Ms. [REDACTED] was wearing a Custom Chutes' parasailing harness in size large. It was properly sized for Ms. [REDACTED] weight as per the "Product Owners and Maintenance Manual" version 13.1, 165 - 230lbs, and was in good condition. Upon further more detailed expert analysis, the dimensions of the harness were found to be within manufacturers' specifications and no abnormalities were noted.

Although there was no information available on the size of Ms. [REDACTED] life jacket and the jacket itself could not be recovered for analysis, based on witness testimony it is surmised that either Ms. [REDACTED] was not fitted correctly into her life jacket or the jacket was too large for her, or both.

Manufacturer product information and ASTM Standards indicate that a parasail harness's waist strap must fit around the passenger's waist and not over the life jacket. The waist strap must be made tight over the waist to prevent the passenger from sliding out of the harness and keep the person correctly positioned on the seat of the harness.

Taking into account the findings above, this investigation concludes that Ms. [REDACTED] harness waist strap's incorrect positioning contributed to her inability to maintain a safe position while aloft and failed to prevent her from slipping out of the harness. Had the harness been properly fitted as directed by the manufacturer and ASTM Standards, Ms. [REDACTED] death may have been prevented.
