UNITED STATES COAST GUARD

**REPORT OF THE INVESTIGATION
INTO THE
TX5645JL COLLISION WITH TX9011JL
RESULTING IN LOSS OF LIFE AND PASSENGER
INJURIES AT TURTLE COVE, PORT ARANSAS,
TX ON SEPTEMBER 10, 2022**

**COLLISION BETWEEN THE UNINSPECTED PASSENGER VESSEL (UPV) TX5645JL
AND THE UPV TX9011JL RESULTING IN INJURIES AND THE LOSS OF ONE LIFE
WHILE UNDERWAY IN THE VICINITY OF THE CORPUS CHRISTI SHIP CHANNEL
INNER BASIN NEAR CORPUS CHRISTI, TEXAS ON SEPTEMBER 10, 2022**

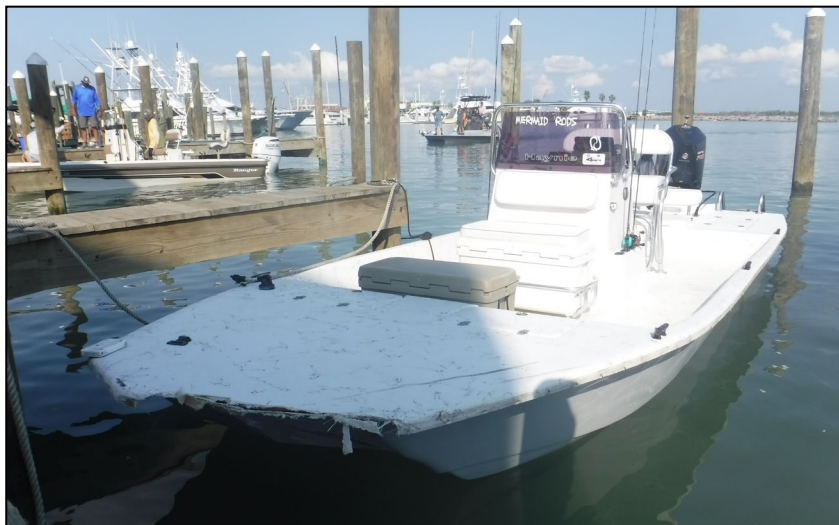
Figure 1. UPV 1 post-accident at Fisherman's Wharf in Port Aransas, TX (September 10, 2022/USCG)

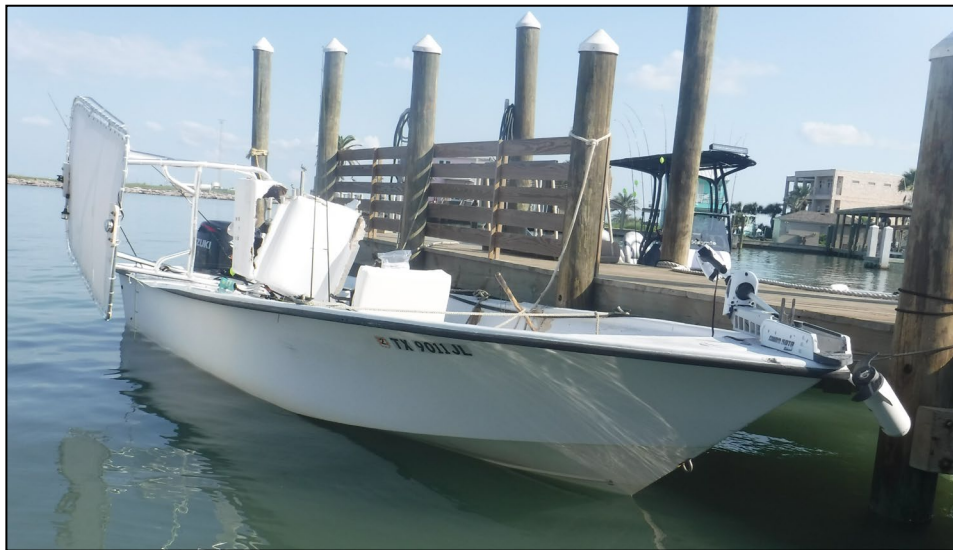
Figure 2. UPV 2 post-accident at Fisherman's Wharf in Port Aransas, TX (September 10, 2022/USCG)

- 5.5. *Improper navigational light configuration.* While reviewing photographs and witness interviews, it was evident that Captain 2 saw UPV 1 before Captain 1 saw UPV 2, but still not within an appropriate amount of time to avoid collision. As seen in Figures 1 and 6 previously in this report, it is possible that UPV 1’s all-around white light was obstructed by Captain 1 and his center console. Navigation Rules 33 CFR 84.15 states all-around lights shall be so located as not to be obscured by masts, topmasts, or structures within angular sectors of more than six degrees. This obstruction could have contributed to late awareness. Additionally, as seen in Figures 2, 7 and 8, UPV 2’s all-

around white light was approximately 6-inches higher than the sidelights, but visible on Port Aransas Ferry Terminal security footage. Navigation Rules 33 CFR 84.02 (Annex I) states the masthead light, or all-around light of a power-driven vessel of less than 12 meters in length shall be carried at least one meter higher than the sidelights. This vertical separation ensures visibility from all directions and reduces the chance of confusion with other light signals. The obstruction of UPV 1's all-around light and the insufficient height of UPV 2's all-around light may have hindered early detection and recognition of each vessel's presence and intentions. Had the navigational lights been configured correctly, the risk of collision could have been recognized sooner, allowing for timely and appropriate evasive actions to avoid the accident.

8.2.1. Recommend the Officer in Charge, Marine Inspections, Sector Corpus Christi issue a Finding of Concern regarding recreational vessel navigation light placement.

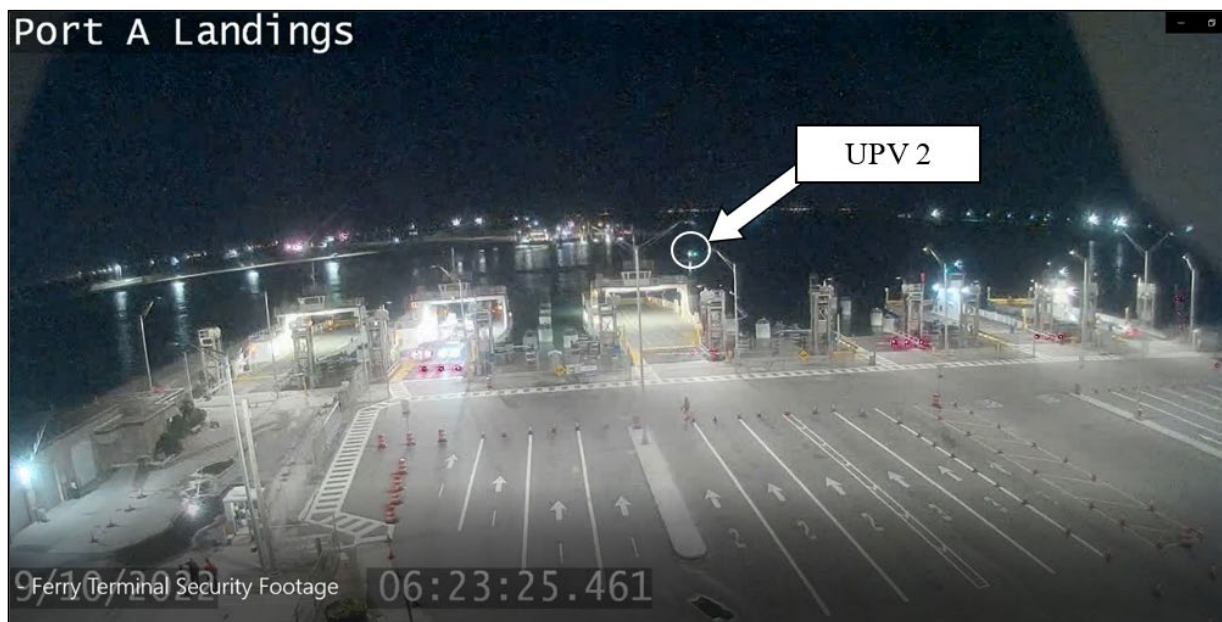
4.1.3. At 0623, UPV 2 passed the Port Aransas Ferry Terminal, exhibiting a visible all-around light and sidelights, heading east in the Corpus Christi Channel (Figure 3).

Figure 3. UPV 2 eastbound Corpus Christi Channel with visible navigation lights. (September 10, 2022, Port Aransas Ferry Security)

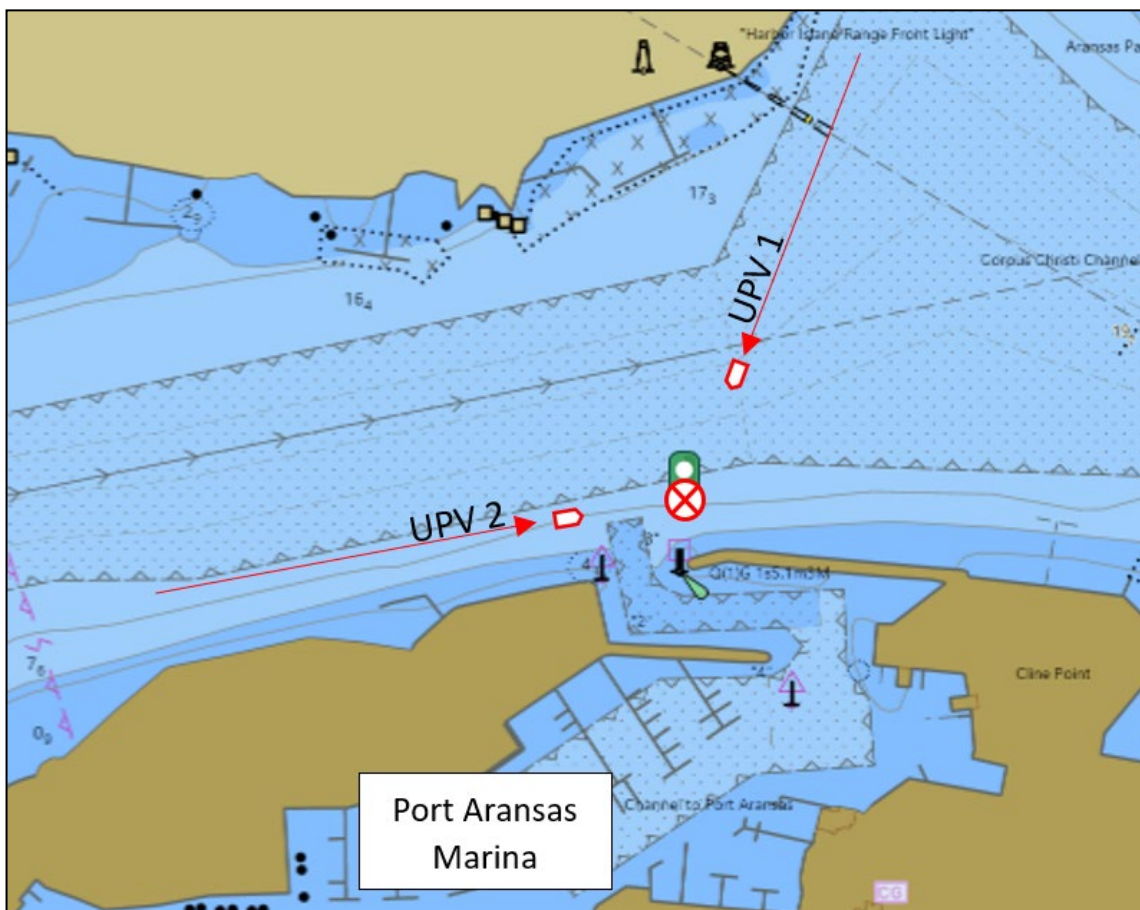
4.1.7. At 0626, the starboard bow of UPV 1 collided with the port beam of UPV 2 and struck Captain 2, ejecting Captain 2 and his leaning post into the water, and striking Passenger 1 on his left leg. UPV 1’s engine did stop immediately due to kill switch activation.

Figure 4. Diagram of UPV 1 and UPV 2 with approximate collision position developed by USCG.

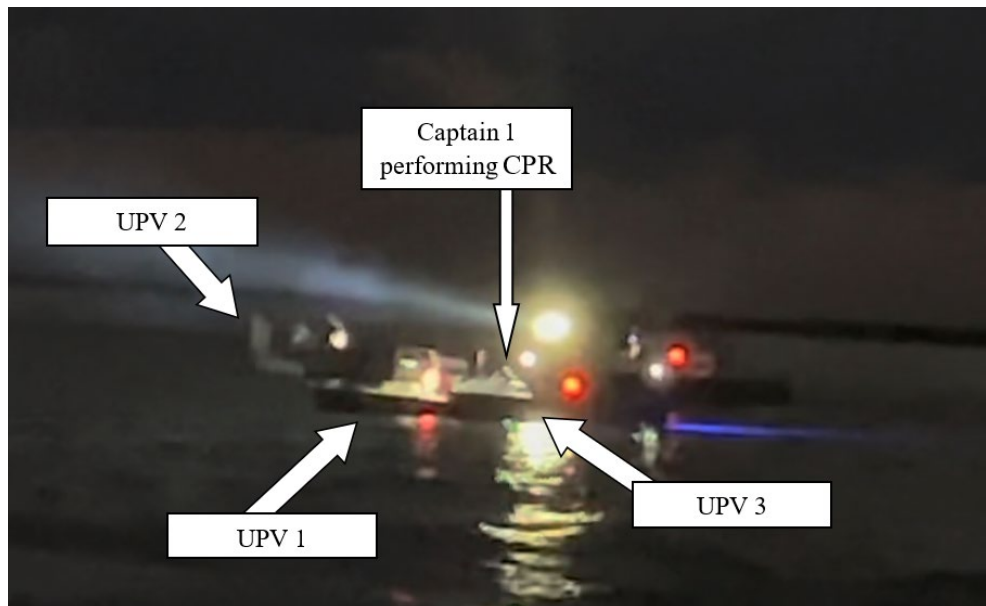
4.1.9. At 0628, Captain 1 on UPV 1 pulled alongside UPV 3 and assisted in rendering CPR (Figure 5).

Figure 5. Screenshot from video provided by Passenger 4 awaiting Captain 1 pick-up, taken from Roberts Point Park at 0633 (September 10, 2022 / Passenger 4)

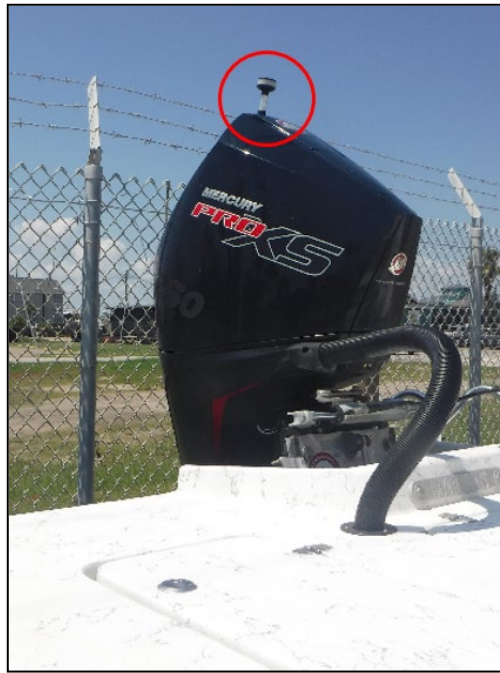
4.2.8. UPV 1 was a custom 23.4-foot 2021 Haynie 23 SC model, driven by a single Mercury 250HP outboard engine. It featured an approximately 3.5-foot-wide center console equipped with a tinted shield. UPV 1 had one all-around white light installed on the stern motor (Figure 6) and two sidelights installed on the center console prior to vessel purchase. Figure 1 depicts the location of the motor in relation to the center console. The all-around white light was obscured by the center console and operator location at angular sectors greater than six degrees. All navigational lights were

Figure 6. UPV 1 All-around white light close-up circled in red. Light was installed on outboard motor. (September 10, 2022/USCG)

6.1.1.5. UPV 1 and UPV 2 navigation lights were configured incorrectly.

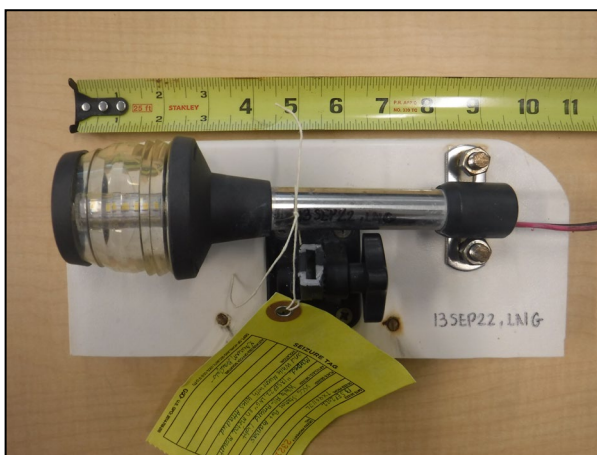
Figure 7. UPV 2 all-around white light, post-accident with ruler guide. (September 13, 2022 / USCG)

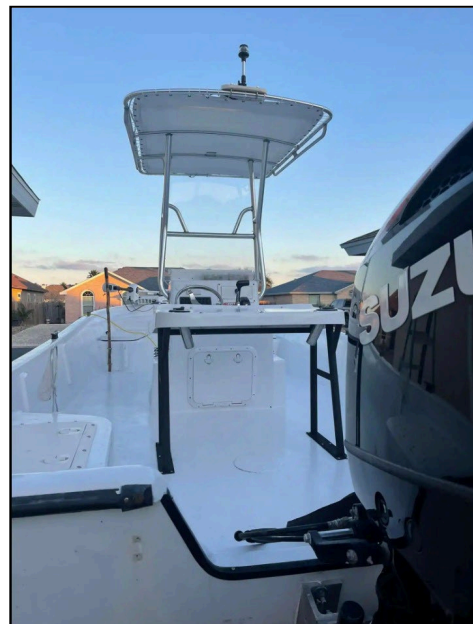
Figure 8. UPV 2 prior to collision with navigation lights intact, all-around white light location shown. (Unknown / Captain 2)
