# UNITED STATES COAST GUARD

**THE REPORT OF INVESTIGATION  
INTO THE  
LOSS OF LIFE RESULTING FROM THE  
TX7817EB RUNNING OVER A RECREATIONAL  
KAYAK ON REDFISH BAY ON MAY 27, 2019**

MISLE ACTIVITY NUMBER: 6714225

**COLLISION BETWEEN THE UNINSPECTED PASSENGER VESSEL TX7817EB  
AND A RECREATIONAL KAYAK RESULTING IN THE LOSS OF ONE LIFE ON  
REDFISH BAY, TEXAS ON MAY 27, 2019**

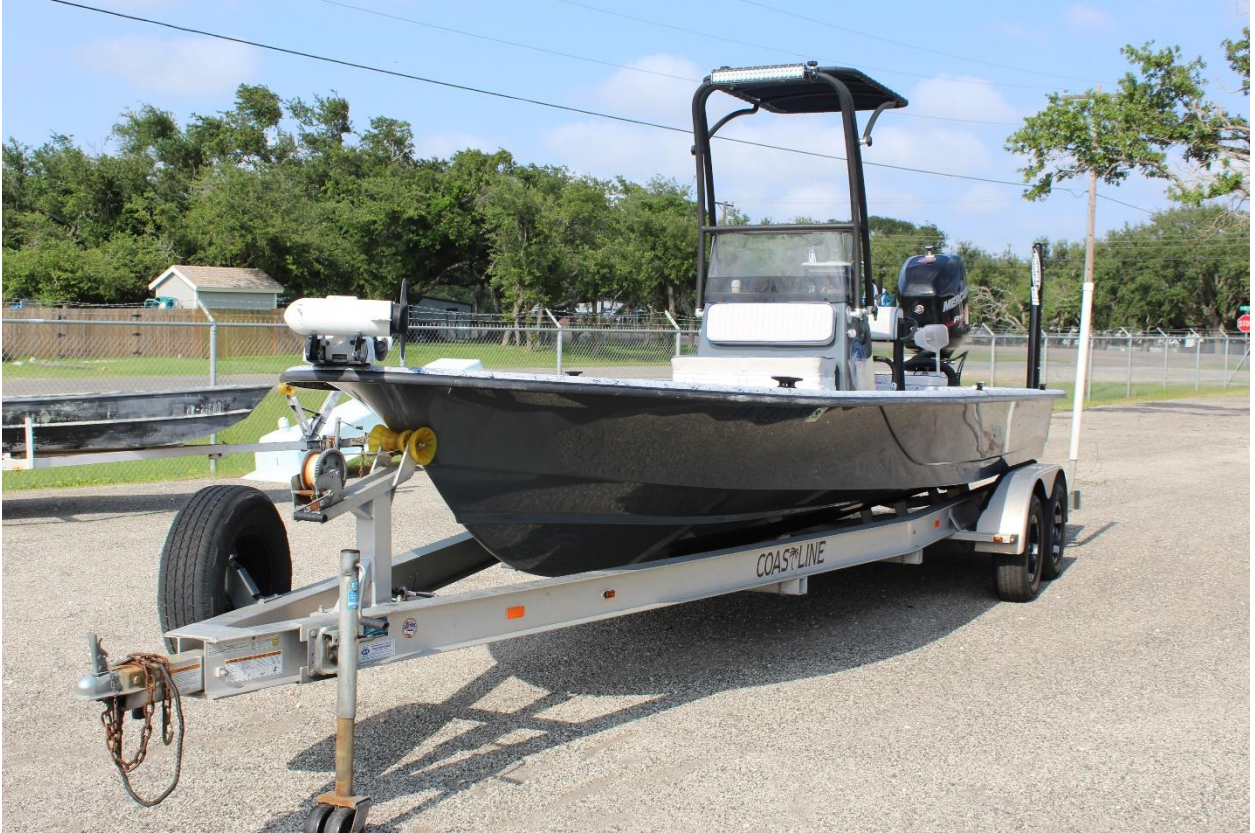
Figure 1: TX7817EB on its trailer after the incident. (Unknown Date/TPWD)

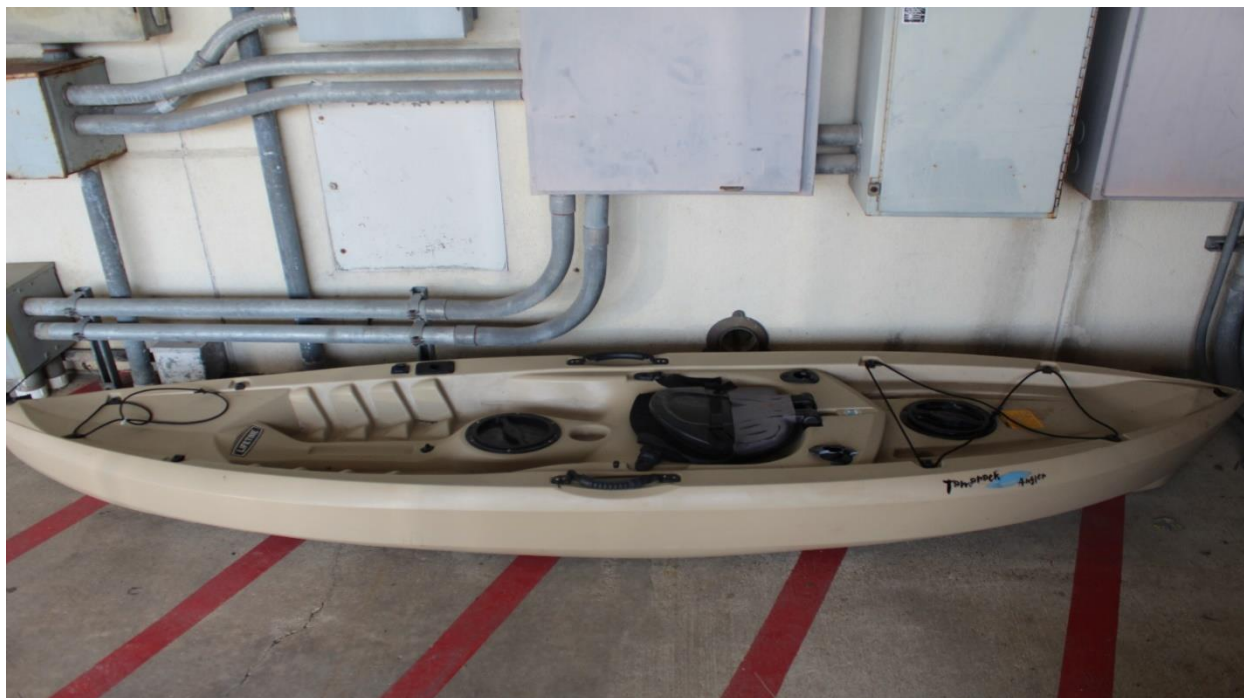
Figure 2: Port aspect of recreational kayak. (Unknown Date/APPD)

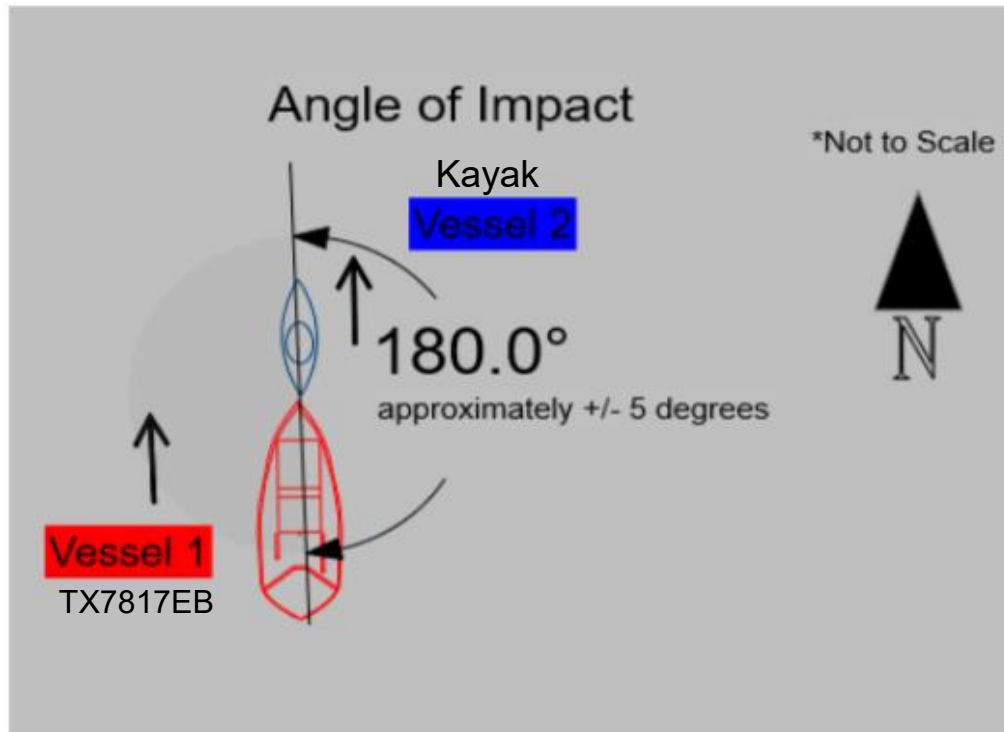
4.1.6. At 0543, the X7817EB collided with the recreational kayak traveling at 39 knots (44.9 mph).

Figure 3: Diagram of angle of impact as determined by the Texas Parks and Wildlife Accident Reconstruction Team (Unknown Date/TWPD) .

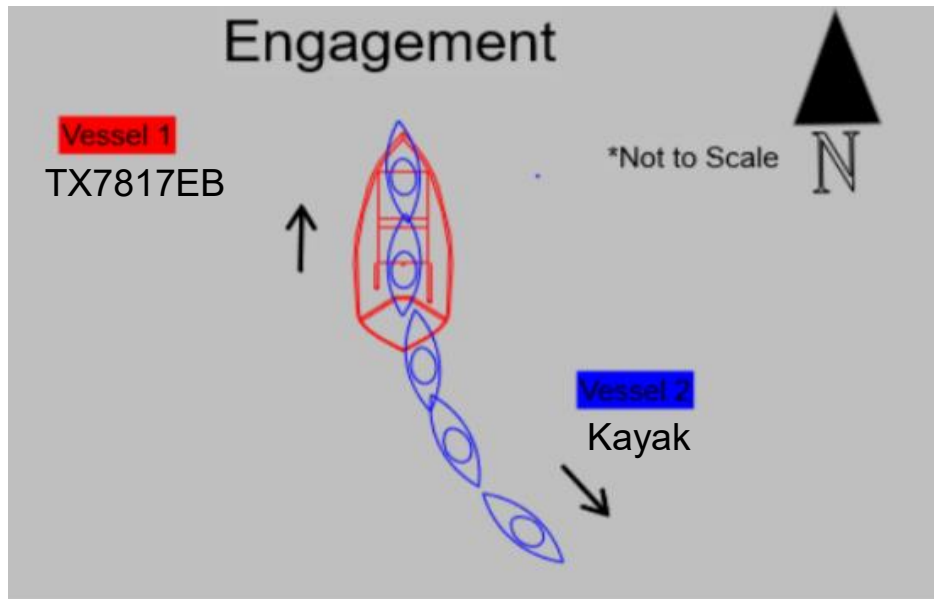
4.1.7. At 0543, the TX7817EB ran over the kayak with the kayaker in the seat.

Figure 4: Diagram of engagement as determined by the Texas Parks and Wildlife Accident Reconstruction Team. (Unknown Date/TPWD).

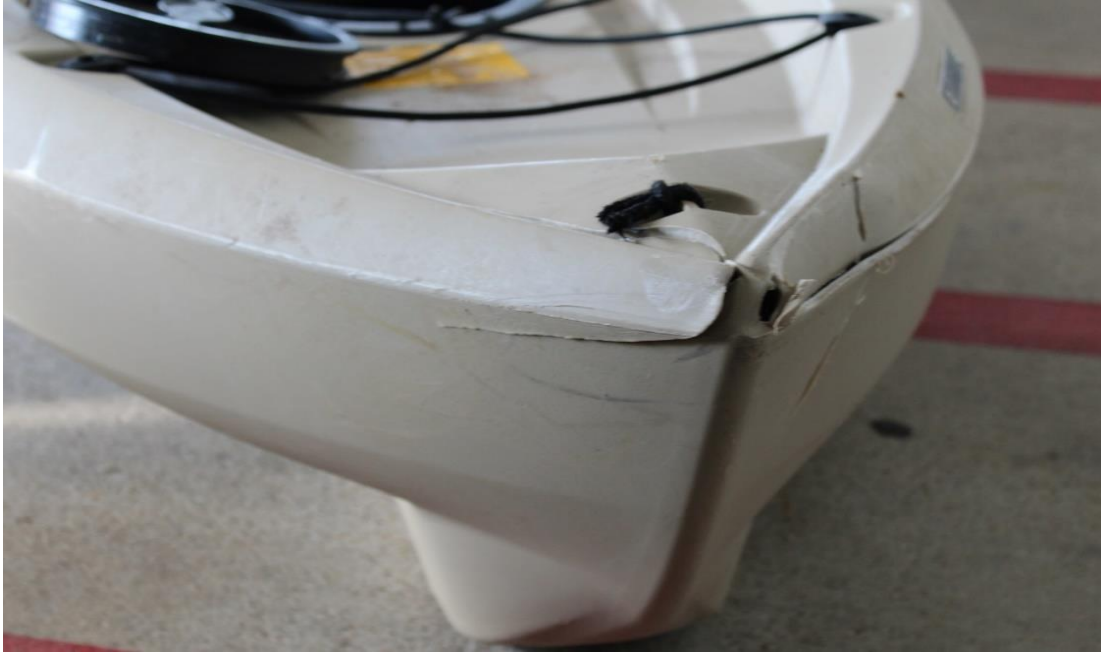
4.1.13. The kayak was recovered shortly after, which contained a cell phone with a picture of the victim. The kayak sustained damage, including cracks and scrapes (See Figure 5).

Figure 5: Damage to stern of the recreational kayak. (Unknown Date/APPD)
