## **REPORT OF THE INVESTIGATION INTO THE CAPSIZING OF THE VESSEL UNA MAS (OR854ACS), IN THE PACIFIC OCEAN NEAR GOLD BEACH, OR, WITH LOSS OF LIFE, ON AUGUST 31, 2025**

**CAPSIZING OF THE COMMERCIAL FISHING VESSEL UNA MAS (OR854ACS)  
RESULTING IN THE LOSS OF TWO LIVES WHILE TRANSITING IN THE PACIFIC  
OCEAN APPROXIMATELY FOUR NAUTICAL MILES WEST OF GOLD BEACH,  
OREGON ON AUGUST 31, 2025**

**INVESTIGATING OFFICER'S REPORT**

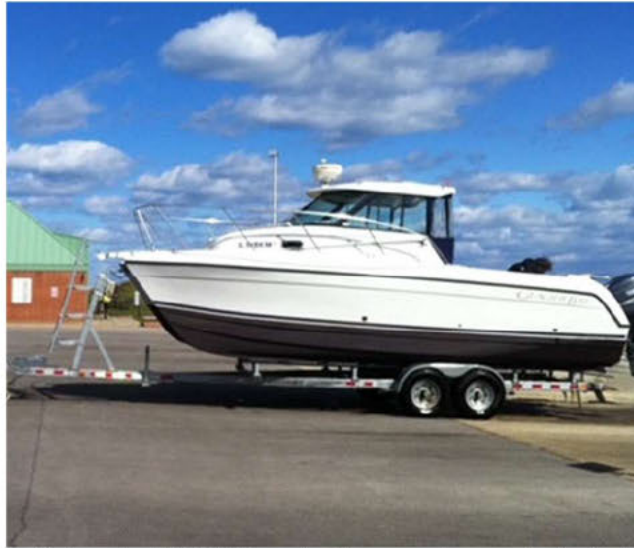
Figure 1. Photograph of UNA MAS received from owner's son on September 15, 2025.

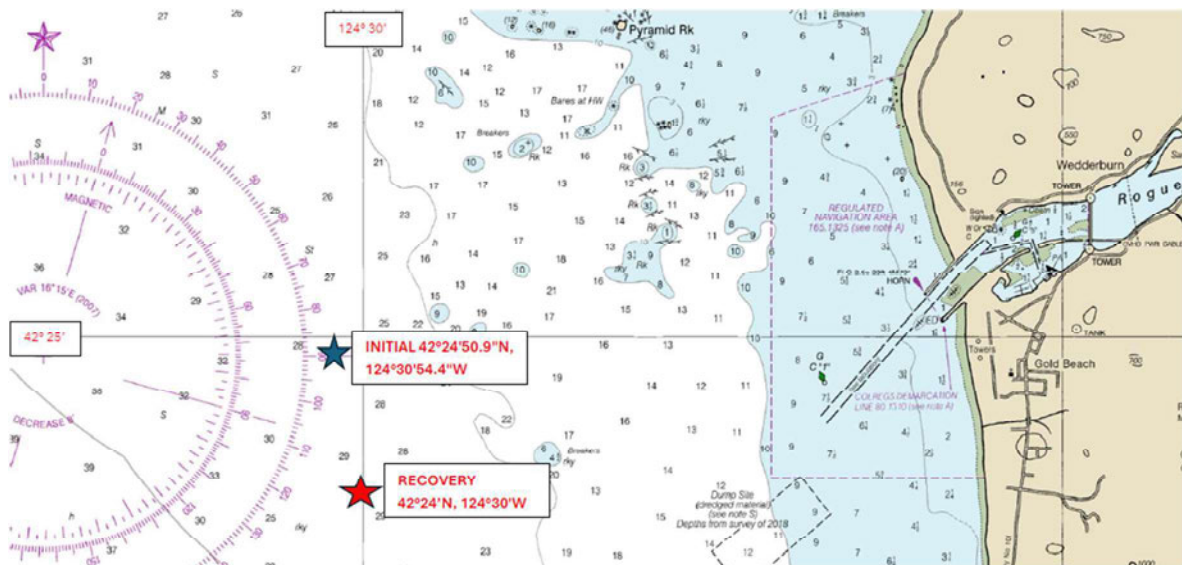
Figure 2. Modified chart image of the approximate location of the initial incident location and recovery of C-1. Not to scale.

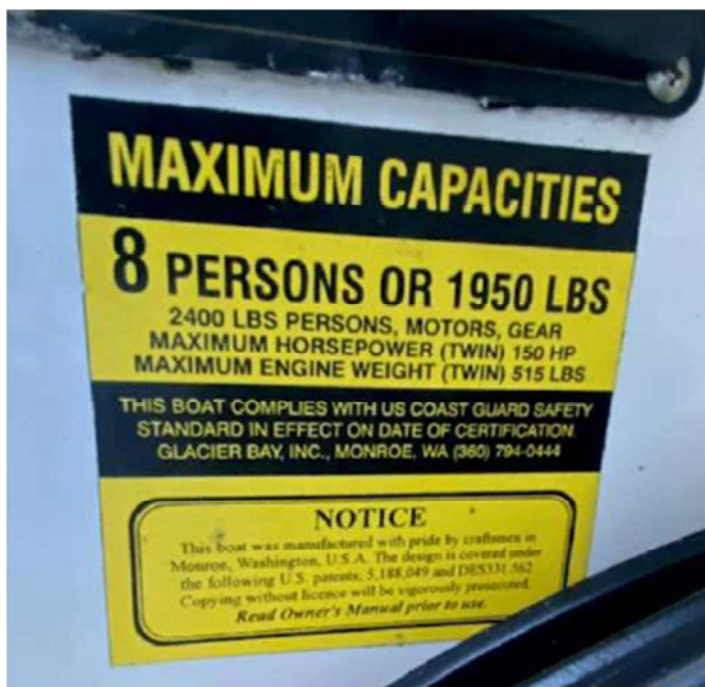
Figure 3. Enlarged photo of maximum capacities label adhered to UNA MAS on September 22, 2025. Obtained from CG Inspector.

5.1.1. The UNA MAS, a 2002 Glacier Bay Coastal Runner 2680 catamaran, had a manufacturer-specified maximum weight capacity of 2,400 pounds for persons, motors, and gear, as indicated on the label at the captain's station. At the time of the incident, the vessel carried three people with a combined weight of approximately 550 pounds and was equipped with two Yamaha 150 HP outboards totaling 1,018 pounds. Considering the report of how much fish, ice, and storage was on board the calculated approximate weight was 2,274 pounds. The total estimated weight of persons, motors, and gear on board was 3,842 pounds, exceeding the manufacturer's recommended limit. This excess weight, combined with severe weather and increasing swells, may have compromised the vessel's ability to right itself, potentially contributing to its capsizing. A proactive assessment of the anticipated total weight by the Operator may have identified these risks and allowed for preventive adjustments.
