**REPORT OF THE INVESTIGATION
INTO THE
AUTONOMOUS CRAFT VICAR 602 &
RECREATIONAL VESSEL ROWING SCULL
COLLISION AND TOTAL CONSTRUCTIVE LOSS
OF ROWING SCULL ON THE PATAPSCO RIVER
IN BALTIMORE, MD, ON AUGUST 07, 2024**

MISLE ACTIVITY NUMBER: 7989592

INVESTIGATING OFFICER'S REPORT

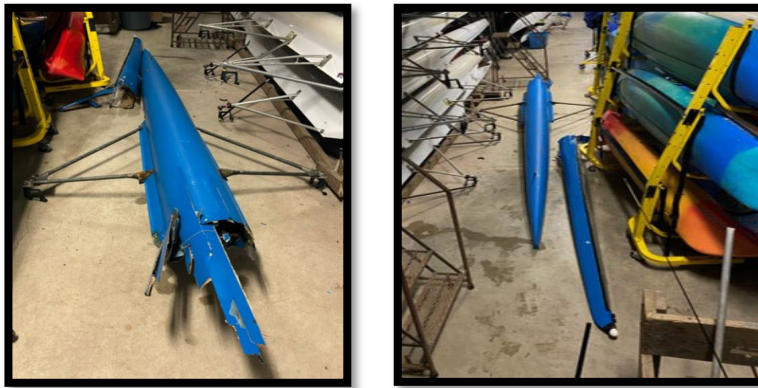
Figure 2. Photos of Rowing Scull (post collision) at Baltimore Community Rowing Facility. 07August 2024 Taken by Coast Guard Investigator.

4.1.11. At 0800, the bow of the VICAR 602 collided with the starboard side of the rowing scull, splitting the vessel in half.

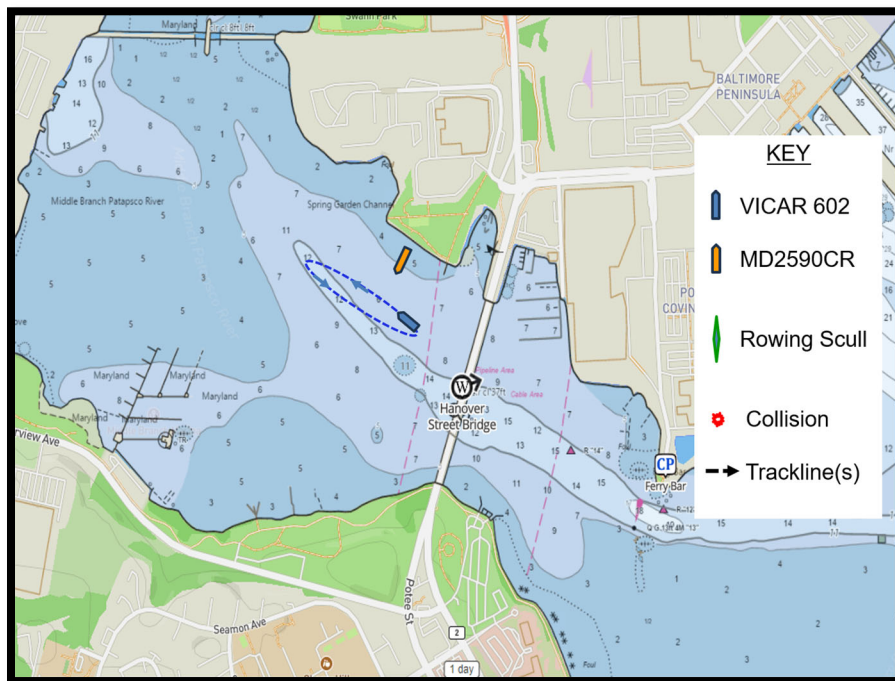
Figure 3. Approximate location and track line of VICAR 602 and anchored position of the MD2590CR. Image created by USCG.

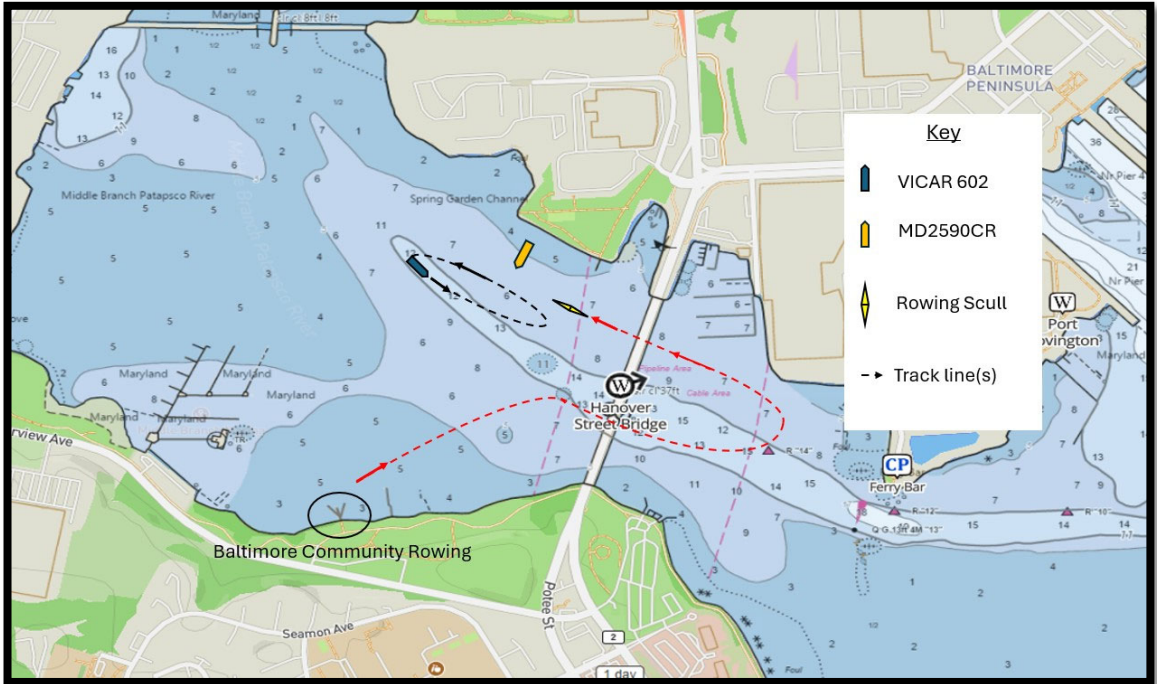
Figure 5. Approximate track line of Rowing Scull, departing from Baltimore Community Rowing and eventually heading west through the Hanover Bridge Span. Image created by USCG.

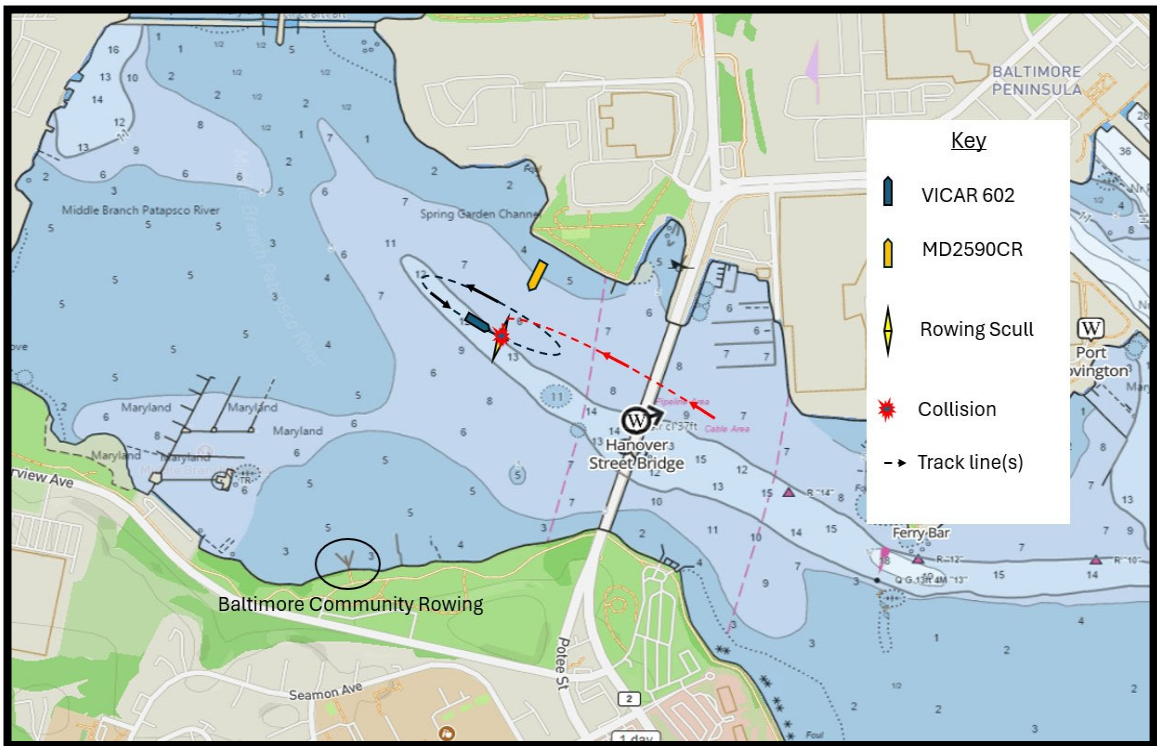
Figure 6. Approximate Location and Track line of VICAR 602, MD2590CR, and Rowing scull. Image created by USCG.

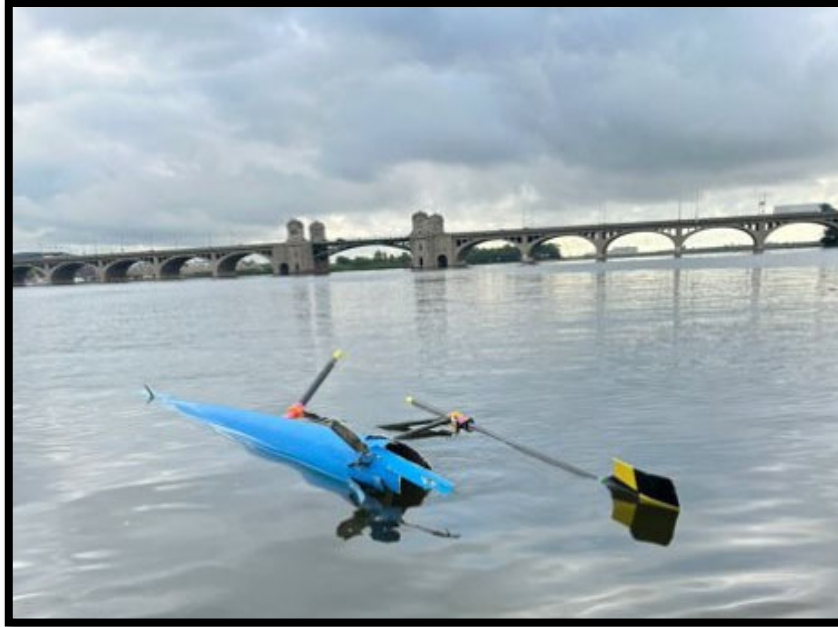
Figure 7. Rowing Scull in the Patapsco River after the collision. Photo taken by Baltimore Community Rowing.

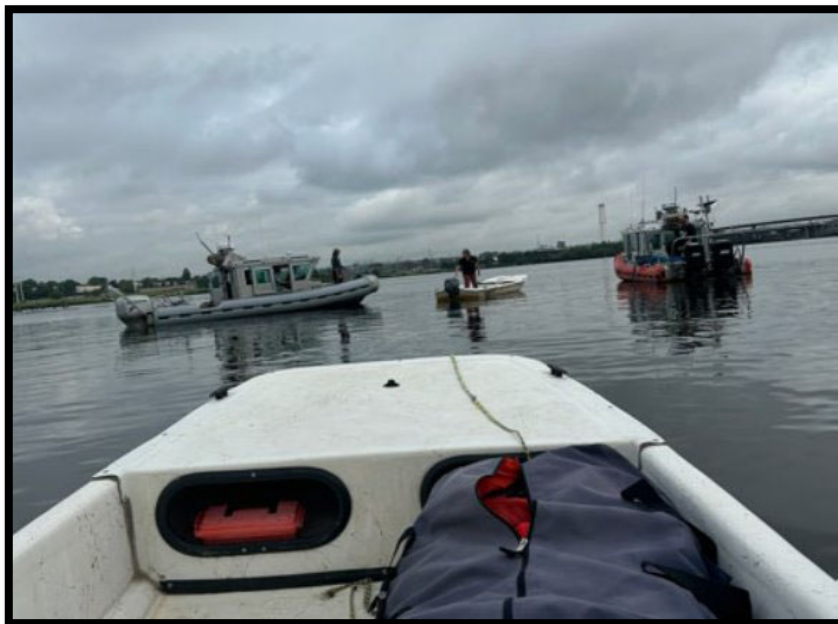
Figure 8. Members of Baltimore Community Rowing (center), MD2590CR (right), and another vessel from MAPC (left) responded to the scene to recover the rowing scull operator and the rowing scull from the water. Photo taken by Baltimore Community Rowing.

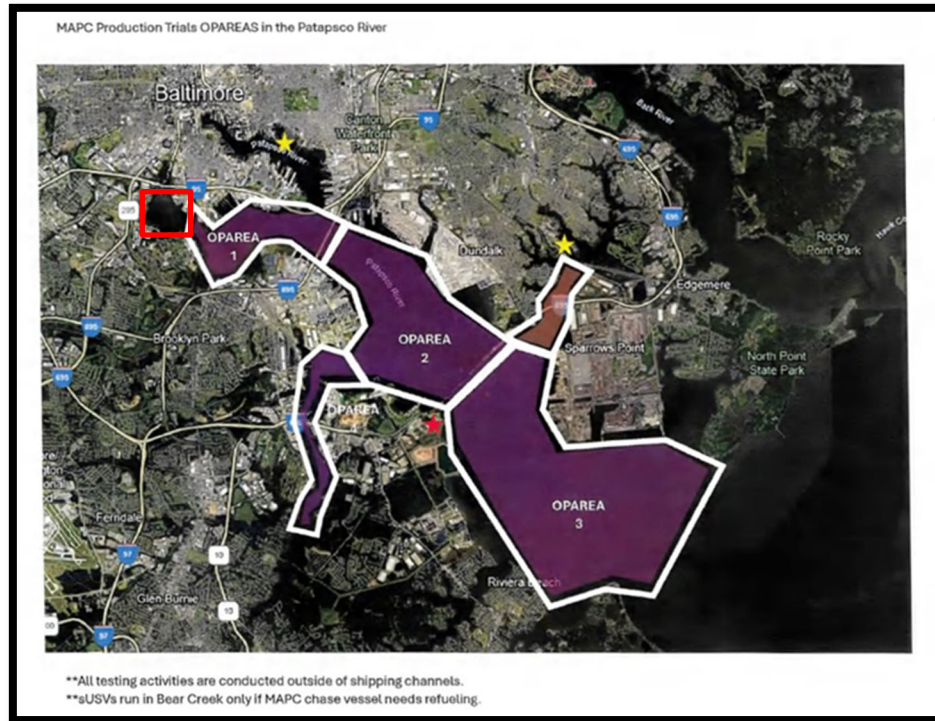
4.2.7. For planning purposes, MAPC identified four operational areas for GARC testing; however, the Middle Branch (where the incident occurred) had not been identified as an operational area. The Middle Branch had been chosen to conduct the 72-hour endurance test as MAPC believed it would be a quiet location to conduct said test. MAPC did not conduct any public outreach to notify the public that they would be conducting testing in the new area, prior to testing (Figure 11).

Figure 11. Middle Branch/testing area indicated by red square. Obtained from MAPC.

5.5 Failure to adhere to proposed testing location and procedures. In July 2023, Sector Maryland-NCR staff met with MAPC and received a briefing on GARC production and planned testing operations. MAPC outlined its intent to conduct tests within specified operational testing locations and provide test schedules to the Sector Command Center before conducting testing operations. Leading up to the 72-hour test and subsequent collision, no test schedules were provided to the Sector Command Center, nor was the test taking place in one of the pre-specified testing locations. Had the company provided the Coast Guard with the schedule and new testing location prior to the test, the Coast Guard may have been able to conduct an adequate risk assessment which identified the Middle Branch of the Patapsco River as a high traffic recreational rowing area and helped implement appropriate risk mitigation measures to avoid collisions.

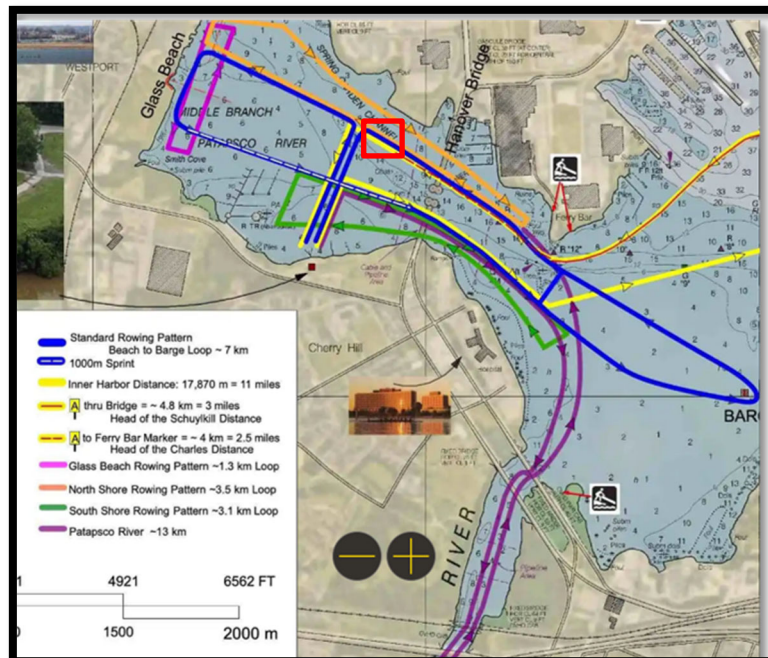
4.2.8. Baltimore Community Rowing had several publicly advertised rowing traffic patterns on the Middle Branch of the Patapsco River. The routes were posted on their public website.

Figure 12. Baltimore Community Rowing traffic patterns. Red Square was the approximate location of the 72-hour test and collision. Obtained from Internet.
