REPORT OF THE INVESTIGATION
INTO THE
WAYMON BOYD (O.N. 261512) EXPLOSION,
FIRE, AND LOSS OF LIFE ON TULE LAKE
CHANNEL IN CORPUS CHRISTI, TX ON
AUGUST 21, 2020

16732/IIA # 7039383
19 December 2025

**EXPLOSION AND FIRE ON THE DREDGE VESSEL WAYMON BOYD (O.N. 261512)
RESULTING IN THE LOSS OF FIVE LIVES WHILE DREDGING ON TULE LAKE
CHANNEL NEAR CORPUS CHRISTI, TEXAS ON AUGUST 21, 2020**

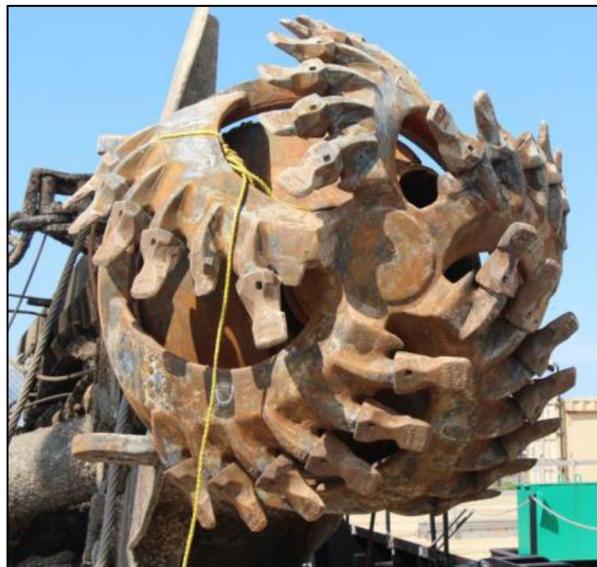
4.2.2. The WAYMON BOYD functioned with a cutterhead (*see Figure 5*) mounted to framework, which could move up and down, affixed to the bow of the dredge. The cutterhead had teeth, which broke up the rock and dirt as the cutterhead spun. The broken-up debris was then suctioned through a pipe positioned directly behind the cutterhead, and the debris continued to be pumped through the dredge via attached dredge-pipeline. A series of pumps on support vessels moved the dredged material via the dredge-piping to a dredge material placement area.

Figure 4. WAYMON BOYD cutterhead, post-accident. (September 17, 2020, USCG)

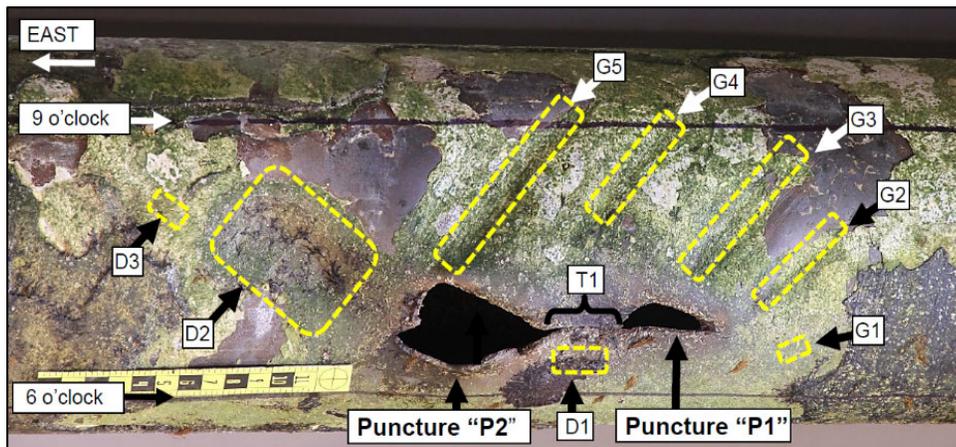
4.2.16. Beginning on October 5, 2020, a 14-foot, 4-inch segment of the pipeline (see Figure 9) was removed and transported to NTSB for analysis and metallurgic testing. NTSB laboratory facilities noted that the segment had five elongated dents, three dents, and two punctures (located at the 7 o'clock position) connected by a fracture. On the two punctures, the metal was folded into the pipe. Both punctures showed evidence of impact marks.

Figure 9. Close-up view of the struck pipeline, taken from NTSB Materials Laboratory Factual Report.

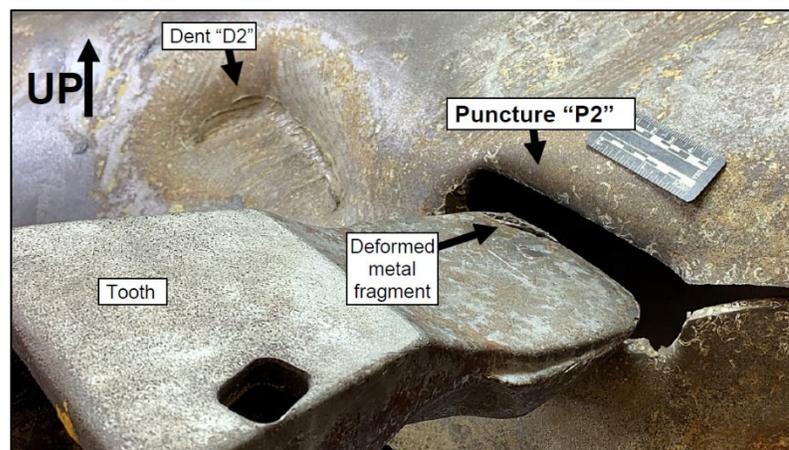
Figure 10. "Oblique view of puncture 'P2' with the tip portion of tooth 'C1' facing the puncture and dent 'D3' containing gouges in the background, after cleaning. The tip of tooth 'C1' contained evidence of a deformed metal fragment", taken from NTSB Materials Laboratory Factual Report.

4.2.17. On October 27, 2020, three damaged cutterhead teeth were removed and transported to NTSB for analysis and metallurgic testing (*see Figure 10*).

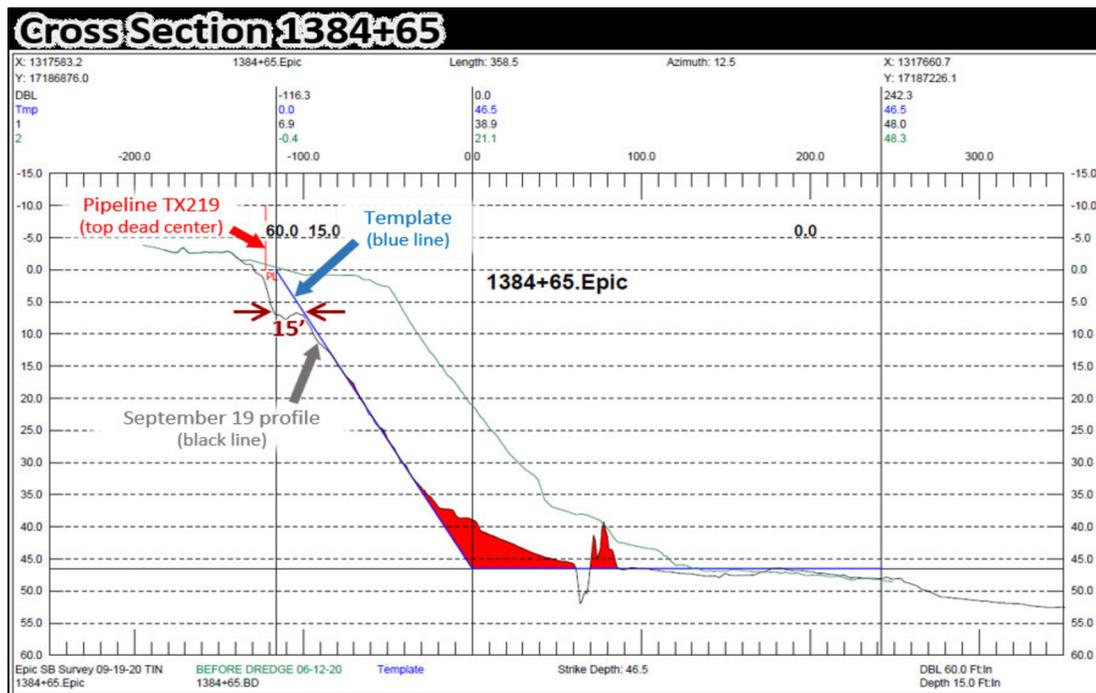
4.2.35. On September 19, 2020, Orion conducted a post-accident hydrographic survey with a GPS probe to verify the pipe location in relation to the excavated material. The survey showed that dredge material was excavated in accordance with the template, except for the excess material removed from the top of the slope where there was a “pocket” of material removed directly below the damaged pipeline. Additionally, comparing the GPS location of the pipe determined during this survey and the dredge template, the Survey Superintendent estimated TX219 was 6.5 to 7 feet from the template at its closest point.

Figure 7. Cross sectional view of dredging area at accident location from September 19, 2020, survey. Red line and “PL,” which appear in the original document, denote top dead center of pipeline as located by Orion personnel during the survey, take n from NTSB Nautical Operations, Human Performance, and System Safety Group Report.

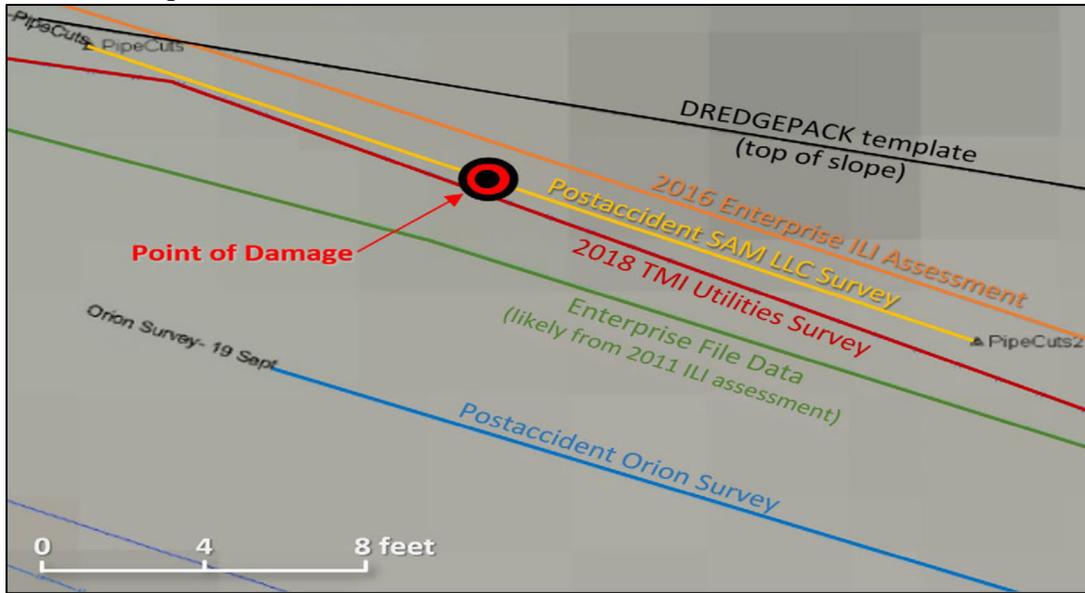
4.2.36. Noting inconsistencies with pipeline location and estimated distance from the dredge template, NTSB investigators, with the assistance of HYPACK technical representatives, subsequently inputted each reported pipeline location into DREDGEPACK to measure the distance between the pipeline and the edge of the

dredge template. While none of the data put the pipeline within the dredge template, some of the surveys put it as close as 0.8 (closest point) to 1.9 feet (accident location) from the template.

Figure 97. Sample of various pipeline location data near accident site, taken from NTSB Nautical Operations, Human Performance, and System Safety Group Report.

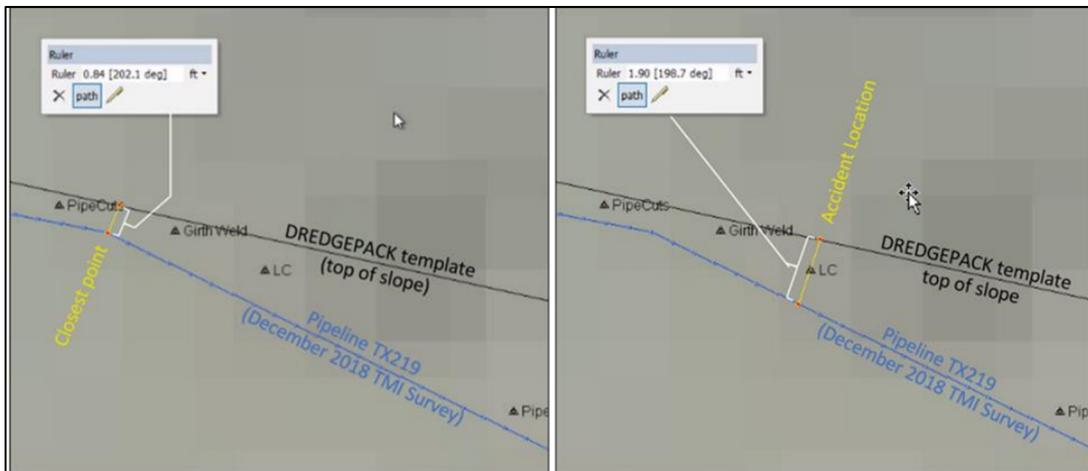
Figure 88. Screen captures from DREDGEPACK dredge template for the EPIC dock project, with imported location data for pipeline TX219 from 2018 TMI Solutions utilities survey. Left image shows distance between pipeline and template at closest point. Right image shows distance from pipeline to template at the accident location, taken from NTSB Nautical Operations, Human Performance, and System Safety Group Report.

5.2. *Failure of Orion to incorporate pipeline into dredging software.* The Leverman and crew only used the DREDGEPACK software program while dredging. Thus, any obstructions, including pipelines, would have been required to be in the DREDGEPACK software for the Leverman to identify the TX-219 pipeline to avoid contact. Here, the Survey Superintendent was responsible for uploading the dredge template in a software program called DREDGEPACK. Once the template was completed, he uploaded the template onto a computer aboard the WAYMON BOYD for it to be incorporated into the DREDGEPACK software. Generally, the Survey Superintendent included pipelines in the DREDGEPACK template if they were in the project area. The Orion Project Manager or Orion Project Engineer, as noted in section 4.2.49, would usually provide the coordinates of the pipeline to the Survey Superintendent. However, neither provided any coordinates for this project to the Survey Superintendent. In fact, the Survey Superintendent stated *he was aware* of pipelines in the area, but he thought they were out of the way on the bank. As the dredging contractor, it was allegedly Orion's duty to investigate utility and pipeline crossing for the dredging areas. This responsibility should have included extensive review of line drawings, available charts, and other resources to ensure all pipelines were identified. Consequently, the Survey Superintendent failed to incorporate the identified pipelines into the DREDGEPACK software. This failure led to a false assumption that the dredging area was free of submerged pipelines or underwater utilities. As such, had the Project Engineer ensured there were no submerged pipelines in the dredging area, the vessel would have been aware of the pipeline and subsequently could not have struck the pipeline.

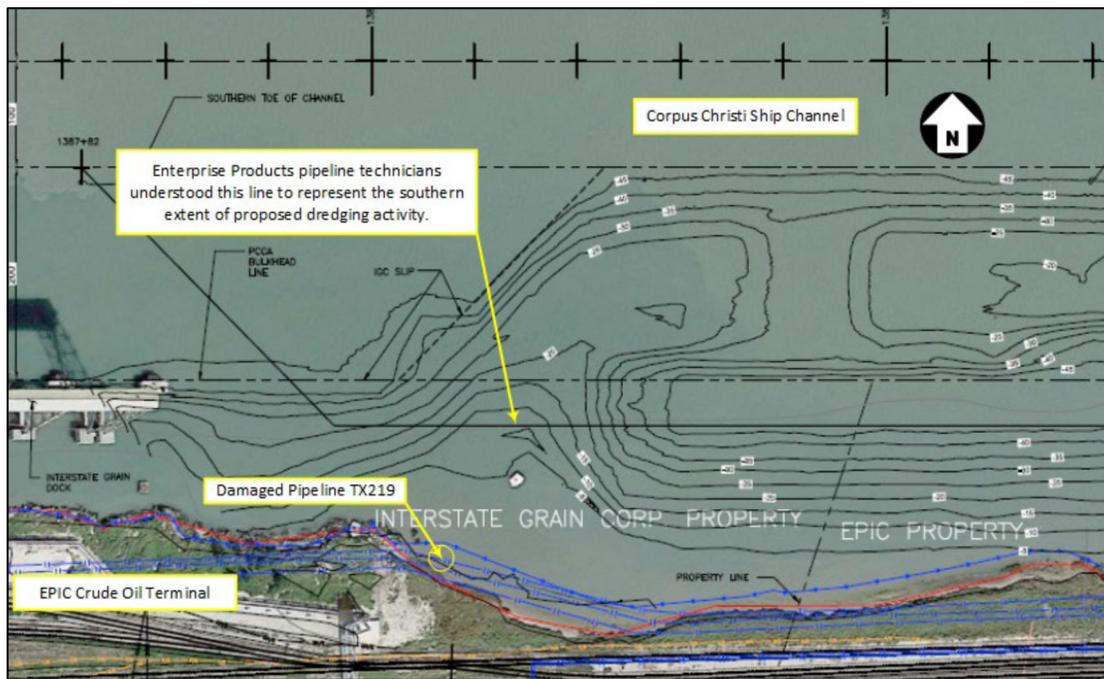
Figure 10. Annotated drawing of dredge plans showing where Enterprise technicians understood the end of the dredge template to be located, taken from NTSB Pipeline Operations Group Factual Report.

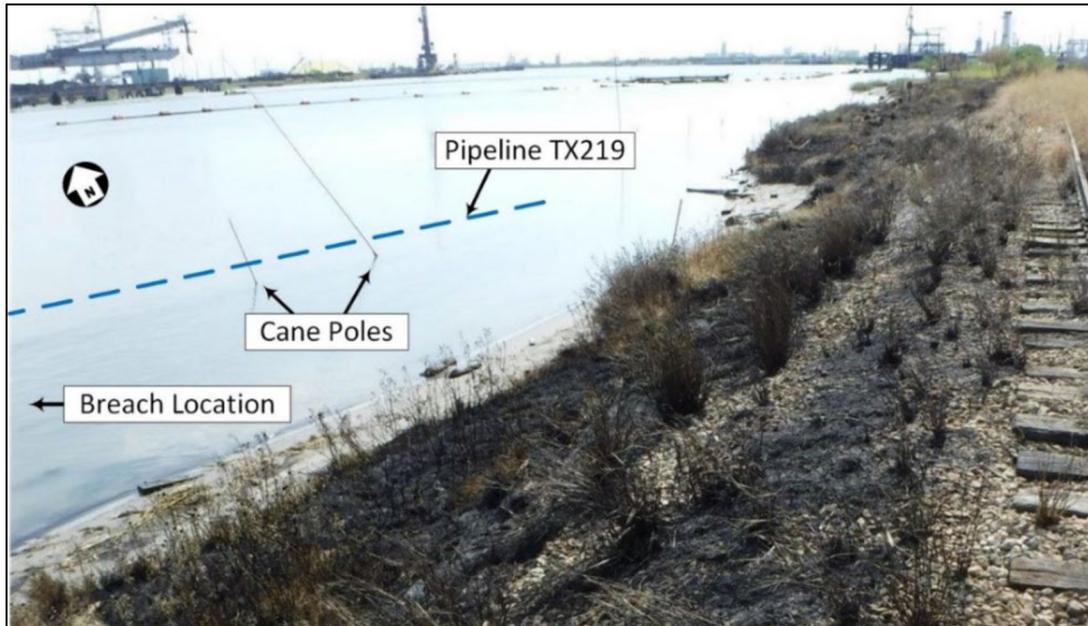
Figure 11. Photo of cane poles taken after the incident with annotations by NTSB, taken from Pipeline Operations Group Factual Report.
