**REPORT OF THE INVESTIGATION  
INTO THE  
ALLISION AND LOSS OF LIFE ONBOARD THE  
INSPECTED SMALL PASSENGER VESSEL  
WILDERNESS I (LA8393GG), ON  
BAYOU SEGNETTE IN  
WESTWEGO, LOUISIANA ON JULY 28, 2023**

**ALLISION OF THE SMALL PASSENGER VESSEL WILDERNESS I (LA8393GG)  
WITH TREES ALONG THE EASTERN BANK OF BAYOU SIGNETTE RESULTING  
IN THE LOSS OF ONE LIFE NEAR WESTWEGO, LOUISIANA ON JULY 28, 2023**

**INVESTIGATING OFFICER'S REPORT**

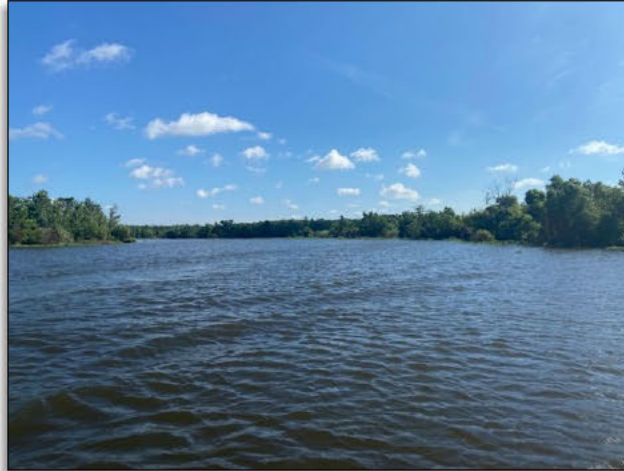
Figure 3 Picture of Bayou Segnette Main Channel taken after the incident (July 2023/USCG)

5.2. *Operating close to shore.* The Main Channel of Bayou Segnette is approximately 50 yards wide. While in the Bayou Segnette Main Channel, Ultimate Swamp Adventures' operators commonly navigated the company's airboats in the center of the channel to reduce the risk of allision with the tree branches from the numerous trees that lined the edge of the waterway. Though the investigation could not obtain the trackline of the *Wilderness I* for the

date of the incident, it is reasonable to believe that the mechanic may have been operating the vessel out of the center of the main channel, close to the edge of the waterway. Had the mechanic operated the vessel in the center of the channel, the *Wilderness I* may not have allided with the trees on the eastern bank of Bayou Segnette.

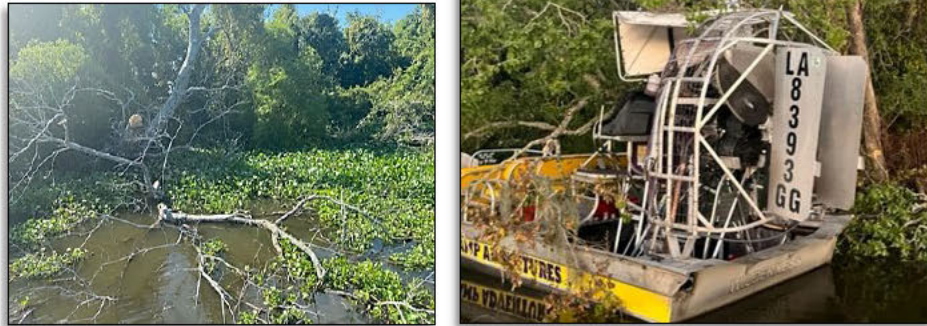
4.1.11. At approximately 1810, while heading northbound on Bayou Segnette Main Channel, the *Wilderness I* allided with tree branches on the eastern bank.

4.1.12. The *Wilderness I* continued forward for approximately 20 yards and where it then allided with a large tree, which stopped the vessel's forward momentum. The vessel's final resting place was approximately one mile from the Lapalco Boulevard Bridge.

Figure 5 Initial impact site (left) and found location of *Wilderness I* (July 28, 2023/Ultimate Swamp Adventures)

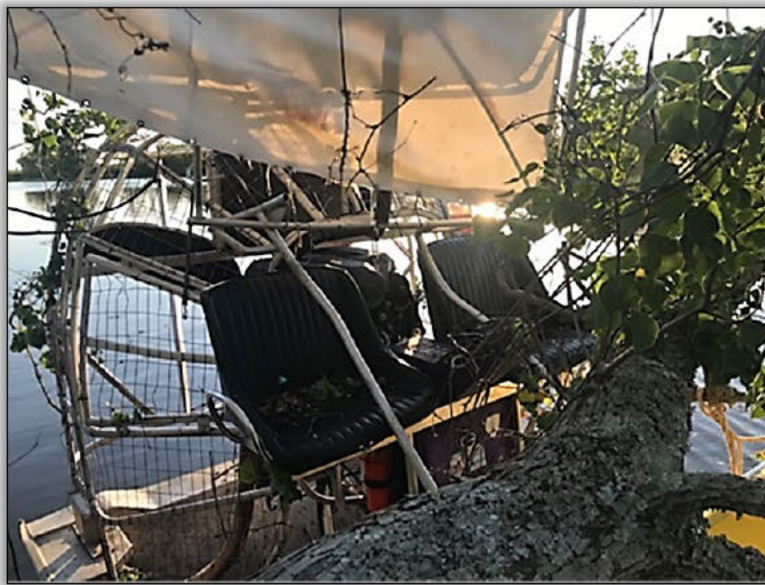
4.1.13. At 1815, the Ultimate Swamp Adventures' airboat, *Captain Nash's Wings*, was completing a swamp tour with 15 passengers onboard when the operator discovered the *Wilderness I* against a tree, covered in branches. The operator saw that the mechanic was unconscious in his seat. The *Captain Nash's Wings* operator noted a large tree branch laying across the *Wilderness I* at the same height as the operator's seat. This large branch was in front of the mechanic's chest, not touching him. Additionally, the starboard side of the vessel was against the base of a tree trunk and a blade tip of the propellor was broken.

Figure 6 Post-incident picture of *Wilderness I* with branches on and around the operator's seat. (July 28, 2023/ Ultimate Swamp Adventures)

4.1.18. At 1825, the managers arrived at the incident location. They saw branches on the deck of the *Wilderness I* and abrasions on the mechanic's arms and head. The managers yelled for the mechanic to wake up, but the mechanic remained unresponsive. Shortly after, the Westwego Fire Department and EMS arrived on scene and determined the mechanic was injured, unresponsive with a pulse, and had shallow breathing.

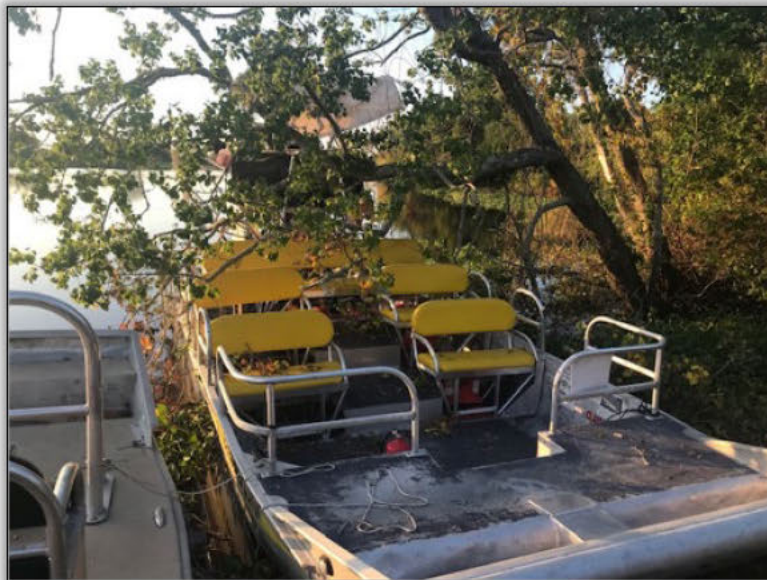
Figure 7 Post-incident picture of *Wilderness I* (July 28, 2023/ Ultimate Swamp Adventures)

4.2.1. On July 28, 2023, Marine Inspectors from Sector New Orleans conducted a post-casualty damage assessment of the *Wilderness I* and found the vessel's steering components to be in good working order. There was significant damage to the vessel's canopy, and a blade tip of the propeller blade was broken. The starboard quarter had a smooth inset.

- 7.1. Following the damage survey of the *Wilderness I* by Sector New Orleans, a CG-835V Vessel Inspection Requirement, was issued to the vessel requiring the completion of permanent repairs prior to the carriage of passengers.

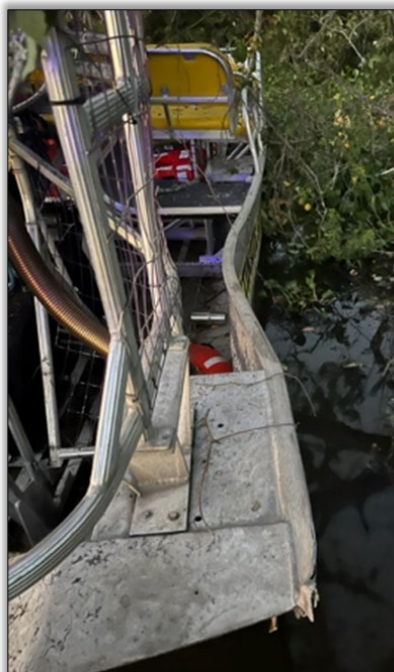
Figure 8  
*Wilderness I*  
starboard quarter  
(July 28, 2023/  
Ultimate Swamp  
Adventures)

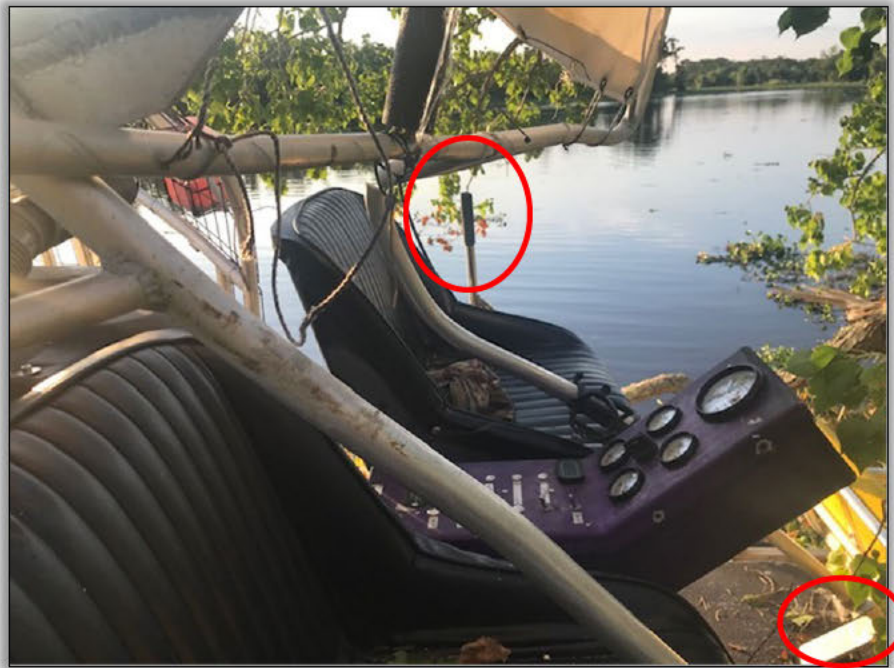
4.3.3. Airboats like the *Wilderness I* turn with a delayed response when compared to other vessel types. When an operator moves the lever controller, thereby directing the rudders, the airboat's bow will point in the direction the operator intends to travel, but the vessel will not move in that direction until the momentum in the previous direction dissipates and is overcome by forces in the new direction. This effect is known as drifting. The *Wilderness I* was known by its owners and previous operators to drift more when operating at a lighter weight, such as when the vessel was operating without passengers.

Figure 9 Post-incident picture of *Wilderness I*'s operator lever controller and pedal (July 28, 2023/ Ultimate Swamp Adventures)

numbness the mechanic routinely experienced in his extremities may have reduced his ability to operate the vessel's foot pedal and hand lever. With a reduced ability to operate combined with the unique handling characteristics of the vessel, the mechanic may have been unable to alter course and/or speed adequately, resulting in the incident. While the coroner stated that the mechanic's pre-existing conditions did not contribute to his death, the investigation ultimately could not determine if the mechanic's pre-existing conditions were causal factors to the incident. The investigation determined that the mechanic's pre-existing health conditions coupled with tendency to operate of Ultimate Swamp Adventures' airboats alone represented an unsafe condition.
