THE REPORT OF INVESTIGATION  
INTO THE  
**COLLISION BETWEEN TOWING VESSEL *RC CREPPEL* (O.N. 1240427), TOWING VESSEL  
*COOPERATIVE SPIRIT* (O.N. 569226) AND  
BULK CARRIER *GLORY FIRST* (IMO # 9713909)  
RESULTING IN THREE LOSSES OF LIFE AND  
LOSS OF A VESSEL ON THE LOWER  
MISSISSIPPI RIVER NEAR MILE MARKER 122  
ON  
JANUARY 26, 2020**

**COLLISION BETWEEN TOWING VESSEL RC CREPPEL (O.N. 1240427), TOWING  
VESSEL COOPERATIVE SPIRIT (O.N. 569226) AND BULK CARRIER GLORY FIRST  
(IMO 9713909) RESULTING IN THREE LOSSES OF LIFE AND LOSS OF A VESSEL  
ON THE LOWER MISSISSIPPI RIVER NEAR MILE MARKER 122  
ON JANUARY 26, 2020**

**INVESTIGATING OFFICER'S REPORT**

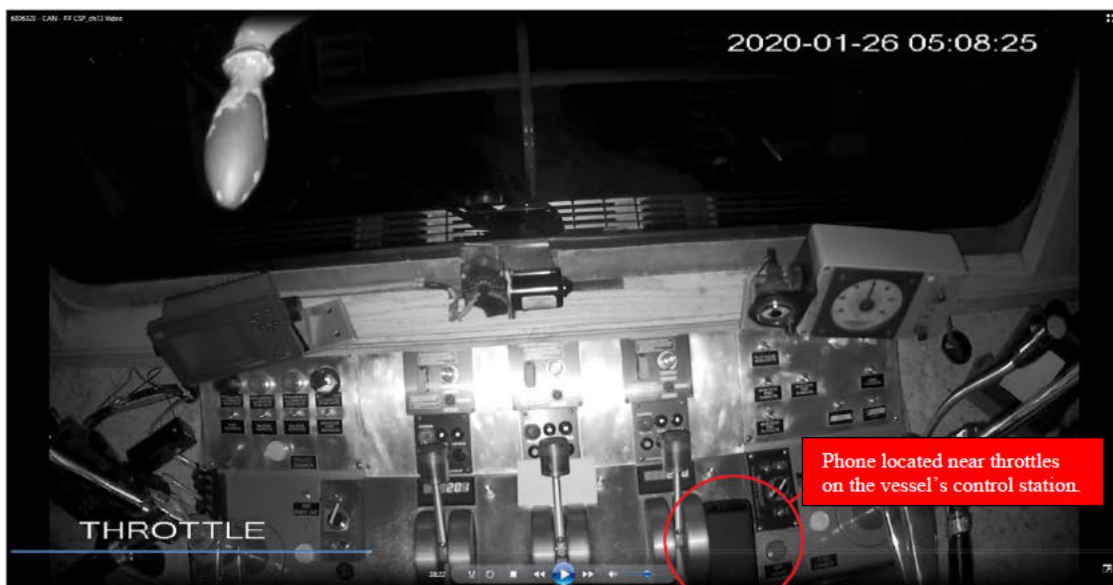
4.1.2. Between 0508 and 0510, the Pilot picks up and puts down a cell phone several times that is located on the vessel's control station near the throttles.

Figure 4. Still shot from *COOPERATIVE SPIRIT*'s helm camera video showing a cell phone at the control station. (January 26, 2020/ARTCO, annotated by the USCG)

*5.5. Failure to follow company SMS regarding personal electronic devices.* The *COOPERATIVE SPIRIT* is equipped with a video monitoring system throughout the vessel. Several cameras point outward of the vessel while an additional camera is mounted overhead of the control station of the *COOPERATIVE SPIRIT*. This camera points down and records the helm controls as the person in charge of the vessel navigates. The camera also captures the front window directly in front of the helm. At night the person in control of the vessel can be seen as a reflection in the window. At various times leading up to the collision the camera captures a cell phone located at the helm controls. The last time the cell phone is clearly captured on video is approximately 17 minutes before the collision. By analyzing the reflection in the window, investigators can see the operator of the vessel manipulating the cell phone at various times before the collision. Subpoenaed cell phone records show data was streaming to and from the phone at the time of the incident. Unfortunately the records cannot tell investigators what kind data was streaming. After the collision occurred, video shows the operator lean forward at the control station. Video clearly shows a blue tooth device located in the operator's right ear.

phone on the bridge of the *COOPERATIVE SPIRIT*, in violation of the companies Towing Management System, his full attention would have been on the navigation of his vessel and this incident may not have occurred.

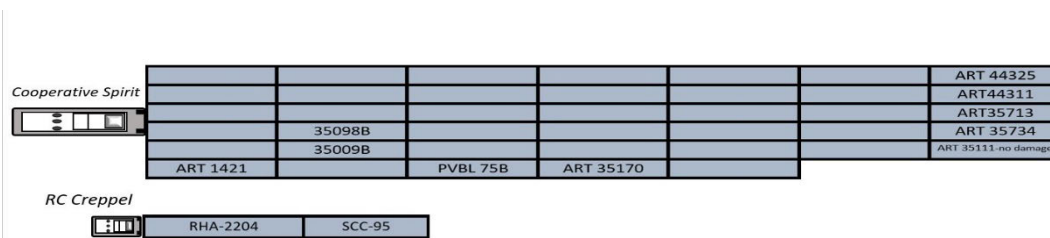
Figure 5. Approximate comparison of the *COOPERATIVE SPIRIT* and *RC CREPPEL* barge tow sizes at the time of the incident. (Date/NTSB)

4.1.24. However, moments later, the *GLORY FIRST* collided with ART 1421 and PVBL 75B, two barges on the aft starboard corner of the *COOPERATIVE SPIRIT*’s tow (see *Figure 5*). This impact caused the remainder of the tow’s cable wires to snap setting the rest of the *COOPERATIVE SPIRIT*’s barges adrift.

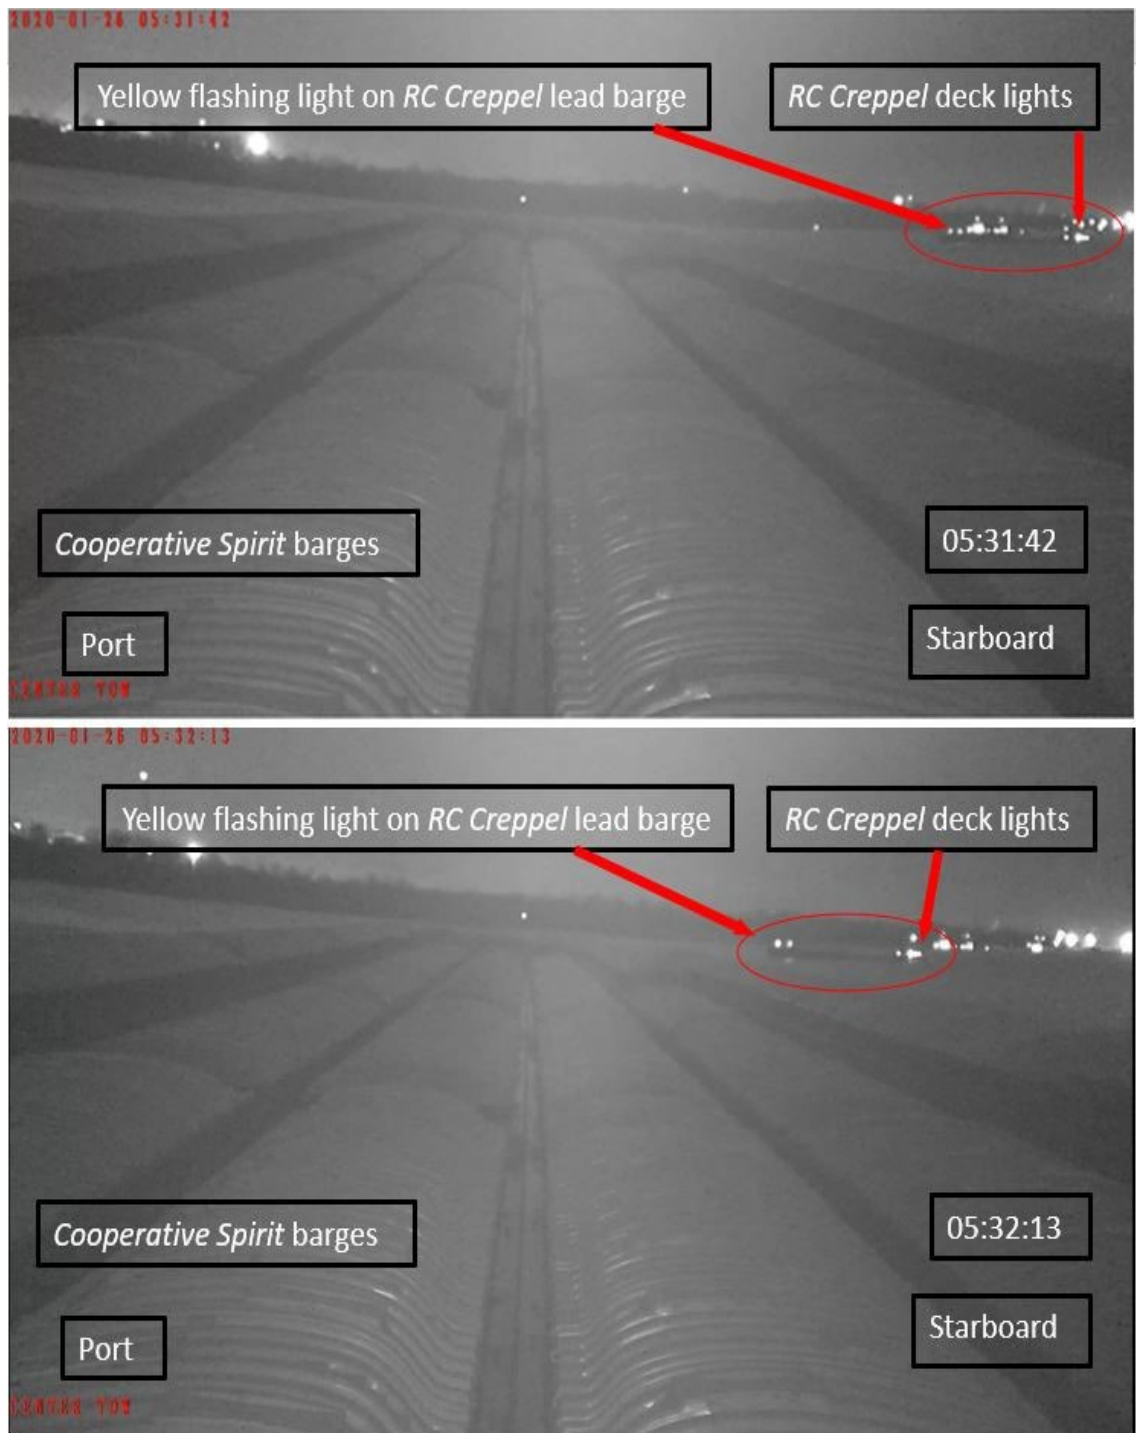
Figure 6. Still shots from *COOPERATIVE SPIRIT*'s camera. *RC CREPPEL*'s navigation lights can be seen off the starboard bow of the *COOPERATIVE SPIRIT*'s tow. (January 26, 2020/ARTCO, annotated by the NTSB)

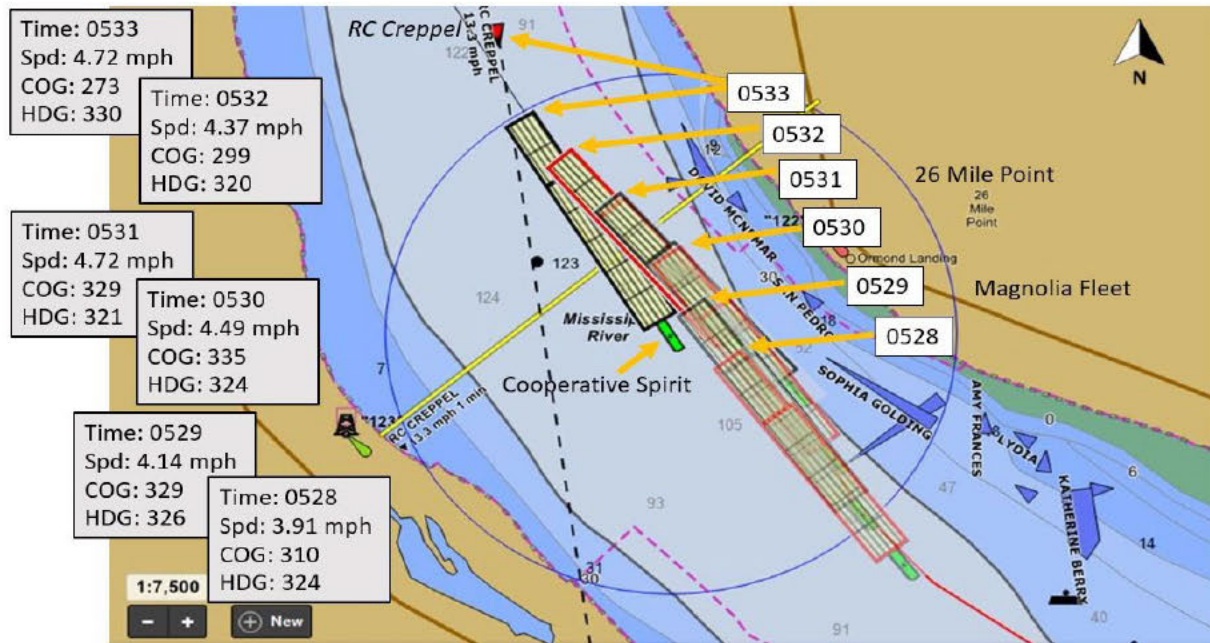
Figure 7. A Rose Point electronic chart system (ECS) display screenshot from the *COOPERATIVE SPIRIT*. (January 26, 2020/ARTCO, annotated by the NTSB)

5.3. *Failure to update vessel dimensions in AIS.* The *RC CREPPEL* and *COOPERATIVE SPIRIT* were outfitted with an AIS, an electronic charting navigation and radar system which provides the vessel's operator with information pertaining to other vessels' location and course. Per 33 CFR §164.46, users of AIS are required to maintain the system in an effective operating condition. This includes accurate input and upkeep of all AIS data parameters. In addition, the USCG has published the AIS Encoding Guide, which is intended to assist in the proper encoding of an AIS used in U.S. navigable waters. A portion of the guide reads: "AIS is a valuable navigation safety radio communication tool. However, its effectiveness is undermined by the broadcast of inaccurate, improper or outdated data." The guide additionally provides a section describing how the dimensions, to include ahead towing, should be measured and entered.

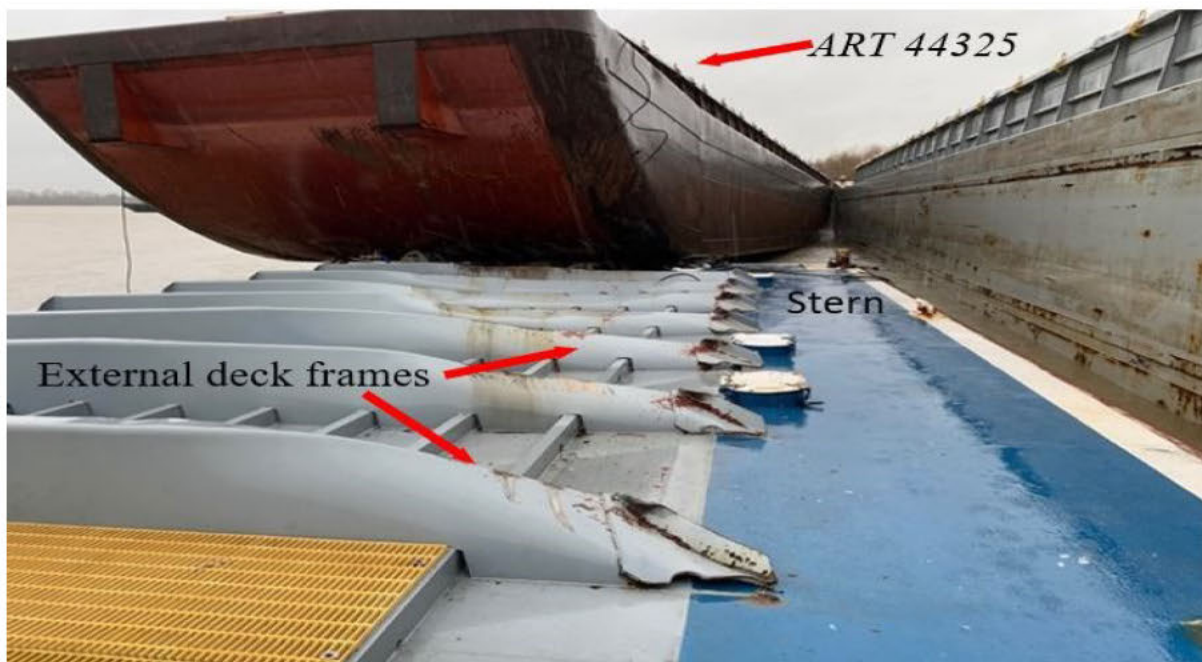
4.1.10. Moments later, the *COOPERATIVE SPIRIT*'s tow collided with the *RC CREPPEL*'s tow. The momentum of the impact pushed the ART 44311 and ART 44325 of the *COOPERATIVE SPIRIT*'s tow, across the top of RHA-2204, the barge tied directly to *RC CREPPEL*'s bow (see Figure 5), overlapping it approximately 100 feet. During impact, the pressure relief valve on the RHA-2204 was damaged and an unknown amount of sulfuric acid was released into the air.

Figure 8. Post-accident damage survey of the RHA 2204 and ART 44325. (McKinney Salvage, LLC, annotated by the NTSB)

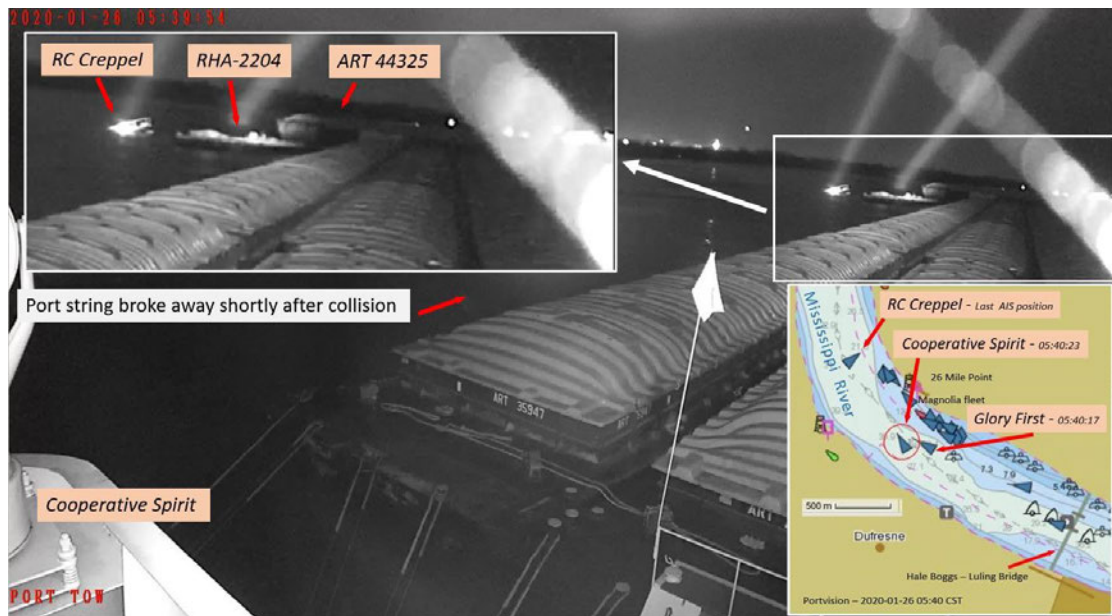
4.1.13. After the collision, the *COOPERATIVE SPIRIT*'s port string of empty hopper barges, behind the ART 44325, broke free and were set adrift from the rest of the vessel's tow.

Figure 9. Video still shot from *COOPERATIVE SPIRIT*'s port camera after the collision. (January 26, 2020/ARTCO, annotated by the NTSB)
