**REPORT OF THE INVESTIGATION
INTO THE
CLYDE S. VAN ENFKEVORT (O.N. 1232691) AND
ERIE TRADER (O.N. 1238380) ANCHOR STRIKE
WHICH DAMAGED SUBSURFACE TRANSMISSION
CABLES AND PIPELINES IN THE STRAITS OF
MACKINAC MICHIGAN ON 01 APRIL 2018**

SUBSURFACE PROPERTY DAMAGE INVOLVING THE ARTICULATED TUG CLYDE S. VANENKEVORT AND BARGE ERIE TRADER ON APRIL 1, 2018

**CLYDE S. VAN ENKEVORT (O.N. 1232691) and ERIE TRADER (O.N. 1238380) Anchor
Strike Which Damaged Subsurface Transmission Cables and Pipelines
In the Straits of Mackinac Michigan on 01 April 2018**

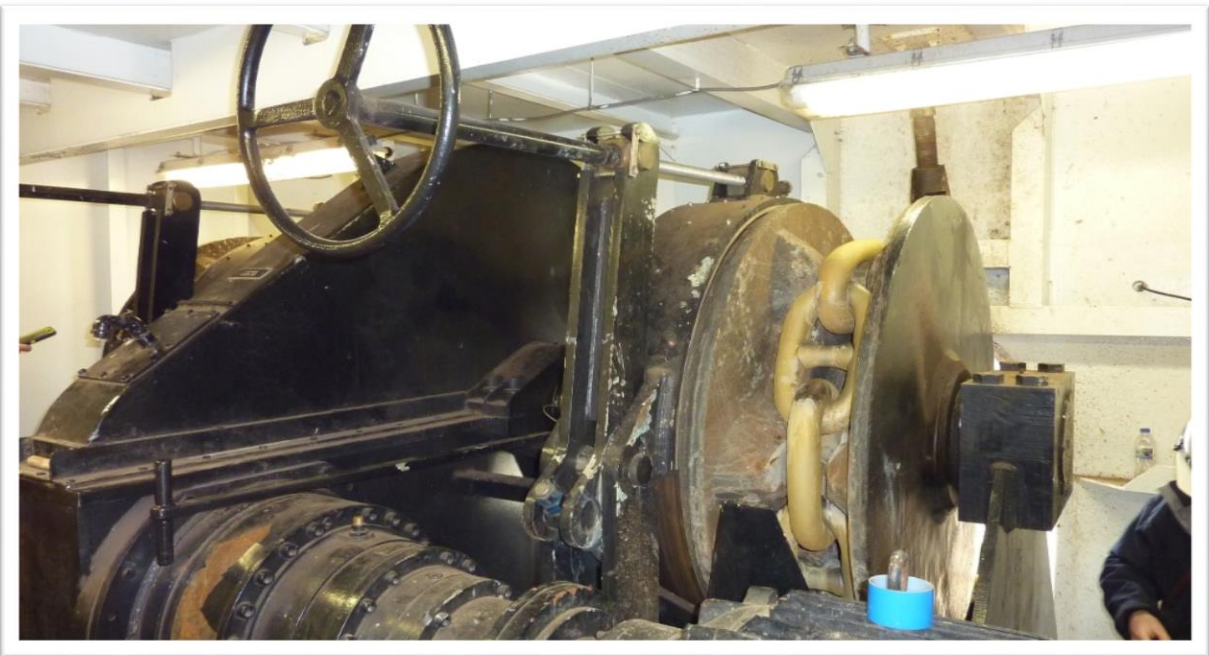
- 4.5 The windlass systems on ERIE TRADER cannot be remotely operated. This means that in order to drop an anchor the windlass system had to be powered up and controlled locally. These systems cannot be controlled from the tug. The windlass brake assembly is comprised of a manual hand crank/wheel and an upper and lower brake band that when tightened secure the windlass and anchor chain in place by means of friction (see figure 4-2 and 4-4).

Figure 4-2 Inside the windlass room on ERIE TRADER. starboard anchor chain, windlass, brake assembly, and brake hand wheel are shown.

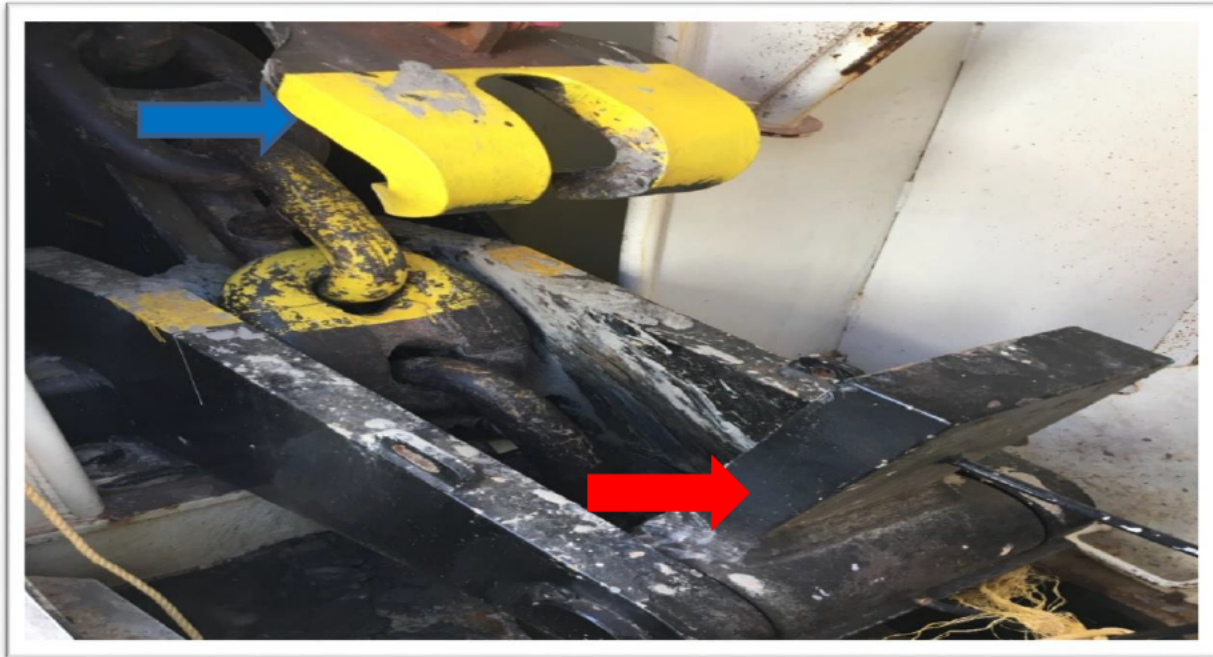
Figure 4-4 The starboard claw and paw on the ERIE TRADER. In this image both devices are un-engaged. The claw (indicated by blue arrow) is tied off to the cleat on the bulkhead. The paw (indicated by red arrow) is pulled back and into an upright position.

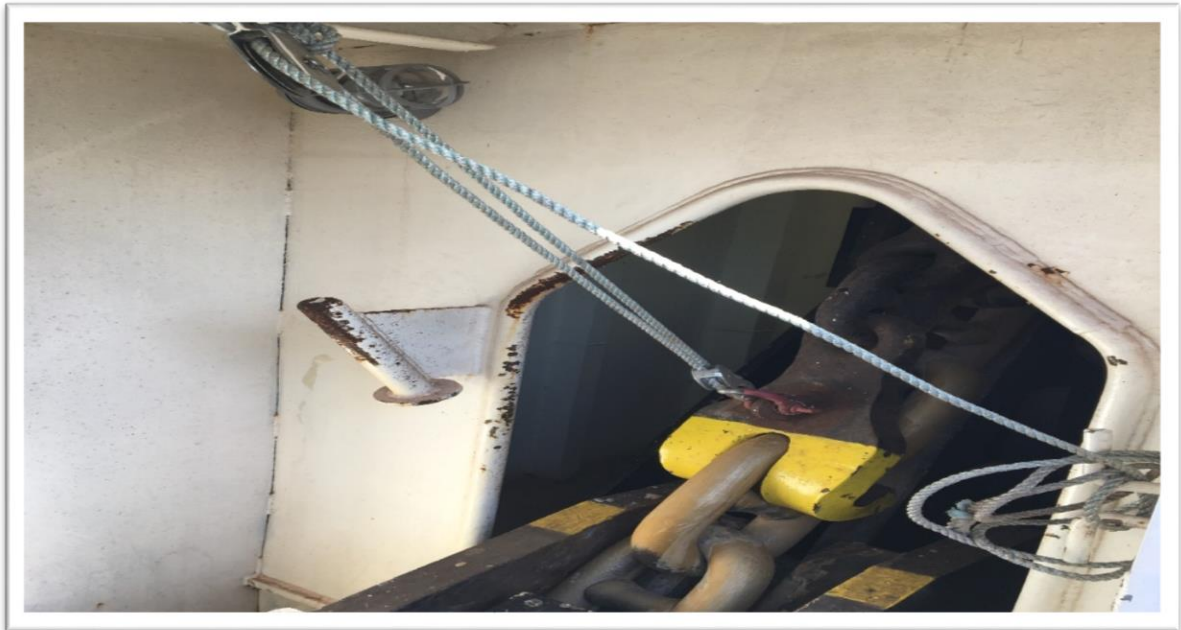
- 4.19 The arrangement of claw on the ERIE TRADER is set up so that when the claw is not engaged on the anchor chain it must be manually tied off to a cleat welded onto the bulkhead. If the claw is not tied onto the cleat, it will freely fall back onto the anchor chain (see figure 4-5).

Figure 4-5 In this image the starboard claw is engaged on the anchor chain. When the not engaged, it is lifted up by pulley and tied to a cleat on the bulkhead.

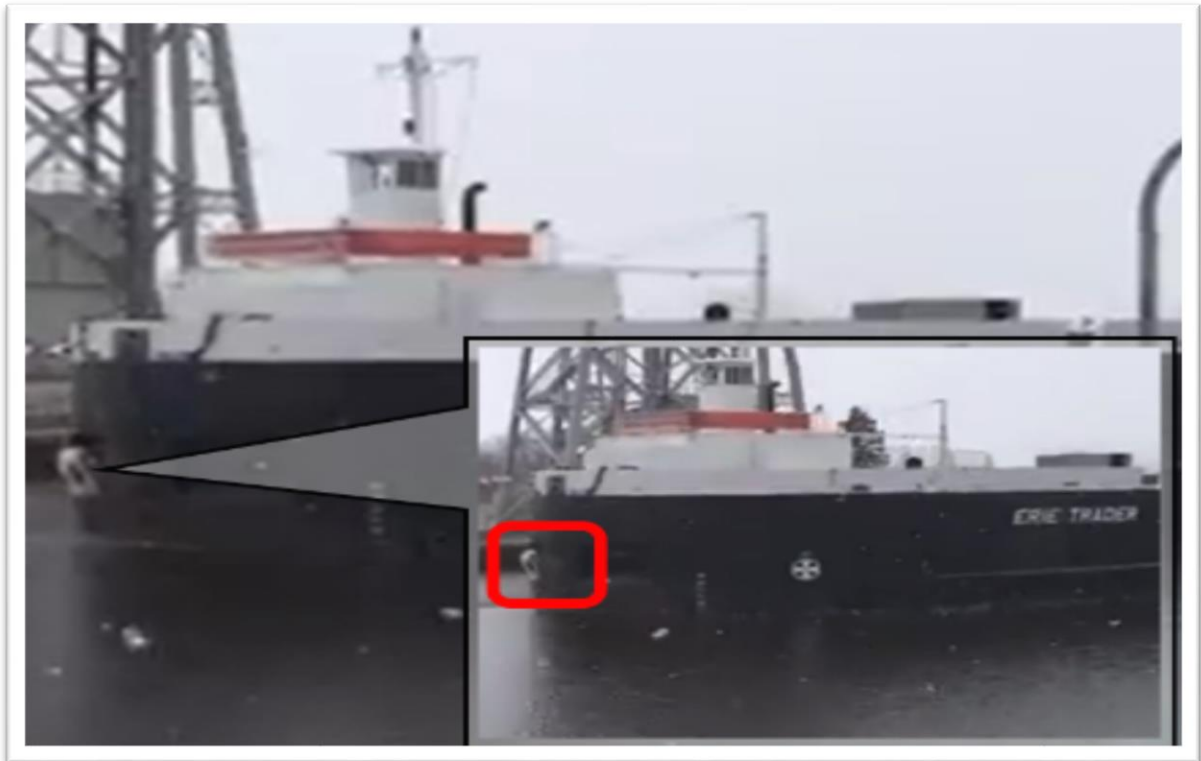
- 4.21 20 March 2018- The ATB sails from Duluth, MN to Detroit, MI and then back to Duluth without incident.
- 4.22 30 March 2018 at 1100- The CLYDE S. VANENKEVORT and the barge ERIE TRADER departed Duluth en route to Indiana Harbor, IN. The starboard anchor is protruding from the hawespipe by approximately 1-2 feet. Ice could be seen forming on the starboard anchor (see figure 4-6).

Figure 4-6 The ERIE TRADER departing Duluth MN on 30 March 2018. The Starboard anchor is seen covered in ice and hanging out of the anchor pocket. (Image taken from video by J. Herrick on youtube.com)

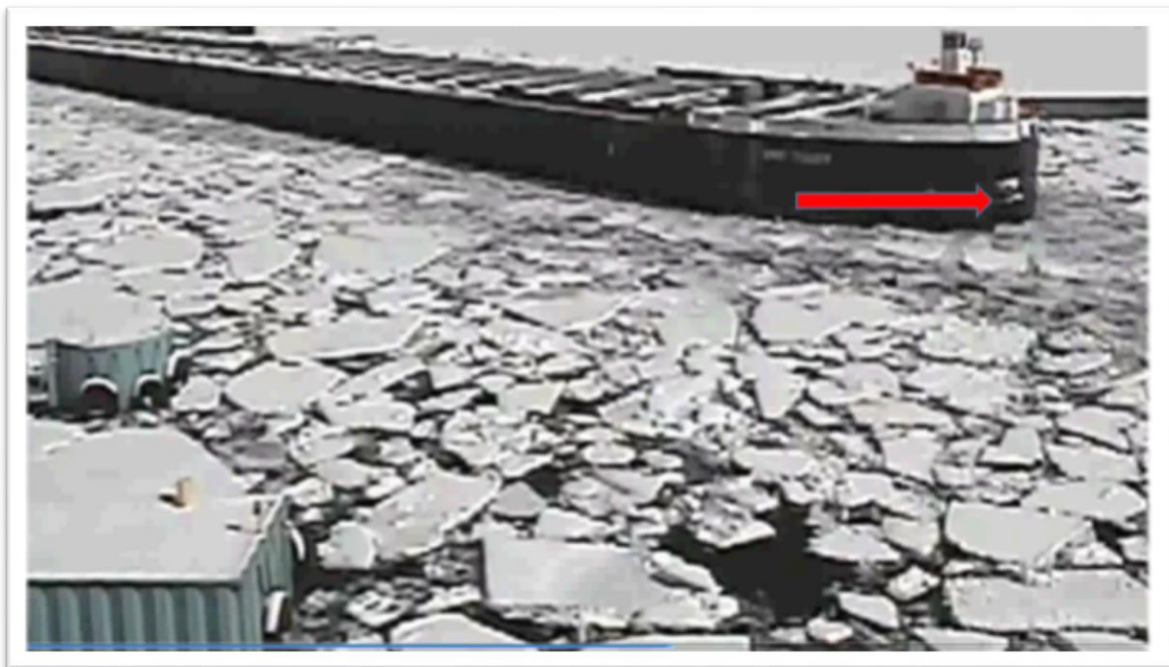
- 4.28 1 April 2018 at approximately 1000- Coast Guard Sector Sault Sainte Marie Vessel Traffic Service (VTS) cameras captured video of the starboard anchor protruding from the hawsepipe of the ERIE TRADER at Mission Point and Rock Cut, west of Neebish Island in the St. Marys River. Despite the significant ice conditions, the ATB experienced no abnormal maneuverability issues during this transit. Water depth was approximately 28 feet (see figure 4-7).

Figure 4-7 The ERIE TRADER in the St Marys River at Rock Cut west of Neebish Island on 1 April 2018. Image captured by Coast Guard VTS cameras depicts significant ice conditions. Red Arrow points to ice on the starboard anchor hanging below the anchor pocket.

Video footage of ERIE TRADER was captured from a VTS camera as the ATB came thorough Rock Cut west of Neebish Island in the St. Marys River on 1 April 2018. This video shows the significant ice conditions the ATB was subjected to while transiting the St Marys River. It also shows the starboard anchor hanging out of the pocket just below the hawsepipe with the weight of ice that had formed on it (see figure 4-7).

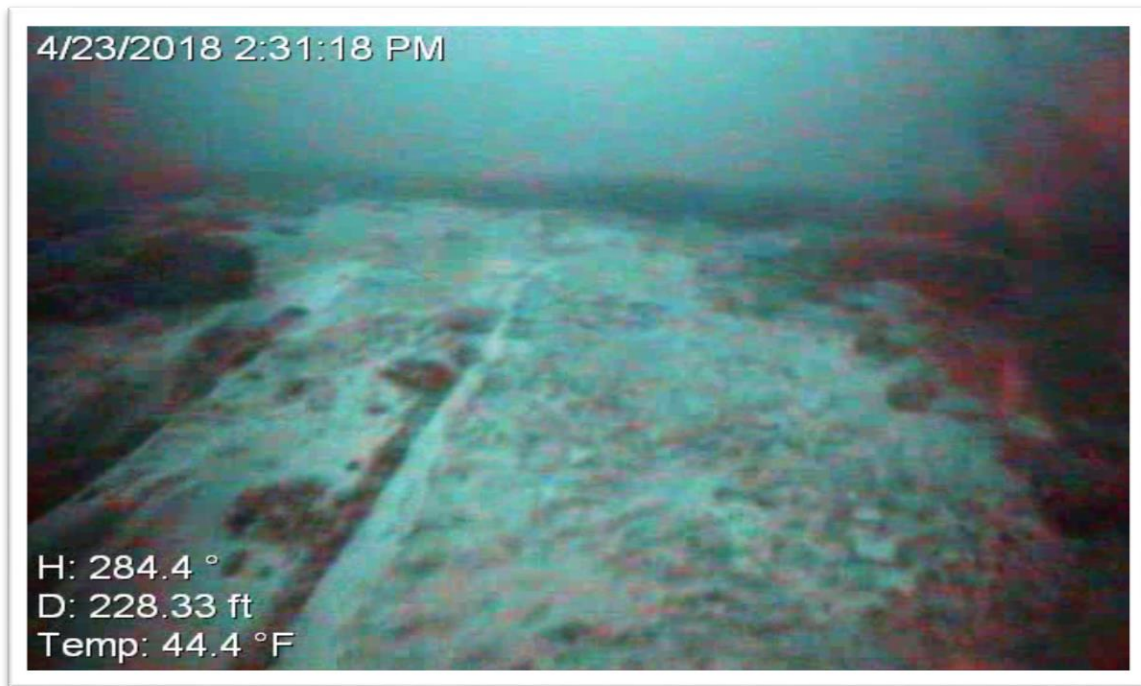
Figure 4-13 Drag marks in the seabed just before the Line 5 Pipeline. The marks depicted were not measured. ROV Image provided by Enbridge Inc.

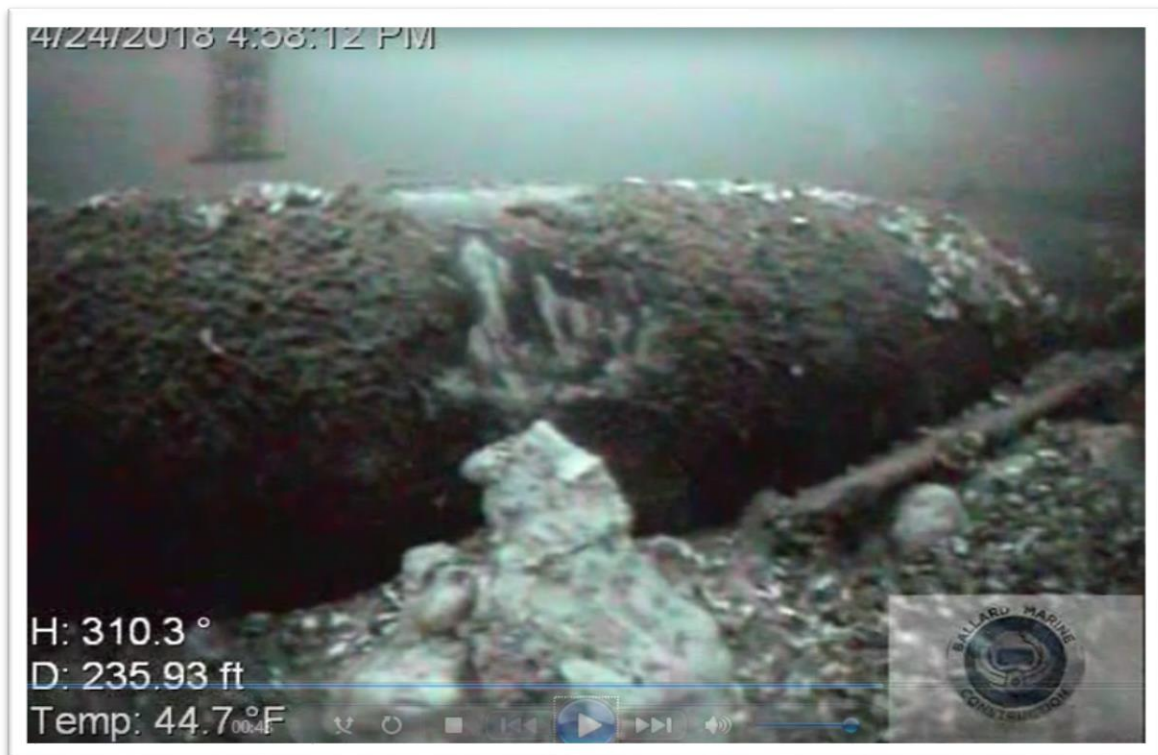
- 4.45 23 April 2018- Enbridge Inc. contracts with Ballard Marine to employ an ROV to inspect their dual pipelines in the Straits of Mackinac. The dual pipelines remained intact and structurally sound, however multiple dents and gouges were discovered. The ROV obtained visual imagery that displays two discernable drag marks in the sea bed just before the Enbridge west pipeline (see figures 4-13, 4-14, 4-15).

Figure 4-14 Dent and impact marks west pipeline. ROV imagery provided by Enbridge Inc.

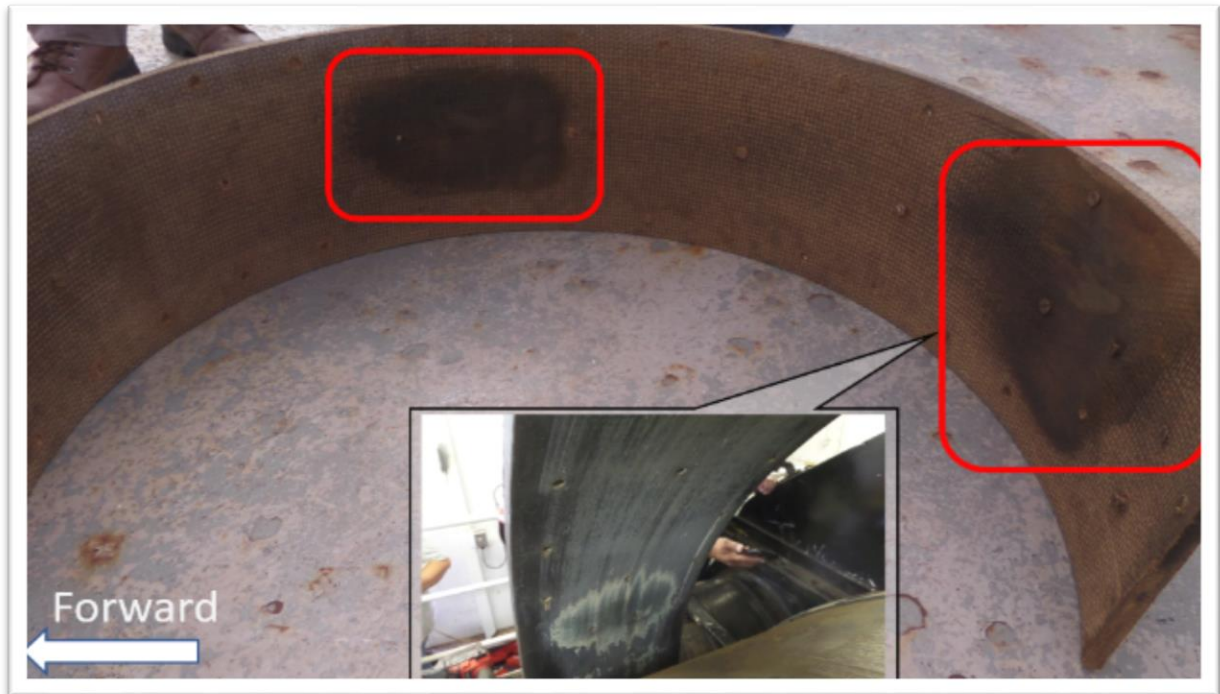
- 5.1.1 Noticeable friction spots were discovered on the upper band portion near the top of the liner and at the aft end of the liner near the edge. Nothing unusual or significant was found on the bottom portion of the brake liner. It was also noted that on the brake band liner inner surface housing paint was burned away in line with the friction markings on the upper brake band itself (see figure 5-2).

Figure 5-2 The upper brake band liner for the starboard anchor. Highlighted in red are the friction spots on the liner. The inset shows the paint worn from the heat accumulation through the liner aft section of the upper band.

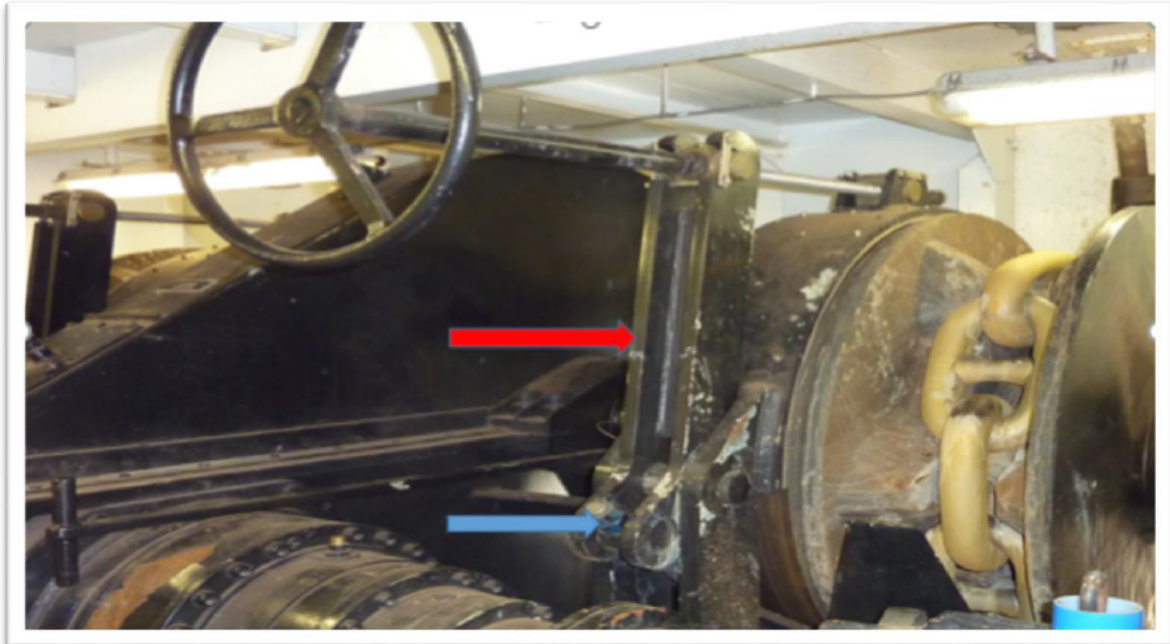
- 5.1.2 During an inspection of the starboard windlass and brake it was confirmed by the CMEI technician that when fitted and torqued properly the brake bar should be in a completely vertical position. The inspection found that with the brake fully engaged there was about 5.2 degrees off vertical (angle to aft bulkhead) on the starboard brake bar. Rub markings in the paint were found on the starboard brake bar. These markings indicated that at one time, there was a 10 degree off vertical deflection of the top bar when the brake was engaged. This degree of vertical deflection indicates that the brake nut was torqued past manufacturer specifications (see figure 5-3). This caused the upper brake band to not be fully seated in contact with the upper portion of the wildcat. This dramatically reduced the capacity of the brake alone to hold the full weight of the anchor and chain.

Figure 5-3 ERIE TRADER- brake vertical bar, brake band nut, brake band hand wheel. Red arrow indicates the vertical bar. Blue arrow indicates the brake band nut.
