UNITED STATES COAST GUARD

REPORT OF INVESTIGATION INTO THE CIRCUMSTANCES SURROUNDING THE INCIDENT INVOLVING SPV SKY SCREAMER - DEATH

**LOSS OF LIFE OCCURRING ON THE SMALL PASSENGER
VESSEL SKY SCREAMER WHILE CONDUCTING PARASAIL OPERATIONS IN
THE GULF OF MEXICO NEAR CLEARWATER BEACH, FLORIDA
ON SEPTEMBER 05, 2010**

On September 5, 2010, an informal investigation was initiated into the parasail casualty and subsequent loss of life onboard the small passenger vessel SKY SCREAMER (O.N. 1059195). With assistance from the National Transportation Safety Board (NTSB) and Mr. [REDACTED] from Coast Guard Headquarters (CG-5451), facts were gathered and a complete analysis conducted to draw conclusions in accordance with the above references. All times contained within this Report of Investigation are approximate unless otherwise noted and referenced in local time. All evidence, correspondence, and testimonies gathered during the investigation and used to create this report are included in the Coast Guard's electronic database (MISLE) incident investigation activity 3844346.

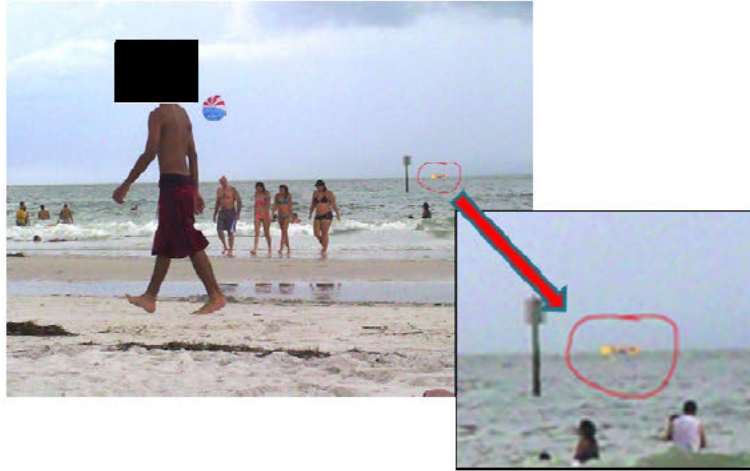
onshore Clearwater Beach and captures the SKY SCREAMER heeled onto the starboard side; the parasail towline is presumably completely payed out.

Figure 23: Photo taken at 1457 by onshore witness depicting SKY SCREAMER heeled to starboard (this image has been enhanced to more clearly show heeling of SKY SCREAMER)

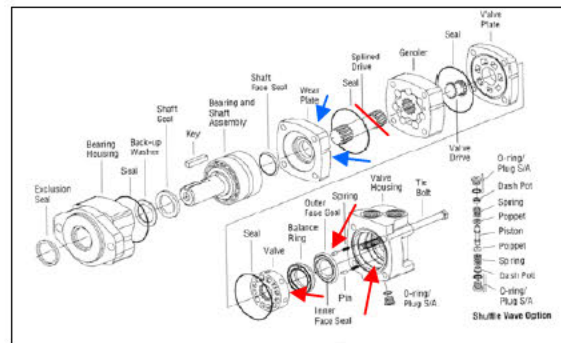
Figure 30: Char-Lynn hydraulic motor

The winch drum assembly (drum, brake, hydraulic motor and level winder assembly) were removed from the vessel for dismantling and further examination. As the components were dismantled, all splines, set keys and union between the motor, brake and drum were observed intact and did not display signs of failure that would have contributed to an uncontrolled free spool. The Char-Lynn hydraulic motor was further dismantled for internal examination. The manufacturer's identification plate was not discernable due to an accumulation of paint. Figure 30 is a schematic depicting the internal components of the Char-Lynn hydraulic motor.

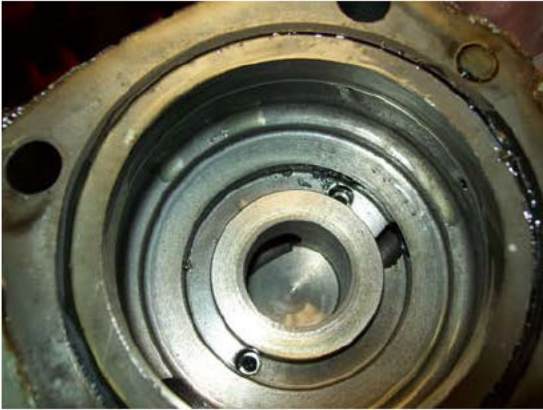
Metal fragments were immediately observed in the valve housing, the first section of the motor removed (figure 31). Metal fragments were further observed on the outer face seal and valve assembly (figure 32). These two sections are annotated in figure 30 with red arrows. As disassembly progressed, the geroler was lifted off revealing a fracture on the splined drive that drives the motor's output shaft (figures 33 and 34). The splined drive was completely fractured in two pieces; the fractured section of the spline remained lodged within the geroler assembly (figures 33 and 34). The fractured splined drive is represented in figure 30 with a red line. The fractured section of the splined drive was removed from the geroler assembly; the remaining section of the fractured splined drive remained lodged within the bearing housing assembly (figure 35). Both sections of the splined drive were sent to the NTSB for forensic analysis.

Figure 31: Metal fragments within valve housing

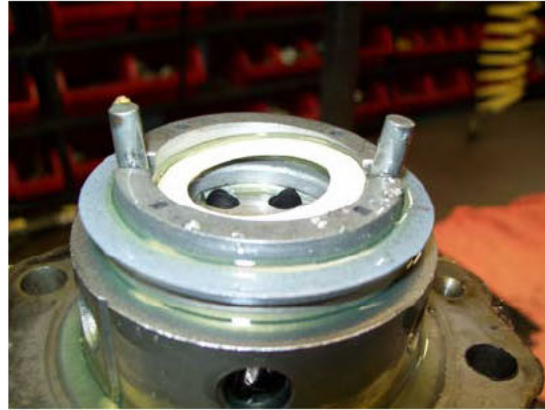
Figure 32: Metal fragments on outer face seal and valve assembly

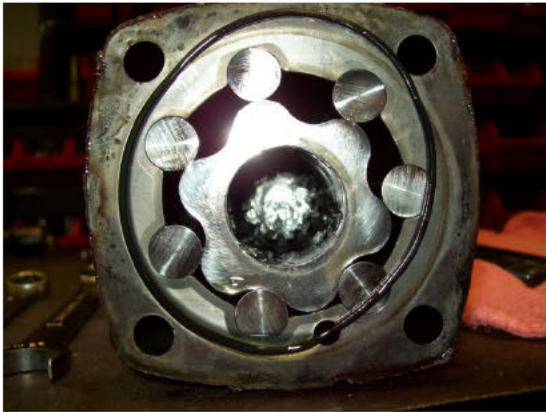
Figure 33: Fractured splined drive stuck inside of geroler assembly

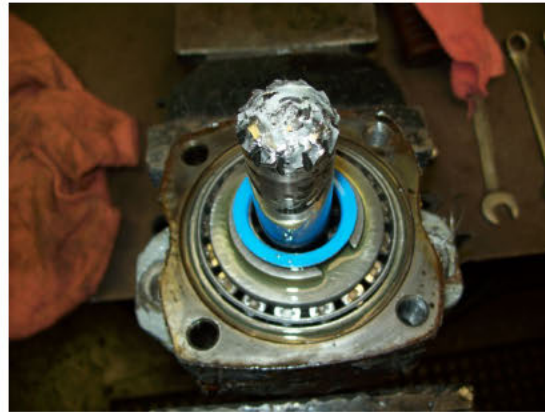
Figure 34: Fractured splined drive

The NTSB forensically examined and conducted metallurgical tests on the fractured splined drive as well as internal components of the hydraulic motor. Examination of the fractured faces of the splined drive revealed spirally smeared surfaces consistent with a torsional overload. The forward section of the splined drive slides into the bearing housing assembly and drives the output shaft. The splined drive was removed from the bearing housing and the output shaft pressed out of the bearing assembly; the splined drive and output shaft are pictured in figure 37.

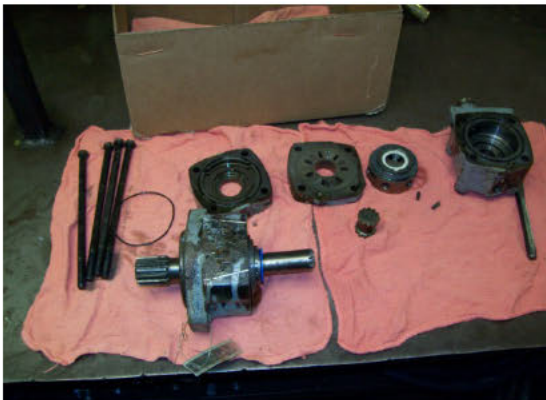
Figure 35: Fractured splined drive

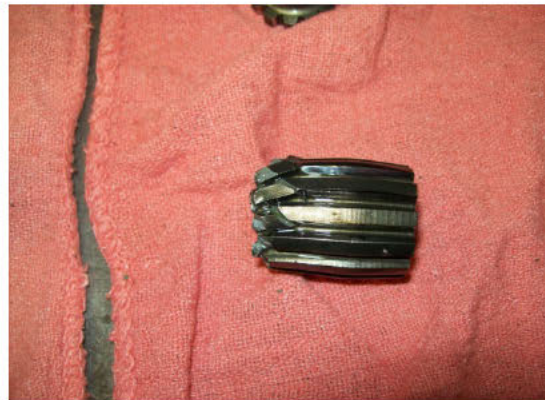
Figure 36: Fractured splined drive

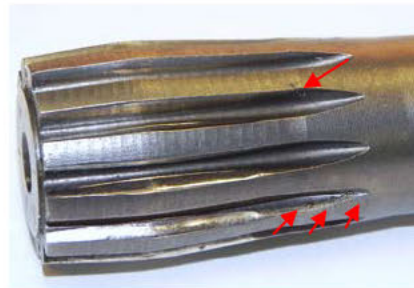
Secondary cracking was observed on the geroler end of the spline drive (figure 38), as well as on the end that slides into the bearing housing (figure 39); these secondary cracks are identified with red arrows.

Figure 39: Secondary cracking on splined drive that inserts into bearing housing

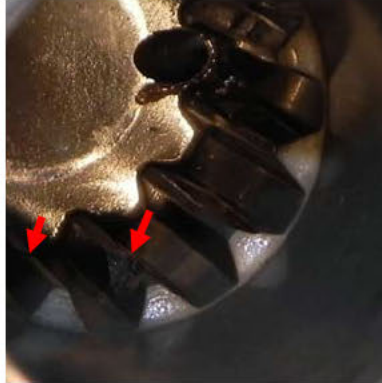
Examination of the internal splines in the output shaft revealed mechanical damage on two splines (indicated by red arrows in figure 40) with a wear pattern on the flanks of the other splines.

Figure 40: Internal splines on output shaft

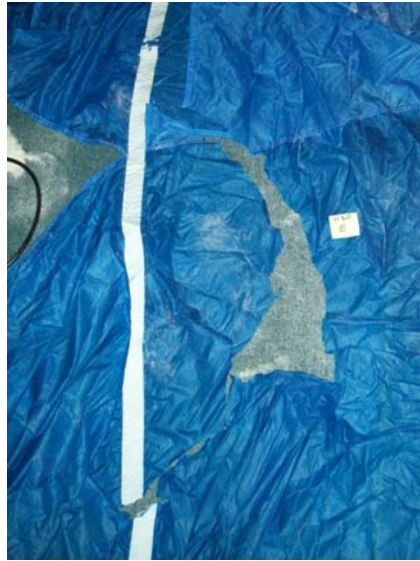
3. *Associated parasail equipment:* Examination of the associated parasail equipment used during the casualty (parasail, harnesses, life jackets, and multiflyer bar revealed the equipment was in serviceable condition. The parasail displayed damage consistent with fabric being cut by a sharp instrument (presumably during rescue efforts). With the exception of this noted damage, the parasail canopy was found intact and in good condition. Figure 41 is a photograph of the damaged section of the parasail presumably cut by first responders during rescue efforts. The manufacturer's disclaimer label sewn into the parasail indicates the parasail is designed to operate in winds not greater than 12 m.p.h. with a passenger weight load between 180 and 600 pounds; the combined weight of Mr. [REDACTED] and Ms. White did not exceed this weight standard. Weather reports obtained from the National Weather Service indicate the parasail was operated in wind conditions exceeding the manufacturer's recommendations.

Figure 41: Damage to parasail canopy

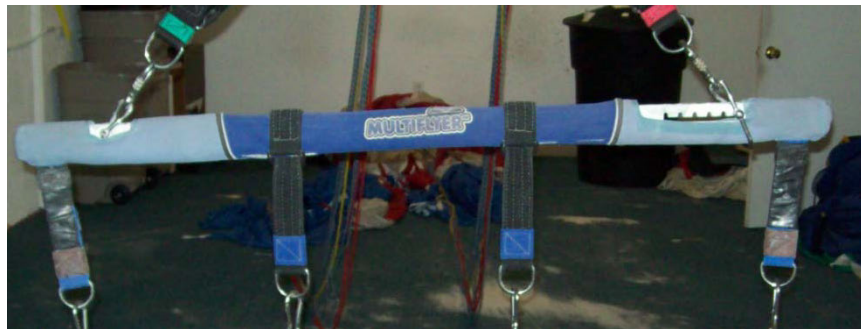
Figure 42: Multiflyer bar

The multiflyer bar was slightly modified from its original configuration. Four inner passenger support straps (affixed by passing through the bar and sewed to itself) were removed and replaced with two straps that completely wrap around the bar's exterior. Examination of the multiflyer bar revealed slight fading attributed to the elements and abrasions to the protective padding. The ratchet assembly used to offset passenger weight moved with ease. In general, the multiflyer bar appeared to be in good working order. Figure 42 is a photo of the multiflyer bar.

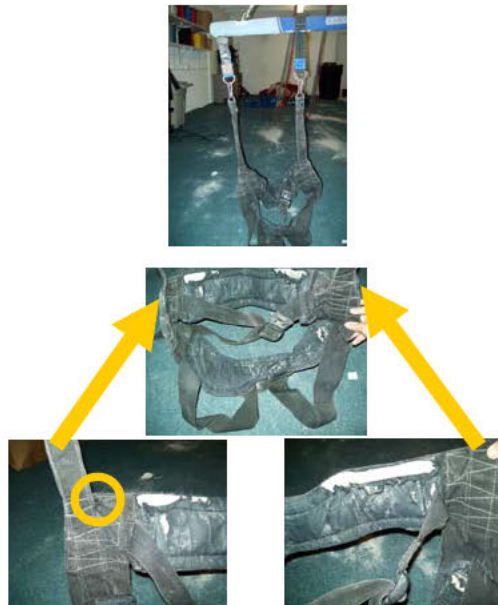
Figure 43: Harness worn by Mr. [REDACTED]

Examination of the harness worn by Mr. [REDACTED] revealed the waist strap was intact and remained secured through the friction buckle after the casualty. A small tear was observed on the passenger's right hand side of the harness. Numerous tears and abrasions were observed in the fabric covering the padding on the back and seat area of the harness. These tears and abrasions exposed padding intended for passenger comfort. The carabiners on the harness that connect to the multiflyer bar functioned freely. Figure 43 is the photo of the harness worn by Mr. [REDACTED]

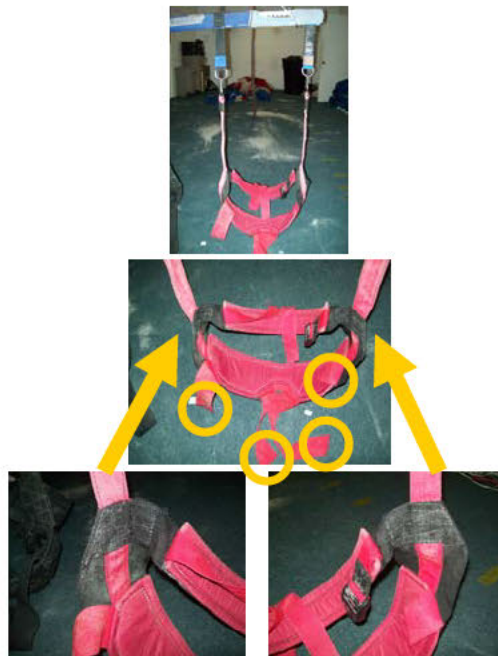
Figure 44: Harness worn by Ms. White

Examination of the harness worn by Ms. White revealed the leg straps were cut by emergency responders (circled below), the waist strap was removed from the friction buckle. The carabineers on the harness that connect to the multiflyer bar functioned freely. Figure 44 is the photo of the harness worn by Ms. White.

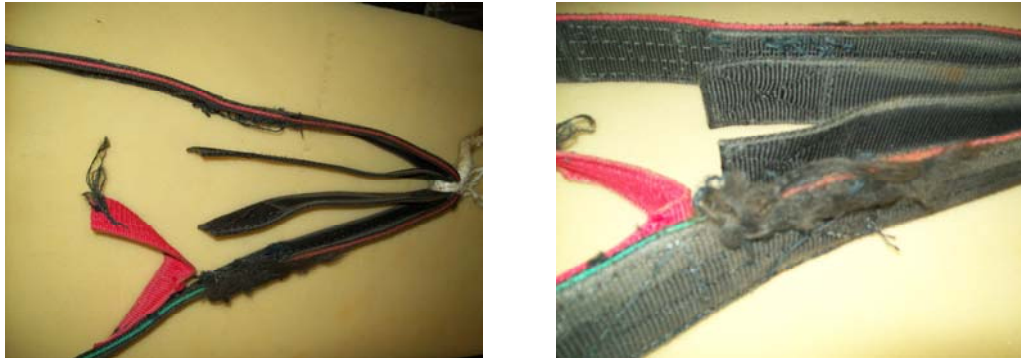
Examination of the parasail riser assembly revealed the riser assembly was faded and exhibited separation of stitching at the yoke where the towline is secured with a bowline knot. Presumably the stitching separation was due to shock loading during the casualty. Photos taken while Mr. [REDACTED] and Ms. White were aloft indicate the stitching was not separated while in flight. Additionally, the forward section of the yoke exhibited signs of previous chafing.

Figure 45: Stitching separation and chafing on parasail yoke

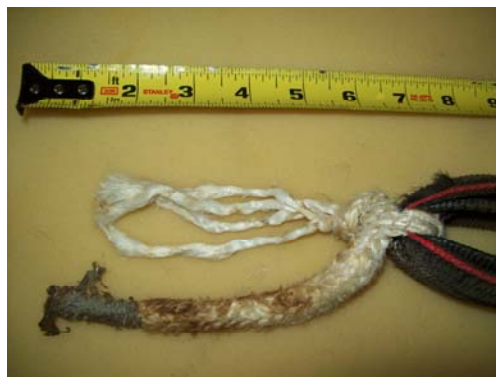
Analysis of the failure rates of the three lines tested indicates all three lines sustained a significant reduction of strength attributed to the incorporation of a bowline knot. Testing results for the section of line obtained from the parted section of line revealed a higher failure rate attributed to environmental exposure and cyclical tension wear, as well as shock loading, as evidenced by the observation of broken filaments at strand crossovers.

Figure 46: Parted towline at yoke

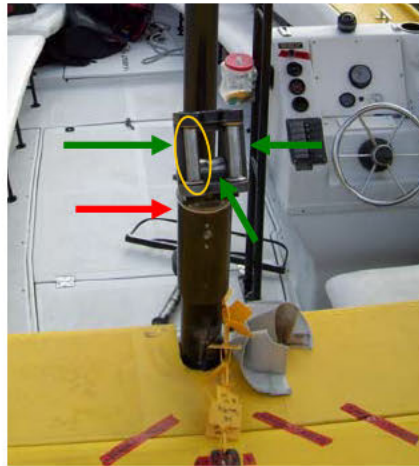
Figure 47: Tow post / roller head assembly

The roller head assembly located on the tow post is constructed with three rollers (indicated with green arrows in figure 47) to minimize line chafing; the roller head assembly rotates around the vertical axis of the tow post to keep the towline perpendicular to the tow post while the vessel is underway (indicated with a red arrow in figure 47). Examination of the roller head assembly revealed the roller head was limited in its ability to swivel freely. Furthermore, one roller assembly (circled in yellow in figure 47) was bound and unable to move.
