**INVESTIGATION INTO THE CIRCUMSTANCES
SURROUNDING THE LOSS OF LIFE OF A PARASAIL
PASSENGER FROM THE VESSEL**

ALMOST HEAVEN

**IN THE VICINITY WEST OF LONGBOAT KEY PASS,
FLORIDA ON 06/27/2011**

**LOSS OF LIFE ABOARD THE UNINSPECTED PASSENGER VESSEL
ALMOST HEAVEN WHILE CONDUCTING PARASAIL
OPERATIONS IN LONGBOAT PASS, FLORIDA ON JUNE 27, 2011**

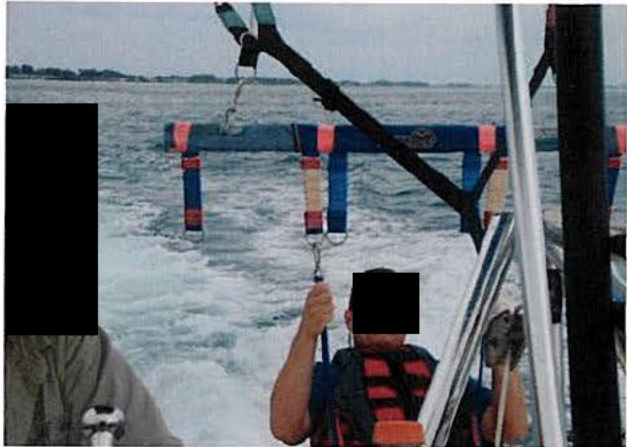
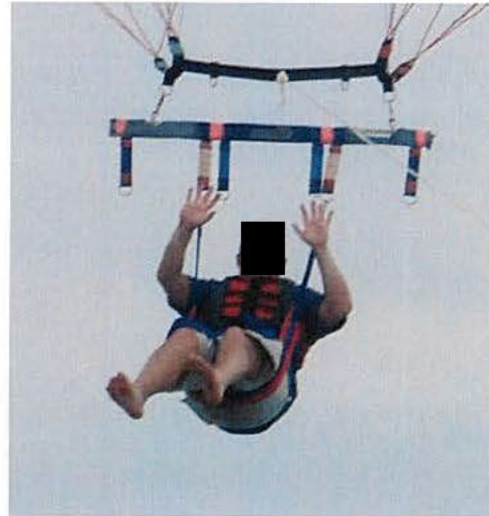
tow rope out for the fourth flight for the usual length (approximately 800 feet) and was navigating the vessel in forward propulsion. (Next images show Mr. Sieradzki during the launch of the fourth parasail flight)

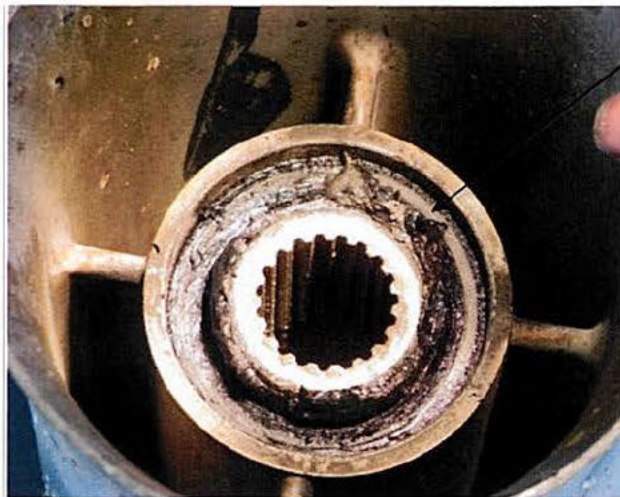
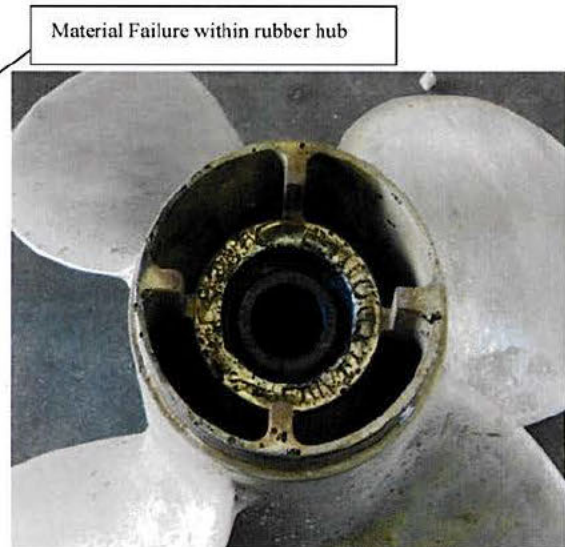
cc. August 02, 2011, USCG Investigator transported the propeller from the M/V ALMOST HEAVEN to General Propeller in Bradenton, FL to be inspected. Mr. [REDACTED], Vice President of General Propeller, stated that his company had "most likely" serviced the propeller although he could not find a service report. Mr. [REDACTED] stated that it was probably more than 18 months before, but the propeller stamping was from his shop. Mr. [REDACTED] ran the propeller on a Prop Scan EPS and found variations in the propeller, but stated that the propeller would still be in serviceable condition once the propeller was re-hubbed. Mr. [REDACTED] also stated that his company would not warrantee the new hub until the propeller was machined to repair variances.

- a. After having the M/V ALMOST HEAVEN examined by a certified Mercruiser Master Technician, it was apparent that the rubber hub on the propeller of the outdrive of the Bravo II failed and caused the M/V ALMOST HEAVEN to lose propulsion.
- b. According to statements, Mr. Sieradzki was not briefed on procedures to take if he were to enter the water unexpectedly. The crew of the M/V ALMOST HEAVEN did not adequately brief safety procedures to their parasail passengers. Although parasail passenger safety briefings are not a federal or state requirement, passenger safety

6. **Conclusions:** In accordance with Marine Safety Manual, Volume V, the Initiating Event (or first unwanted outcome for this casualty) was when M/V ALMOST HEAVEN lost propulsion because the vessel “spun” its propeller hub (photos below of propeller hub). The vessel has a single inboard / outboard engine. The loss of propulsion caused Mr. Sieradzki, who was being towed in a parasail aloft behind the M/V ALMOST HEAVEN, to lose lift and enter the waters of the Gulf of Mexico. When Mr. Sieradzki entered the water he waved his hands above the water. Capt. [REDACTED] retrieved Mr. Sieradzki by pulling the parasail towline in by hand, by winch and by navigating the M/V ALMOST HEAVEN at idle speed toward Mr. Sieradzki’s location. Mr. Sieradzki was out of view for an unknown period of time while being pulled back to the vessel (between 3-5 minutes). Mr. Sieradzki was unconscious / unresponsive and floating face up when he was seen approximately 100 feet from the vessel. Mr. Sieradzki was recovered on board the M/V ALMOST HEAVEN and cardiopulmonary resuscitation was administered. USCG responded to the scene and took Mr. Sieradzki and [REDACTED] to Coquina Boat Ramp where EMS declared Mr. Sieradzki deceased. Although not deemed to be a causal factor, it should be mentioned that all passengers stated that they received no safety briefing before or during the parasail rides. There is no evidence of failure to properly respond to this situation by retrieving / recovering the person in the water using different techniques (pulling / winching / navigating) by the vessel’s crew. With exception to the medical explanations, it is unknown, what other factors contributed to Mr. Sieradzki’s death.
