**REPORT OF INVESTIGATION INTO THE  
CIRCUMSTANCES SURROUNDING THE PARASAILING  
ACCIDENT WITH LOSS OF LIFE AND INJURY ON THE**

**SMALL PASSENGER VESSEL M/V TURTLE  
(VI0776TC)**

**IN THE VICINITY OF ST THOMAS HARBOR, USVI  
ON NOVEMBER 15, 2011**

**INJURY AND LOSS OF LIFE ONBOARD THE PASSENGER VESSEL  
TURTLE WHILE CONDUCTING PARASAIL OPERATIONS  
IN THE VICINITY OF ST. THOMAS HARBOR, U.S. VIRGIN ISLANDS  
ON NOVEMBER 15, 2011**

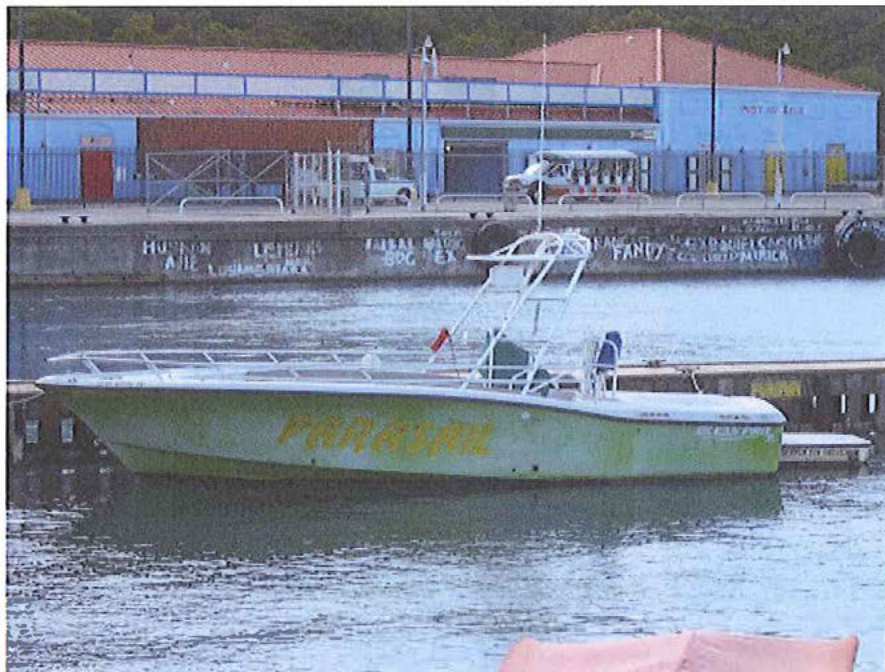
Figure 01. Photo of SPV TURTLE post casualty

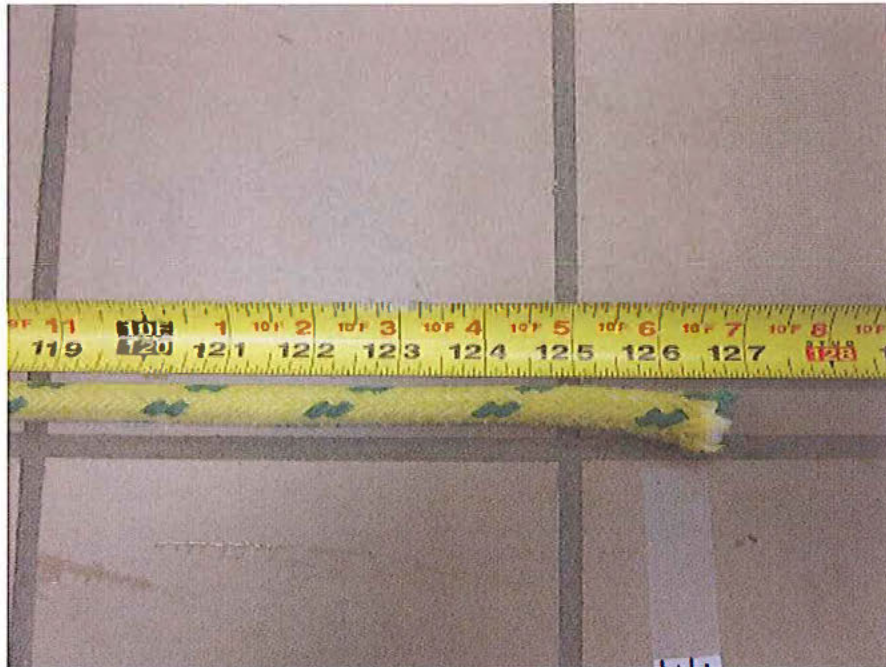
Figure 02. Parasail towline used on the M/V TURTLE on the day of the incident

- c. After unknown days of service, the M/V TURTLE (VI0776TC) un-knotted towline average failure load of 3,625 pounds was a significant 3,215 pounds (47%) below the manufacturer’s minimum breaking strength of 6,840 pounds.
- d. The knotted M/V TURTLE (VI0776TC) towline average failure load of 3,365 pounds was a significant 3,475 pounds (50.8%) below the manufacturer’s minimum breaking strength of 6,840 pounds. As with the exemplar rope, all failures were at the bowline knot.
- e. The M/V TURTLES (VI)0776TC) towline rope tested 7.1% weaker with the bowline knot than without the bowline knot.

A detailed visual examination of the M/V TURTLE (VI0776TC) towline revealed broken filaments that could be seen on its surface giving it a fuzzy appearance. This fuzzy appearance is consistent with a braided rope that has filament breakage.

3. It is recommended that the Commandant of the Coast Guard, in consultation with national parasailing organizations and/or the parasailing industry, develop parasail towline selection, inspection and retirement (removal from service) guidelines. These guidelines should require records to be kept that indicate the size, fiber, construction, length, manufacturer, minimum breaking strength, safe working load, date placed in service, and inspection interval for each towline. Inspections should be logged and should check for damage, wear and include caliper measurements of the towline diameter to determine if the towline has deteriorated. The master of the parasailing vessel should be responsible for keeping these records and reporting the same to management. For each towline, the records should be kept for the duration of its service life and should be made available for review by the Coast Guard upon request. When developing the guidelines, the Coast Guard should further evaluate: the need to conduct additional operational tests to determine a towline's required minimum breaking strength; the need to require the breaking strength of each towline to be certified by the manufacturer by subjecting a portion of the rope to destructive testing prior to its installation; and the need to specify the use of more efficient connections (e.g., eye splices, thimbles, etc.) between the towline and the yoke.

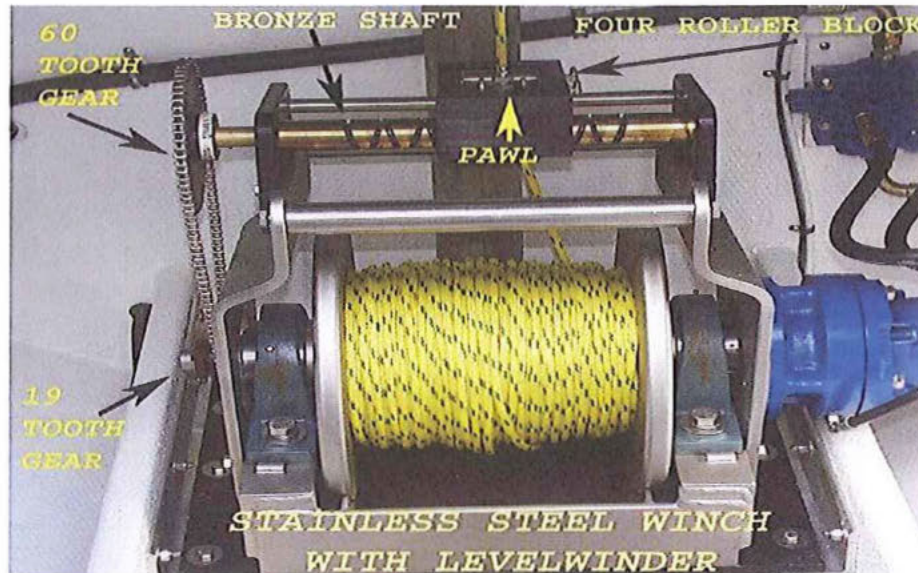
31. The winch drum is turned by a hydraulic motor, which is driven by the engine through a clutch and a power take-off (PTO) unit. The system has a hand operated control level located at the vessel's helm. Van Air and Hydraulics supplied Commercial Water Sports several significant components used in the hydraulic system. Installation of the winch system was completed by Commercial Water Sports. There are no U.S. Coast Guard recognized industry standards or regulations for designing, building, operating, maintaining or inspecting a parasail winch system onboard Coast Guard inspected small passenger vessels. Subsequent tests on the winch and hydraulic systems showed no leaks, equipment damages, or any other forms of excessive wear, system operated satisfactorily.

Figure 06. Manufacturer picture of the type of winch installed on the TURTLE

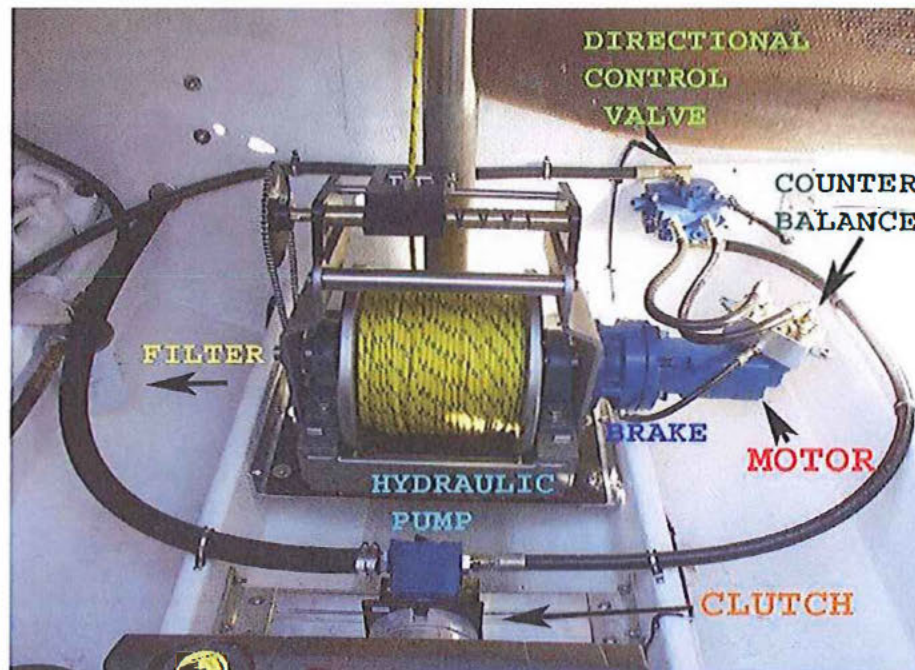
Figure 07. Manufacturer picture of the type of hydraulic system installed on the TURTLE

33. The onboard hydraulic winch system is fitted with a 3000 pressure per square inch relief setting. When relief pressure is reached, hydraulics will stop; hydraulic system will re-circulate fluid, preventing a hydraulic line failure, winch overload, or free spooling of the towline.

34. The M/V TURTLE(VI0776TC) was not outfitted with a gauge of any kind showing the current psi pressure of the hydraulic system.
35. The towline in use onboard the M/V TURTLE (VI0776TC) was a 7/16-inch diameter Double Esterlon polyester double braided rope supplied by Sea Gear Marine, a distributor for Yale Cordage, the manufacturer. Advertising literature supplied by Yale Cordage in September 2009, Industrial Catalog 8<sup>th</sup> Edition, indicated the rope is designed for industrial use and offers low stretch, high strength, and an excellent wear life. According to advertising literature, the line has an average and minimum breaking strength of 7,600 pounds and 6,840 pounds, respectively, and has a recommended safe working load of 1,900 pounds. The working load is based on static or moderately dynamic lifting/pulling operations. Instantaneous changes in load, up or down, in excess of 10% of line's rated working load constitutes hazardous shock load and voids normal working load recommendations.

- b) Equipment: There are four equipment related causal factors.
    - 1) The vessel's parasail winch pressure relief setting of 3000 psi was most likely reached during the high wind conditions. The relief setting effectively shut down the winch motor, locking the brakes, in order to prevent a hydraulic system failure or free spool situation. The crew onboard the M/V TURTLE (VI0776TC) had no method of knowing if the system's pressure relief setting was being reached due to a lack of a system gauge on this class of vessel.

**Safety Recommendation 13:** It is recommended that Commercial Water Sports, Inc, the builder the M/V TURTLE (ON VI0776TC), advertise a service bulletin to the parasailing industry advising of the need to retrofit this particular class of vessel with a pressure gauge for the parasail winch hydraulic system, with notation of specific pressure relief setting.

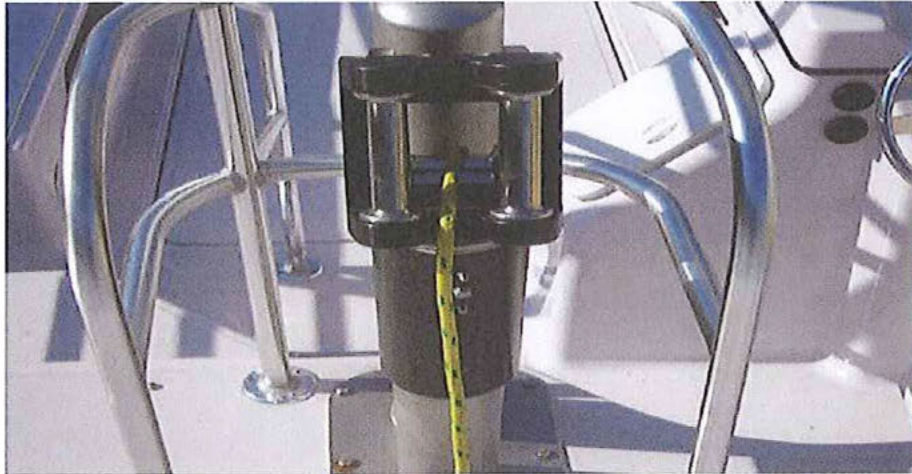
32. A tri-roller head with a two and a half inch diameter swivel mount, equipped with bearings, two vertical rollers on each side, one horizontal roller and a safety mechanism called a knot breaker at the bottom of the line guide was installed on the vessel's tow post. The roller onboard the M/V TURTLE (VI0776TC) was mounted on the tow post using set screws. The roller is capable of swiveling from left to right at approximately 180 degrees as passengers are in flight. Equipment found to be operable post casualty.

Figure 08. Picture of a Tri-roller head similar to the tri-roller head onboard the TURTLE

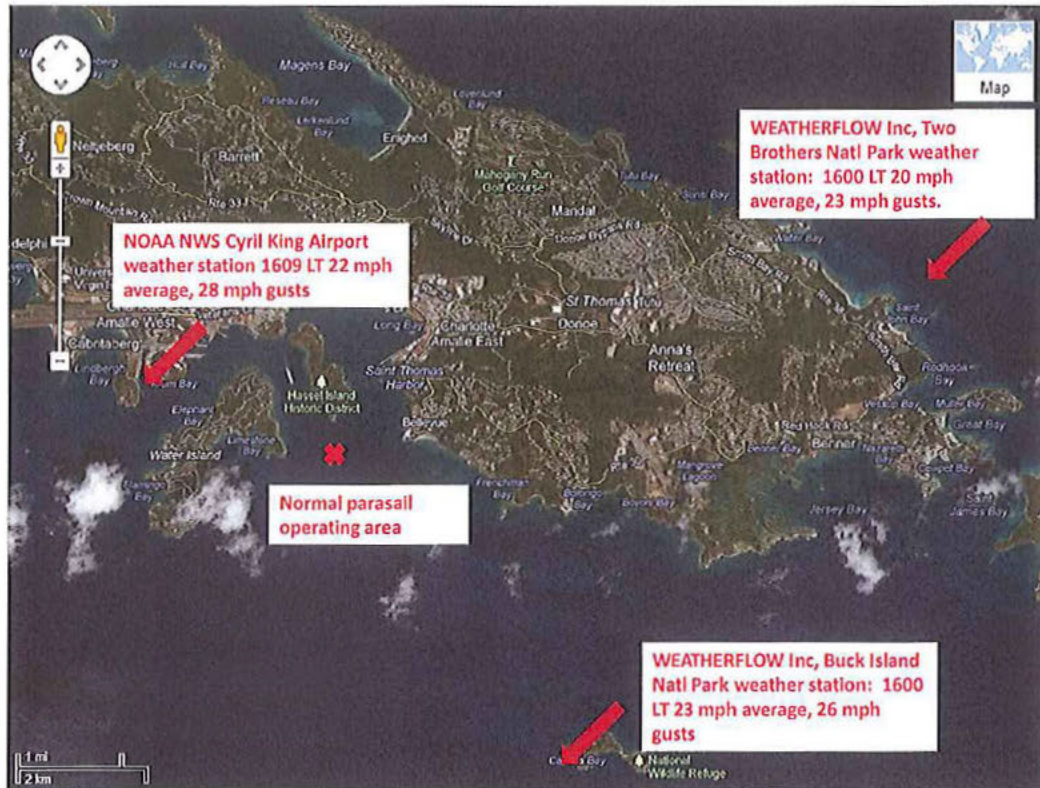
38. Based on witness statements and evidence gathered throughout the investigation, the following is an approximation of the observed weather conditions from weather stations located closest to the estimated incident location at different time periods leading up to and immediately following the incident: See Figure 09

Figure 09. Map depicting three closest weather stations and pre-casualty observations.

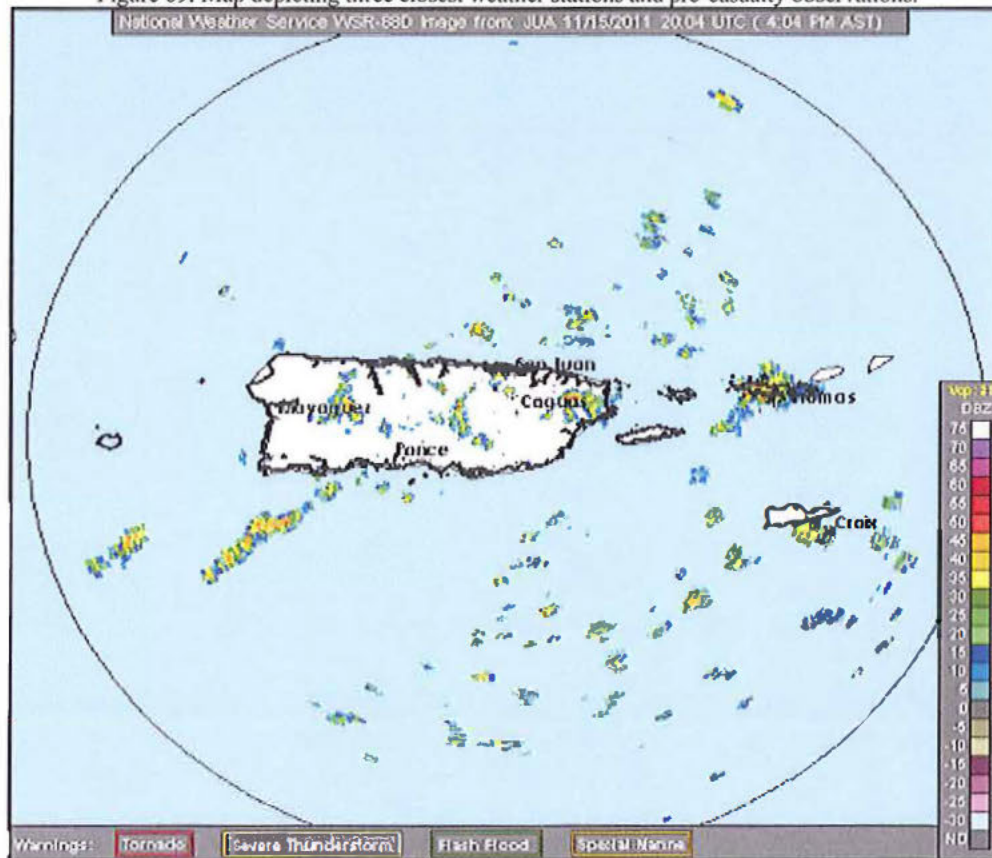
*WILL BE CAPABLE OF PRODUCING LOCALLY HEAVY RAIN...PONDING OF WATER ON ROADWAYS...REDUCED VISIBILITIES AND HAZARDOUS DRIVING CONDITIONS THROUGH AT LEAST 5 PM AST. See Figure 10*

Figure 10. NWS radar image minutes before incident occurred
