## REPORT OF INVESTIGATION INTO THE CIRCUMSTANCES SURROUNDING THE PARASAILING ACCIDENT WITH LOSS OF LIFE AND INJURY ON THE

SMALL PASSENGER VESSEL M/V X-TREME  
(O.N. 1153017)

IN THE VICINITY OF HONOLULU HARBOR HOTEL  
BUOY  
ON JANUARY 29, 2012

**INJURY AND LOSS OF LIFE ONBOARD THE PASSENGER VESSEL X-TREME  
WHILE CONDUCTING PARASAIL OPERATIONS IN HONOLULU HARBOR  
ENTRANCE NEAR LIGHTED BUOY "H" ON JANUARY 29, 2012**

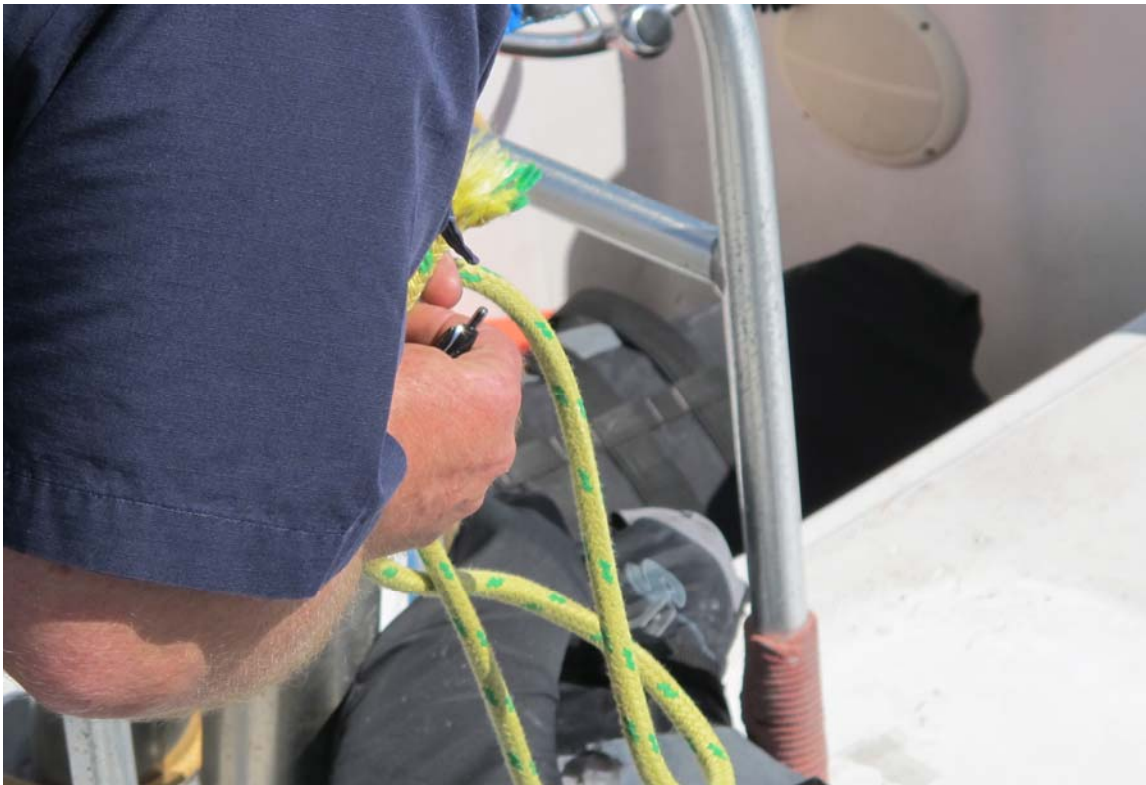
Figure 3: Parasail towline used on the M/V X-TREME on the day of the incident

10. The towline onboard the M/V X-TREME O.N. 1153017 at the time of the incident was Yale Cordage 7/16", yellow "Double Esterlon" double braided nylon line. Custom Chutes, Inc had purchased the towline from Sea Gear Marine, a distributor for Yale Cordage and sold it to X-TREME Parasail Inc. on March 15, 2011. X-TREME Parasail Inc placed the towline into service on May 10, 2011.
11. Advertising literature supplied by Yale Cordage in September 2009, (Industrial Catalog 8<sup>th</sup> Edition) indicated the rope is designed for industrial use and offers low stretch, high strength, and an excellent wear life. According to the literature, the line has an average and a minimum breaking strength of 7,600 pounds and 6,840 pounds, respectively, and has a

recommended safe working load of 1,900 pounds. The working load is based on safety factors associated with static or moderately dynamic lifting/pulling operations. "Instantaneous changes in load, up or down, in excess of 10% of line's rated working load constitutes hazardous shock load and voids normal working load recommendations."

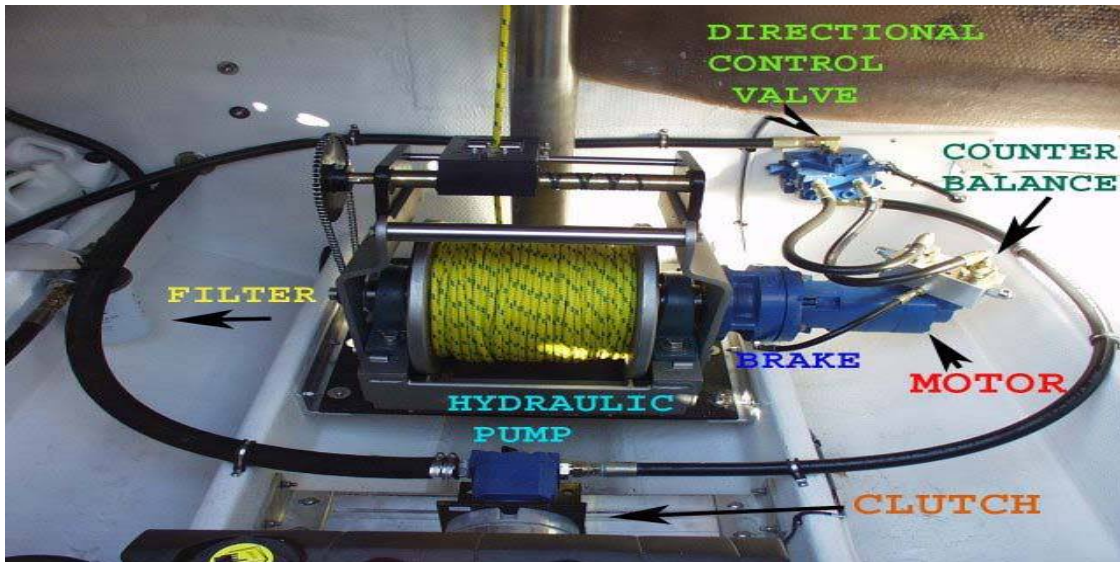
Figure 8: Picture of a hydraulic system similar to the hydraulic system onboard the M/V X-TREME.

18. The onboard hydraulic winch system is fitted with a 3,000 pounds PSI relief setting. When this relief pressure is reached, hydraulics system will re-circulate fluid, preventing a hydraulic line failure, winch overload, or free spooling of the towline and freezing the movement of the towline until the pressure is within operating parameters.
19. A towline tri-roller head onboard the M/V X-TREME was mounted on the vessel's tow post. The tri-roller head consists of a two and a half inch diameter swivel mount, equipped with bearings, two vertical rollers on each side, one horizontal roller and a safety mechanism called a knot breaker at the bottom of the line guide. The roller is capable of swiveling from left to right at approximately 180 degrees as passengers are in flight.

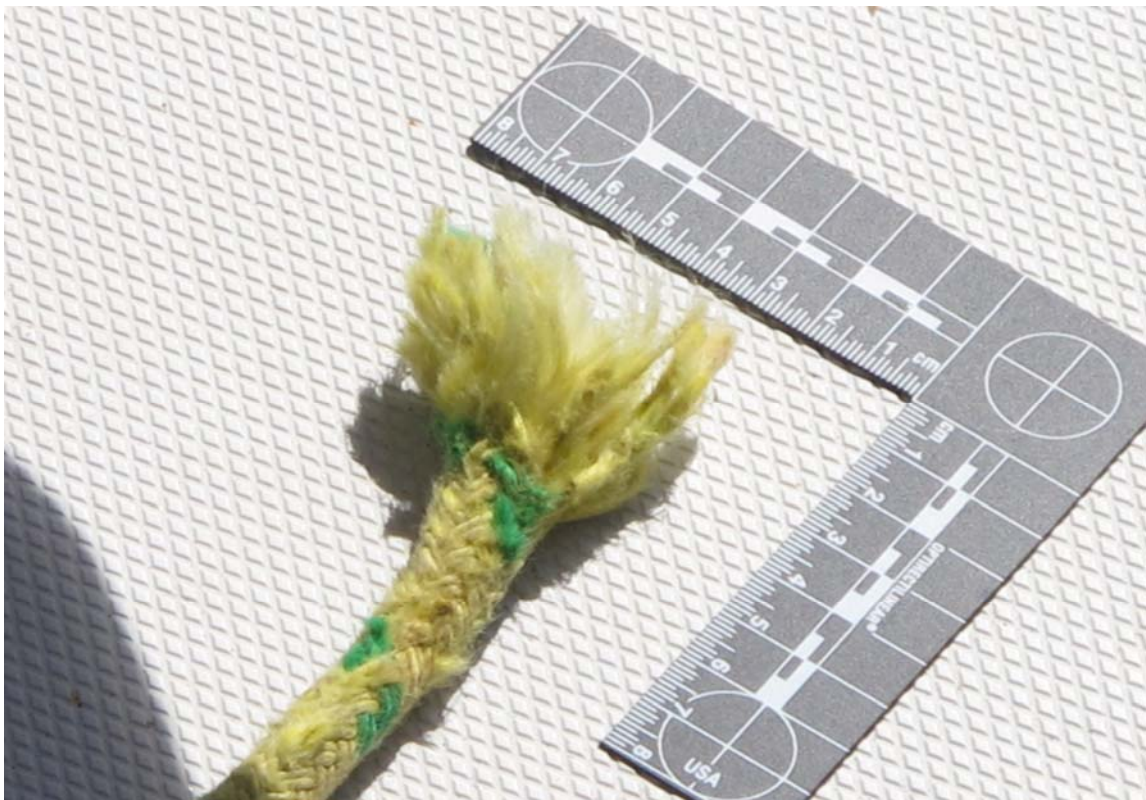
Figure 13: Picture bitter end of the parted towline.

A visual examination of the M/V X-TREME first 100 feet of towline after the parting revealed broken filaments which could be seen on its surface, giving it a fuzzy appearance. This fuzzy appearance is consistent with a braided rope that has filament breakage. This wear is supported by witness testimony stating that the towline on the vessel's deck "looked dirty and fuzzy".

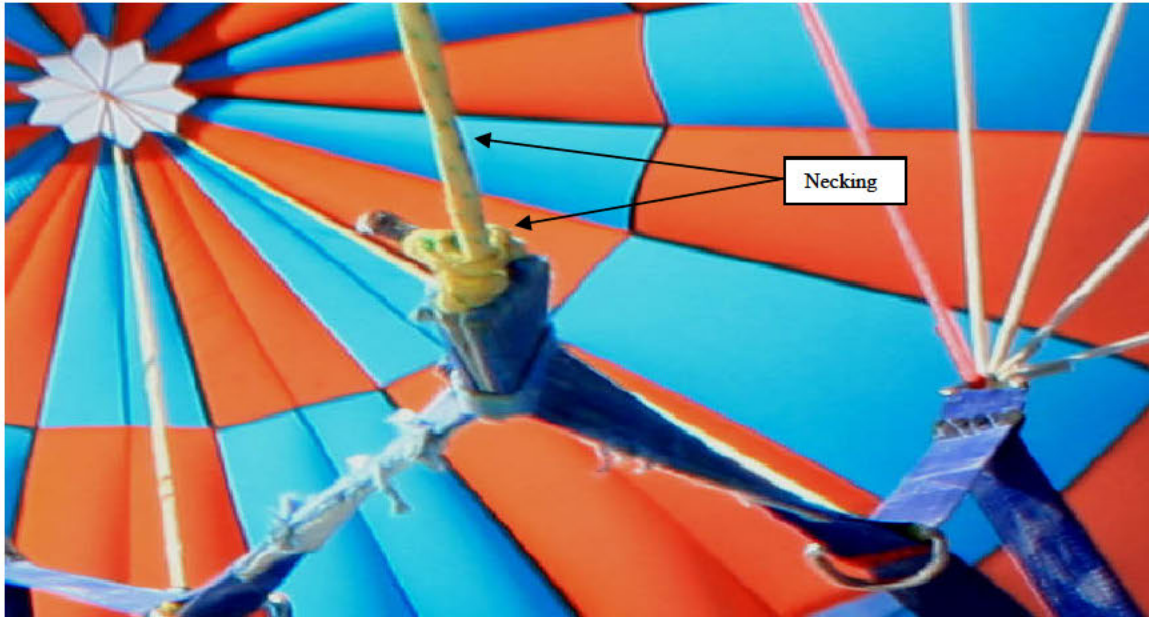
Figure 14: Necking adjacent to the bowline knot.

There is evidence that the M/V X-TREME towline strength was significantly reduced by the bowline knot. Photographs of the parasailing flight minutes before the towline parted shows signs of visibly reduced circumference due to excessive strain ("necking") immediately adjacent to the bowline.

Because, it's a simple way to tie and untie, the bowline knot is typically used throughout the parasailing industry to fasten the towline to the parasail harness. Most knots will induce structural damage and will reduce a line's breaking strength by as much as 50% according to Cordage Institute, International Standard CI 1500-02.

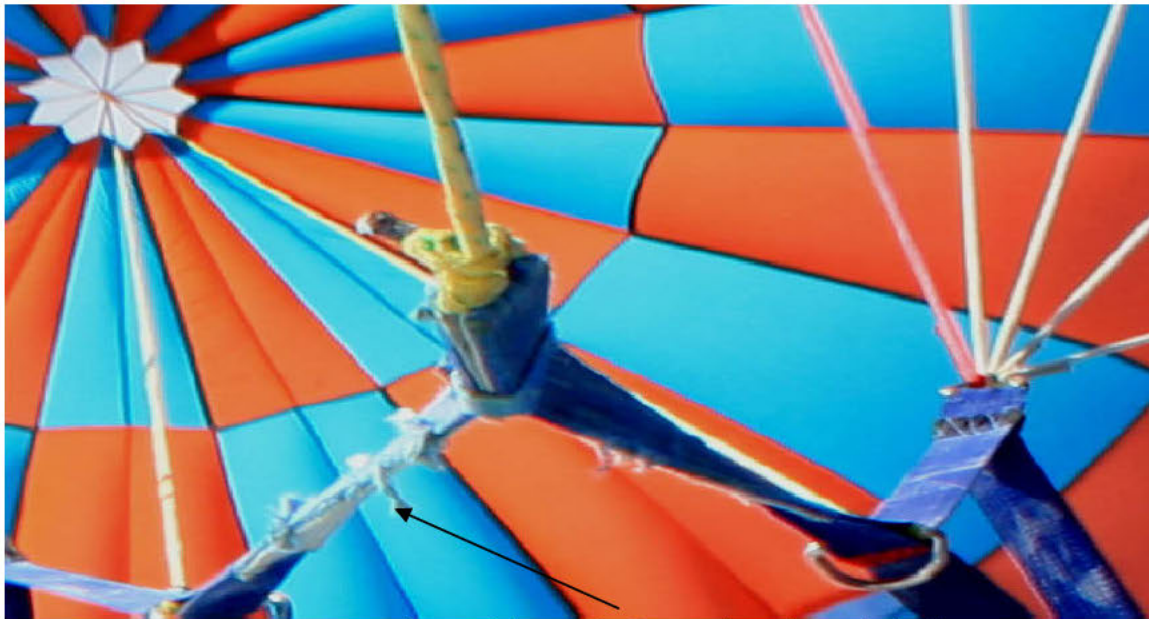
Figure 15: Picture of degraded yoke strap just prior to the incident.

- 4) The 34 foot trivent parasail yokes starboard strap appeared to show signs of deterioration. This deterioration and possible failure could not be discounted in the

investigation. If the strap failed inside the roller as the flyers landed it could have added to the shock-loading of the towline and contributed to the incident.
