UNITED STATES COAST GUARD

REPORT OF INVESTIGATION INTO THE CIRCUMSTANCES SURROUNDING THE INCIDENT INVOLVING A PARASAILING ACCIDENT ON THE

FL0238HY

**ONE MILE OFF HILLSBORO INLET,
POMPANO BEACH, FLORIDA ON 08/15/2012
WITH THE LOSS OF ONE LIFE**

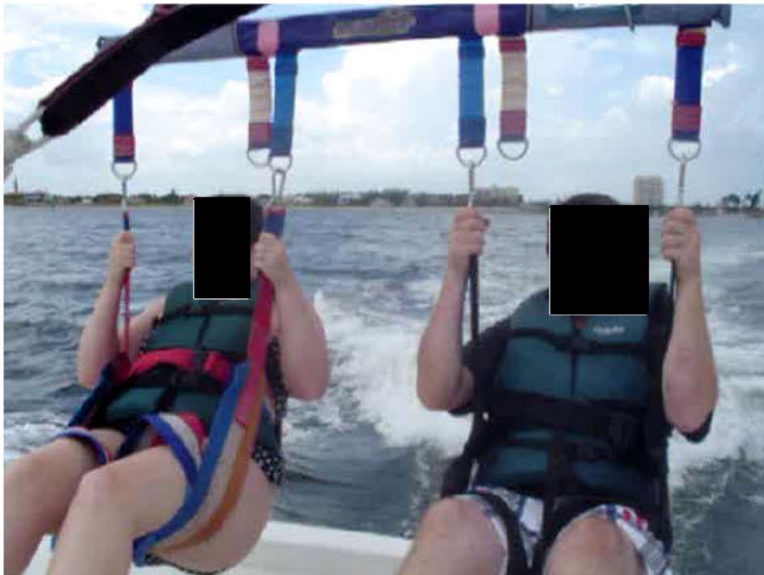
56. Both passengers were wearing their harnesses over their PFDs. The seat strap on Mrs. [REDACTED] harness was positioned approximately mid-thigh and she was in a semi-reclining position with both hands holding onto the hanger straps connected to the flight bar. The seat strap on Mr. [REDACTED] harness was positioned further back on his thighs and his body position was more upright than Mrs. Miskell's (Figure 4).

Figure 4 - Passengers just prior to launch.

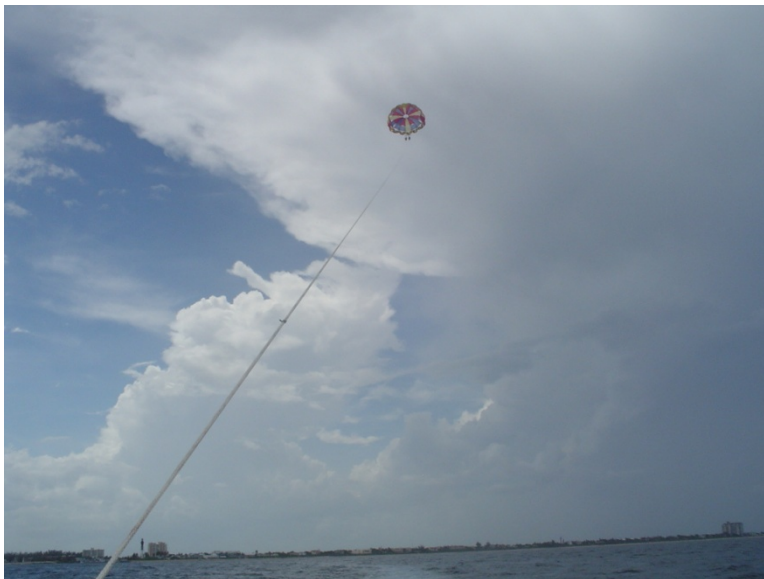
Figure 9 – The parasail at maximum altitude. Black mark on towline is 800' mark.

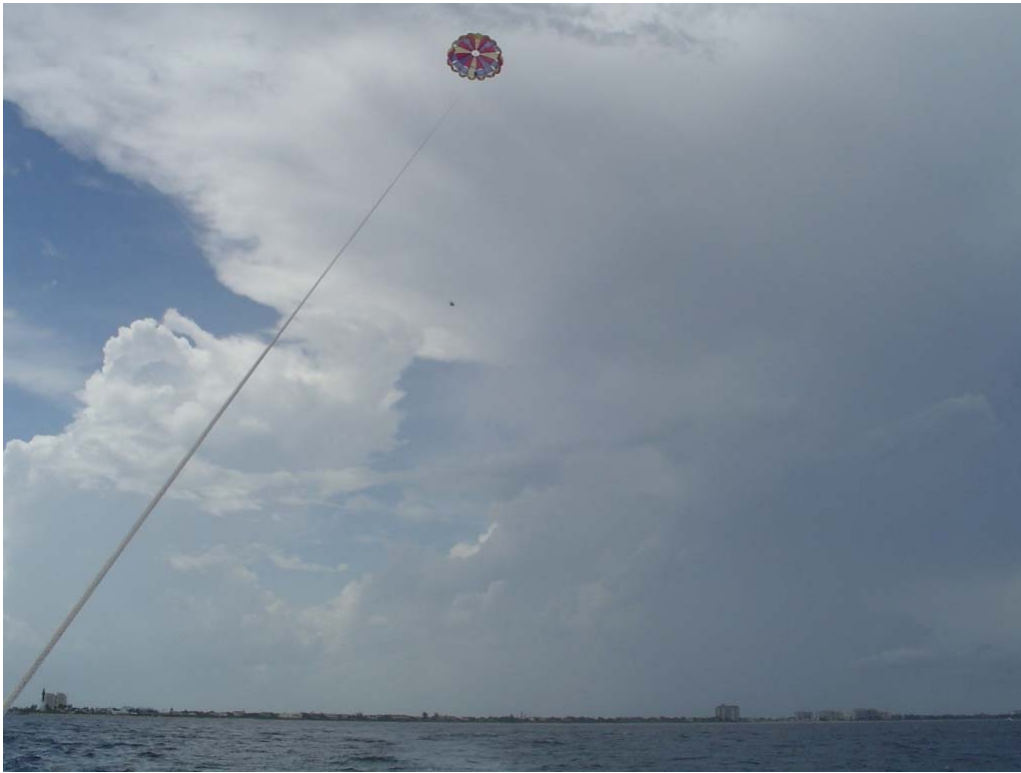
40. A line of position was established for the location of the casualty using the photograph in Figure 10. In this photograph of the moment the casualty occurred, the Hillsboro Lighthouse can be seen in the bottom-left corner of the photograph aligned with a multi-story building. The multi-story building is the Hillsboro Light Towers and using mapping software, it was determined that the casualty occurred ½ to 1 NM from shore on a bearing of 113 degrees true from the Hillsboro Lighthouse (Figure 2). The orange markers in Figure 2 indicate aids to navigation.

Figure 10 - Mrs. Miskell separates from the parasail. The picture captures her at nearly mid-fall.

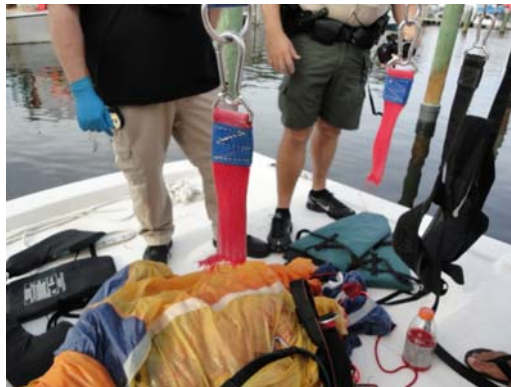
89. Investigators found the upper portions of both the left and right hook riser from the victim's harness still connected to the flight bar (Figure 15).

Figure 15 - Flight deck on FL0238HY with flight bar and remains of victim's harness straps.

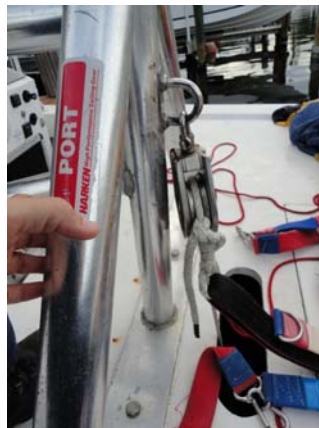
91. Investigators found that the parasail remained attached to the towline using a bowline knot with multiple half-hitches tied to the parasail's yoke (Figure 17).

Figure 17 - Towline connection to yoke was a bowline with multiple half-hitches.

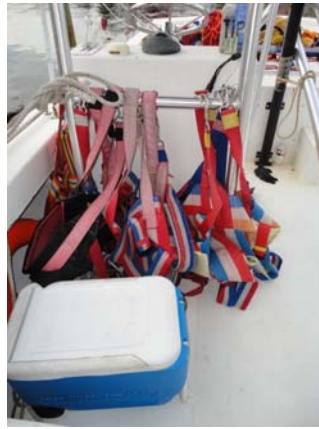
92. Investigators found approximately nine harnesses clipped to a horizontal rail on the forward side of the vessel's operating console (Figure 18). All of these harnesses appeared to be previously used and several appeared to have significant sun damage and/or physical damage.

Figure 18 - Harnesses clipped to rail on forward side of console.

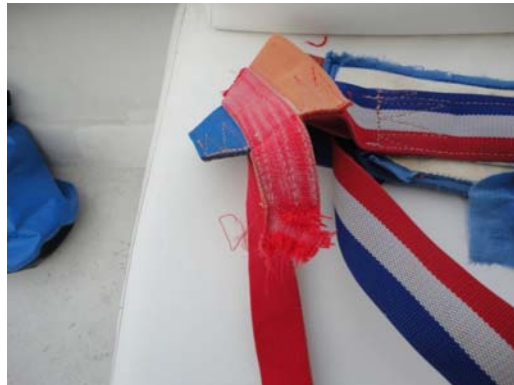
93. The victim's harness had been returned to the FL0238HY after having been removed by EMS after the victim had been moved ashore. Investigators found that the right and left hook riser on the victim's harness had parted where the risers transitioned from two layers of webbing to single webbing (Figures 19, 20).

Figure 19 - Victim's harness showing failed strap (wearer's right side).

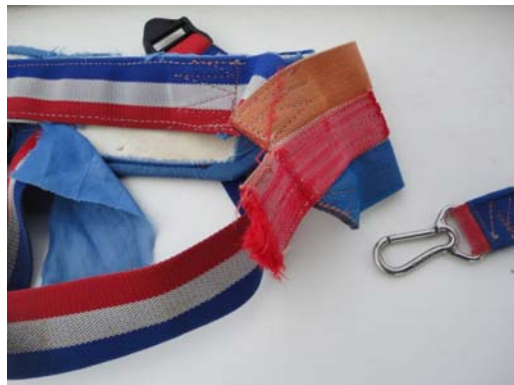
Figure 20 - Victim's harness showing failed strap (wearer's left side).

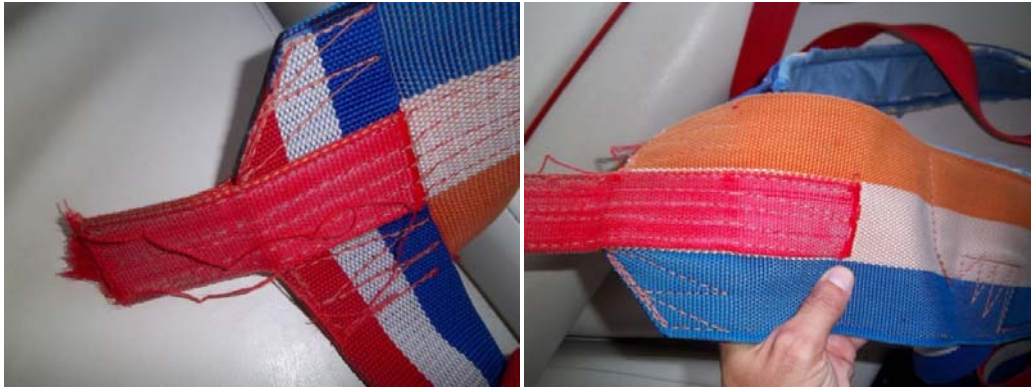
doubler of approximately 6” in length was then sewn onto the inside of each hook riser/seat strap such that it overlapped the hook riser and the seat strap equally. Figure 25 shows the doubler on the inside of the harness (left image) and the attachment of the hook riser to the outside of the seat strap (right image). In more recently manufactured harnesses, the hook risers are formed by a continuous piece of webbing that is attached to the harness in such a way that it doubles the hook risers over their entire length and passes under the entire seat strap.

Figure 25 - Inside and outside portions of the hook risers where they connect to the seat strap.

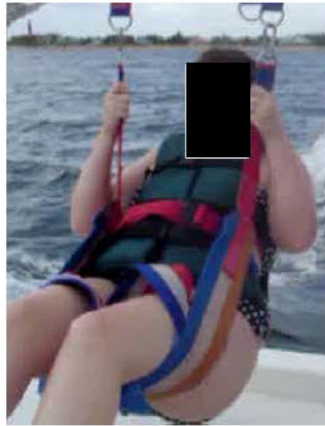
32. Coast Guard investigators analyzed the fit of the victim's harness and observed that it was not properly fitted. First, the deckhand incorrectly put the harness on over the victim's PFD, which prevented the harness from being properly tightened. In the video of the flight's launch, it can be seen that the waist strap is loosely secured on the outside of the victim's PFD. Second, because the waist belt was over the PFD and not properly tightened, the seat strap was able to move forward on the victim's thighs until it was approximately two-thirds of the way from her buttocks to her knee. The position of the seat strap placed the victim in a reclined position that she compensated for by pulling on the hook risers for support. This position also loaded the hook risers unequally, with more weight on the trailing edge of each hook riser than on the leading edge. The unequal loading of the straps caused "scalloping" on the leading edges of the hook risers. The fit of the multicolored harness can be seen in figure 26.

Figure 26 - Fit of the multicolored harness.

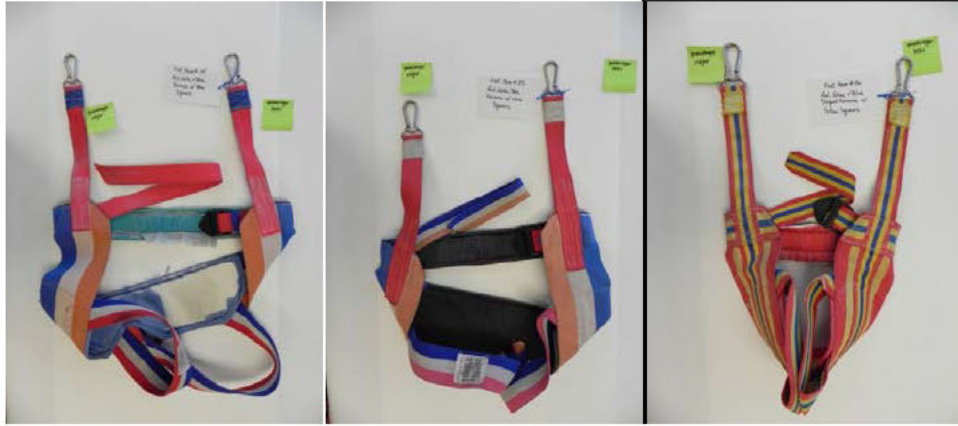
Figure 28 - Harnesses 34, 35 and 36 were not suitable for service.

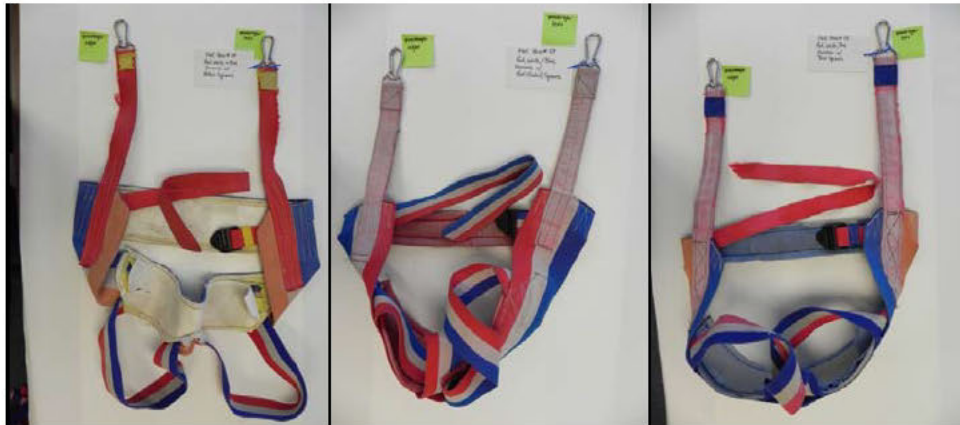
Figure 29 - Harnesses 37, 39 and 43 were not suitable for service.

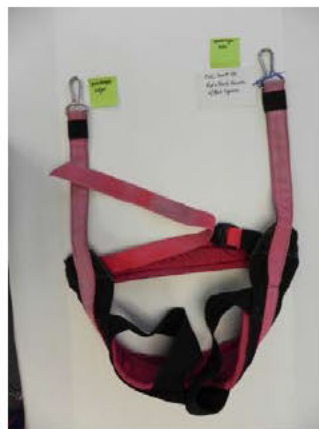
Figure 30 - Harness 38 needed a new waist strap.

b) Harness #38 needed a new waist strap to bring it to a serviceable standard (Figure 30).

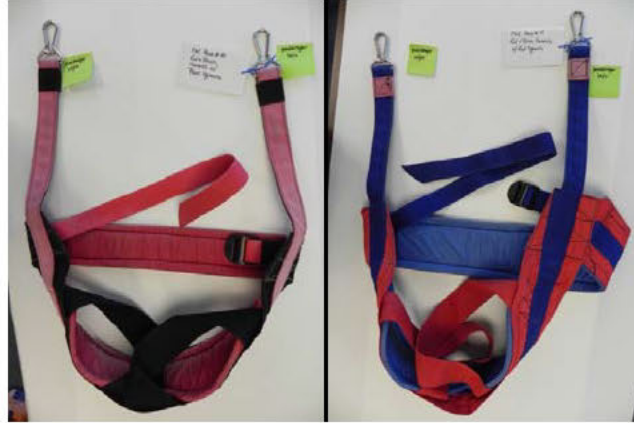
c) Harnesses #40 and #41 were serviceable (Figure 31).

Figure 31 - Harnesses 40 and 41 were serviceable.

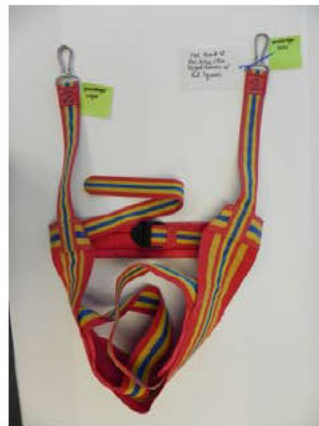
Figure 32 - Harness 42 needed 2 new clip straps.

d) Harness #42 needed new hook risers to render it serviceable (Figure 32).

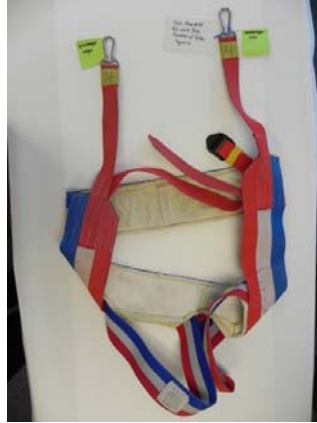
Figure 33 - Harness 44 needed new pads and clip straps.

- e) Harness #44 needed new pads and hook risers to render it serviceable (Figure 33).

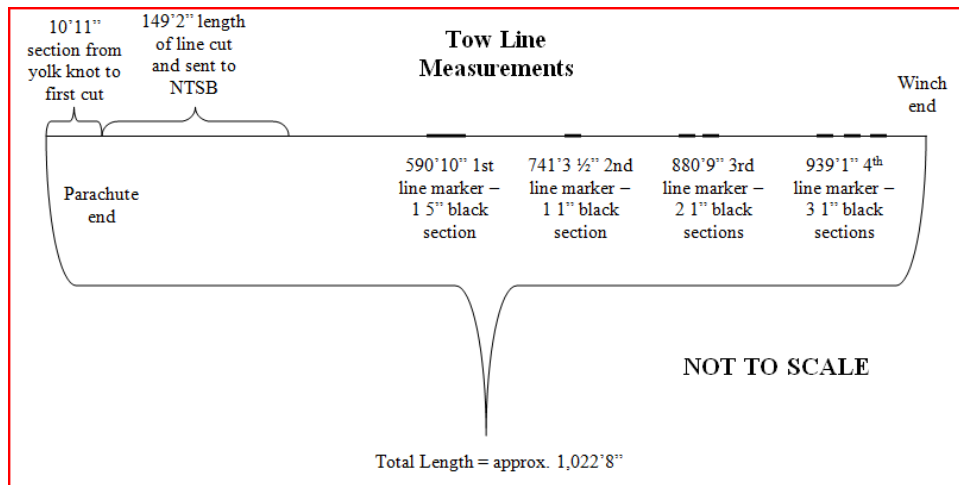
Figure 34 - Towline measurements and markings.

47. The towline was coated with noticeable wax buildup, which was consistent with the master's statement that he waxed the line with surfboard wax in order to reduce "hot spots." Further supporting his statement, bars of Palmer's Surf Wax were found on the FL0238HY.

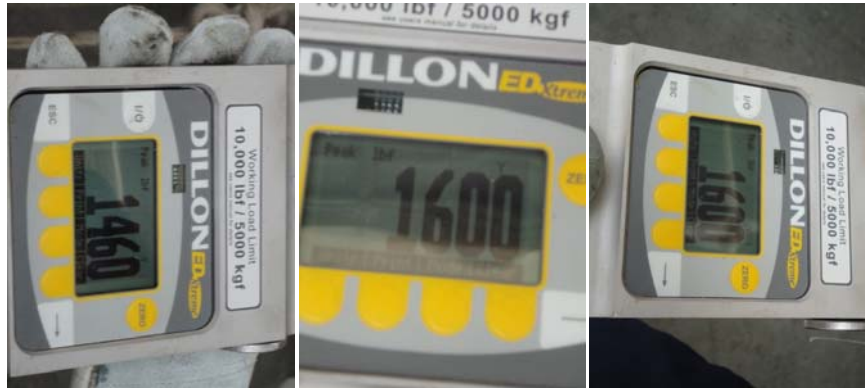
Figure 36 - Winch test results.

61. There is no evidence that the winch had any failure or difficulty retrieving the parasail on the day of the casualty. Additionally, operational tests demonstrated that the winch operated smoothly and did not surge or stutter. The winch test results were lower than expected, but because the RPM gauge was inoperable, it was impossible to set and maintain an appropriate RPM for the tests.

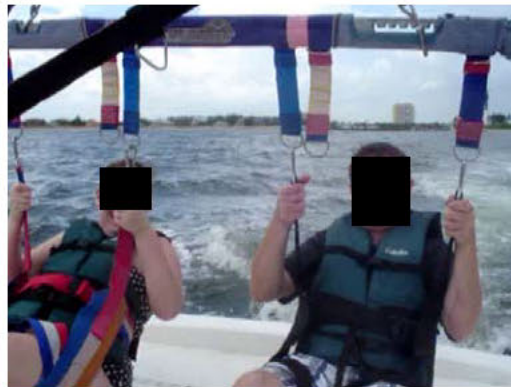
68. The approximate difference in weight of the passengers involved in the casualty was 15 lbs. The CCI “Product owners and maintenance manual” indicates that for doubles with a 15 lb weight difference, the heavier person should be connected to hangers A and C, the lighter person should be connected to hangers D and F, and the shackle should be in position 1 of the adjuster slot. Analysis of the video footage obtained from the camera in use onboard the FL0238HY indicated that the flight bar was correctly configured (Figure 37).

Figure 37 - Configuration of the flight bar.

69. The NTSB examined the flight bar and did not note any significant material defects that would affect its serviceability. The examination did reveal minor defects in the padded cover near the ends of the bar and remnants of adhesive from where several labels had become unfixed. The flight bar was in a serviceable condition and was correctly configured for the flight.

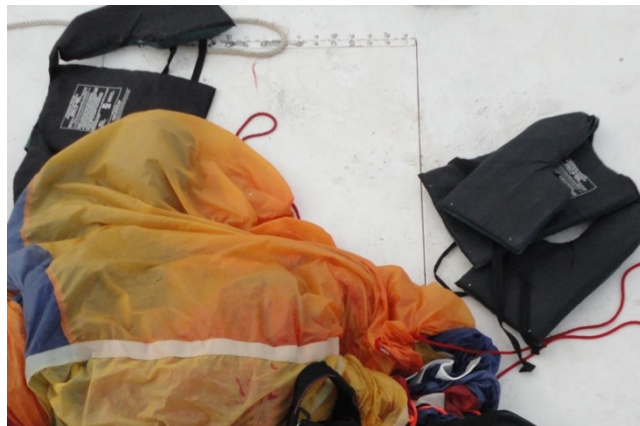
Figure 38 - PFDs on the flight deck immediately following the casualty.

76. The victim's PFD was labeled with the following: "Strength tested at 50 MPH (22.4M/S) – Not tested for personal protection from impact." There was no evidence to suggest that the victim's PFD either minimized or exacerbated the injuries she suffered as a result of the fall.
