**REPORT OF INVESTIGATION INTO THE  
CIRCUMSTANCES SURROUNDING THE INCIDENT  
INVOLVING  
M/V WHY KNOT  
PERSONAL INJURY**

**ON 07/01/2013**

**MATERIAL FAILURE WITH PASSENGER INJURIES OCCURRING ON THE  
UNINSPECTED PASSENGER VESSEL WHY KNOT NEAR PANAMA CITY BEACH,  
FLORIDA ON JULY 01, 2013**

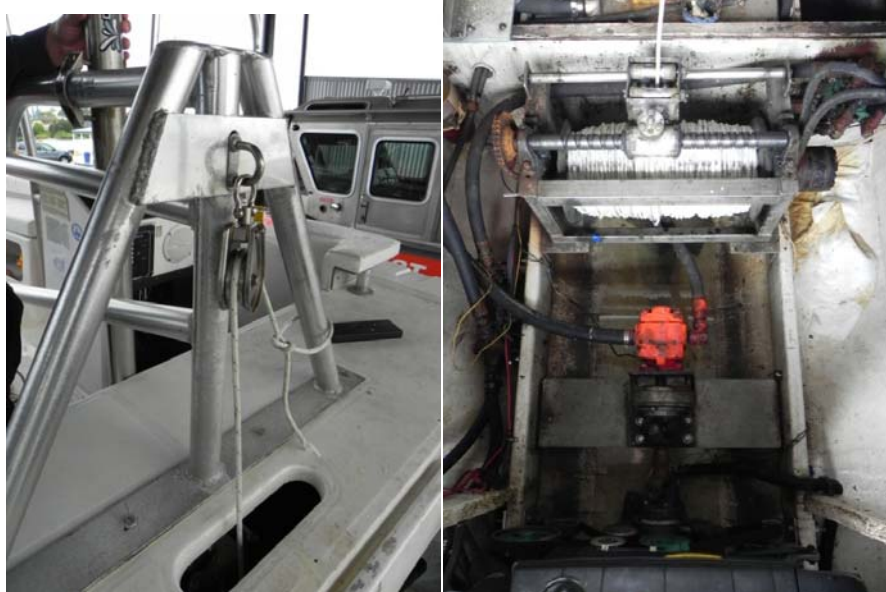
11. The WHY KNOT uses an aluminum A-frame system to conduct its parasail operations. The A-frame consists of a pulley that connects the parasail towline from the parasail apparatus through a hole in the deck to the parasail towline drum and winch.

Left: View of the Pulley and A-Frame. Right: View of winch and hydraulic motor that controls the winch drum from the main deck, looking down toward the front of the vessel.

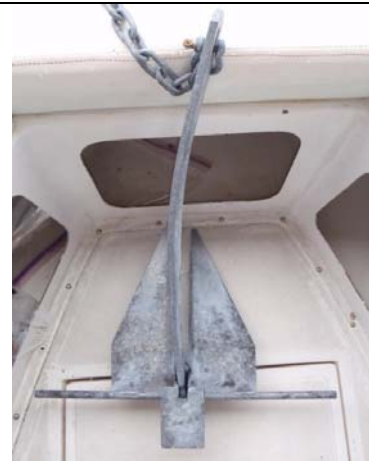
External force applied to WHY  
KNOT bent the anchor's shank  
and right fluk

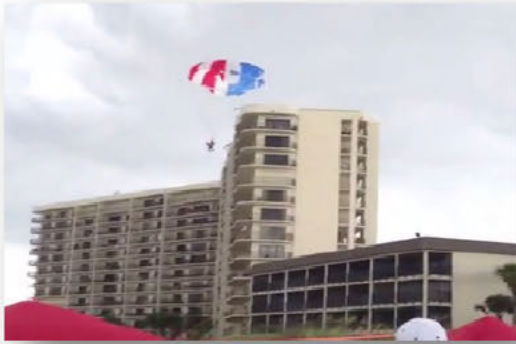
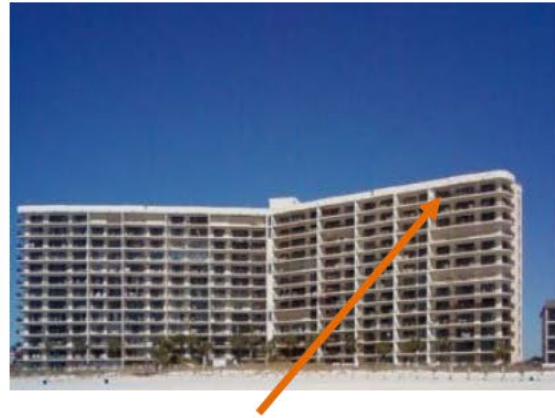
██████████ and ██████████ just prior to hitting the Commodore Condominiums

Commodore Condominiums, South side. Arrow points to area where passengers made first contact with the 12<sup>th</sup> floor balcony rail.

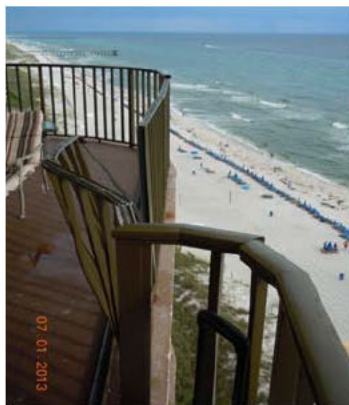
Balcony damage to top floor, east end condominium

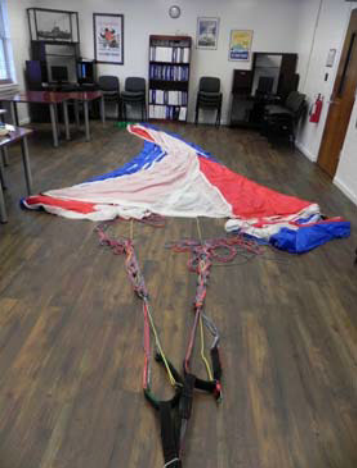
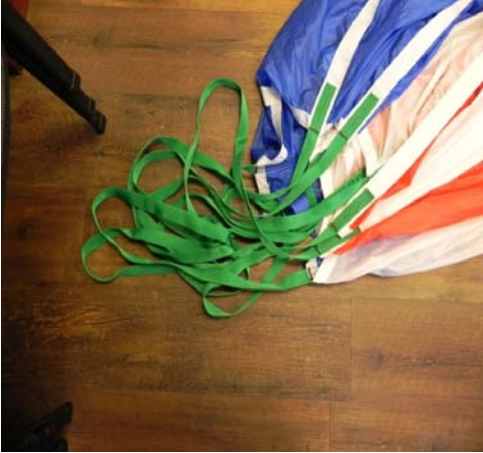
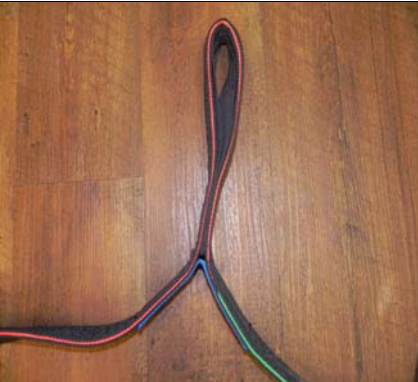
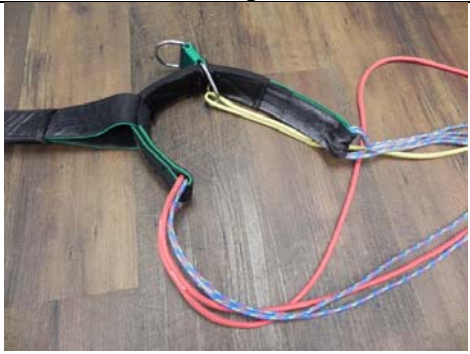
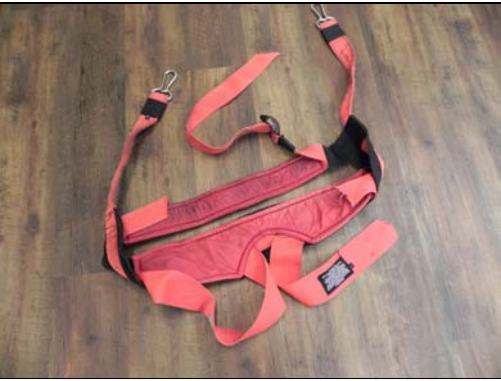
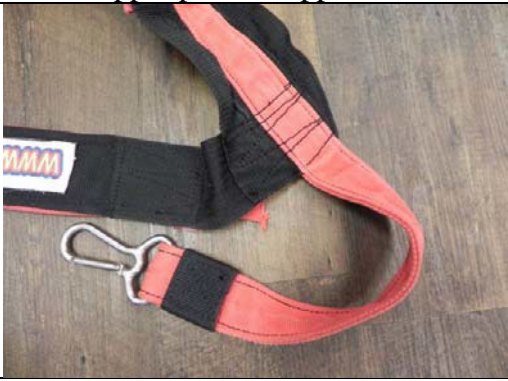
1. *Parasail Equipment:* Inspection of the parasail and the parasail harness apparatus revealed that all the equipment was in suitable condition for the intended service. The 39-foot Custom Water Sports parasail and the parasail harness showed no rips, tears, fayed shroud lines, or ruptured seams with all webbing and stitching appearing in excellent condition.

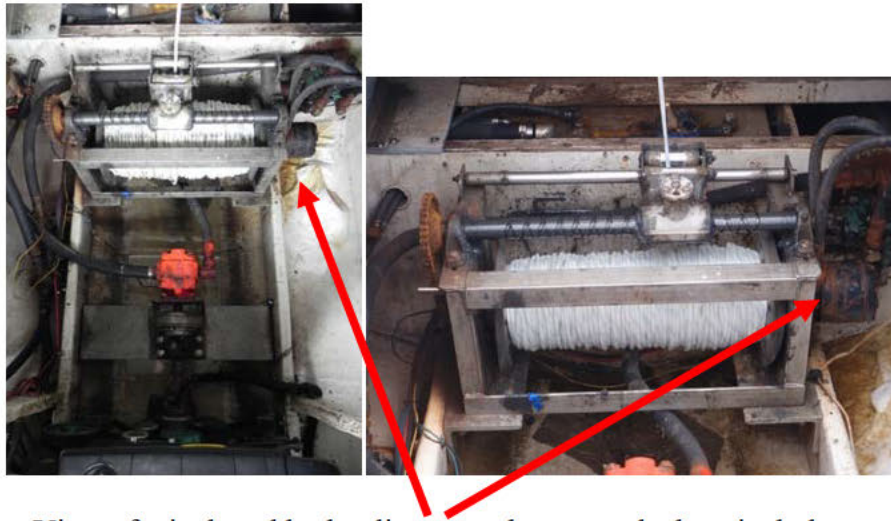
2. *Towline Winch:* On 12 JUL 2013, Coast Guard and FWC investigators, with the assistance of the NTSB investigator, examined the WHY KNOT's towline winch. While investigators observed the winch was functional, they also noted some minor discrepancies or poor mechanical conditions, including a restricted cooling water intake for the heat exchanger, and leaking hydraulic valve used to provide directional control (to pay in or to retrieve), which requiring the crew to place sorbent pads under the system. Despite these findings, supported by the winch operational testing discussed below, the investigators concluded these discrepancies did not reduce the functionality or power of the winch. Further, the investigators noted that the winch was custom built and did not have an associated technical document or manual depicting its specifications, performance parameters, or rated capacities, nor is one required by regulations.

View of winch and hydraulic motor that controls the winch drum from the main deck, looking down toward the front of the vessel. Notice the sorbent pads under the winch system saturated with hydraulic oil.

g. Ensure proper maintenance of all parasail equipment, with particular focus on ensuring all securing A-Frame U-bolt nuts have a means to prevent loosening or backing, and all winch hydraulic lines and systems are leak free and in good working order.

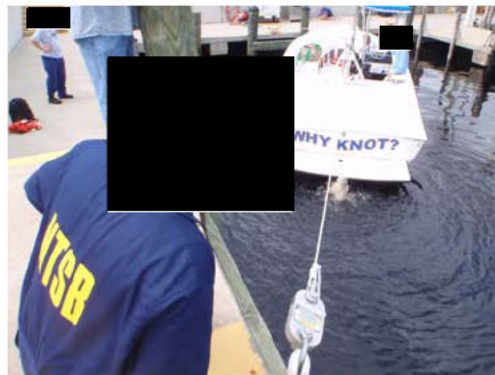
On 12 JUL 2013, Coast Guard and FWC investigators, with the assistance of the NTSB investigator, conducted a static winch test to determine the force in pounds required to cause winch failure on the WHY KNOT. Test results show a maximum tension of force required to reach a point where the winch would no longer reel in the towline was 1,350 pounds, or an average of 1,280 across all RPMs.

Static Pull test on the towline and winch of WHY KNOT

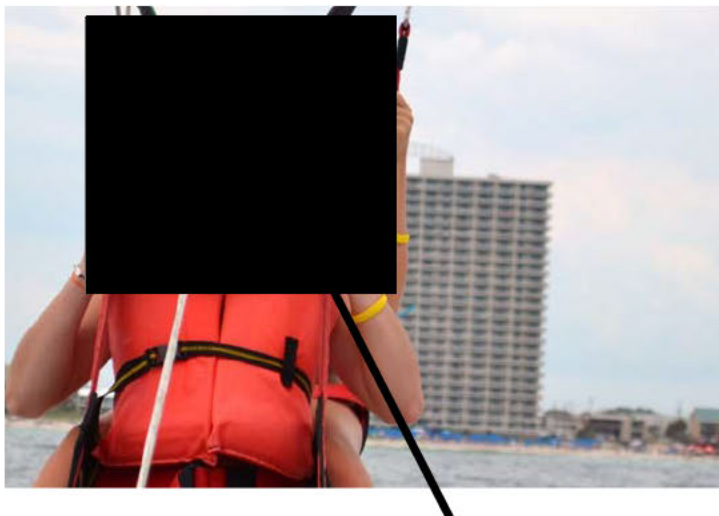
3. *Parasail Towline and Knot:* When [REDACTED] tied the rope to the parasail harness with a bowline knot (the standard knot used by parasail and mariners); there was a piece of black tape on the end of the rope, just above the bowline knot. When investigators examined the rope after the casualty, there was no tape on the end of the towline. The lack of tape on the end of the line indicated to investigators that the line parted under strain and caused the line to split into two separate pieces at the knot. The NTSB report discussed below confirmed this assessment.

Line end has black tape on it at the beginning of the parasail flight

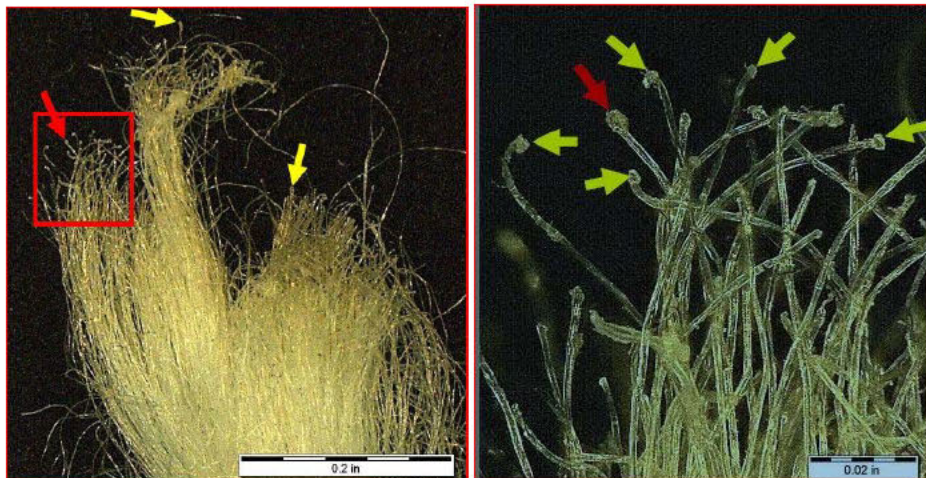
On 22 NOV 2013, Coast Guard investigators received NTSB report 13-064 providing their analysis of the end of the towline (section that parted). The NTSB visually examined the end of the parasail towline using low and high magnification levels, stating, “The test revealed raveling of the filaments adjacent to the tips and globules at the tips, consistent with a relatively high speed loading rate. Under such conditions, the loading of the filaments produces heat, which softens the filament and causes its fracture. The resulting snap-back from the release of stored energy causes the material to collapse to form the globules and the raveling.”

Low-level magnification of parted towline end    High-level magnification of parted towline end

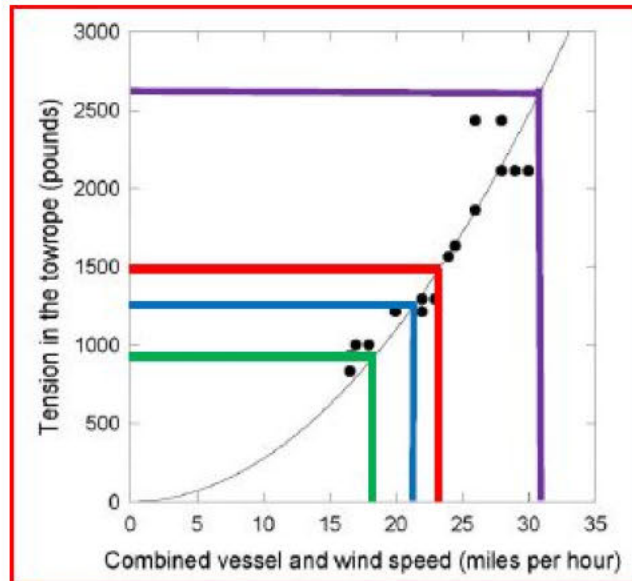
NTSB's report presented a graph depicting combined Bessel and wind speed to towrope tension. In refereeing to this graph, the report stated: "a tensile load of 2,642 pounds in the towline, represented by the purple line, would be consistent with a wind speed, or a combined vessel and wind speed, in the vicinity of 31 mps".

Graph from NTSB report 13-064 showing the combined wind speed/tension correlation

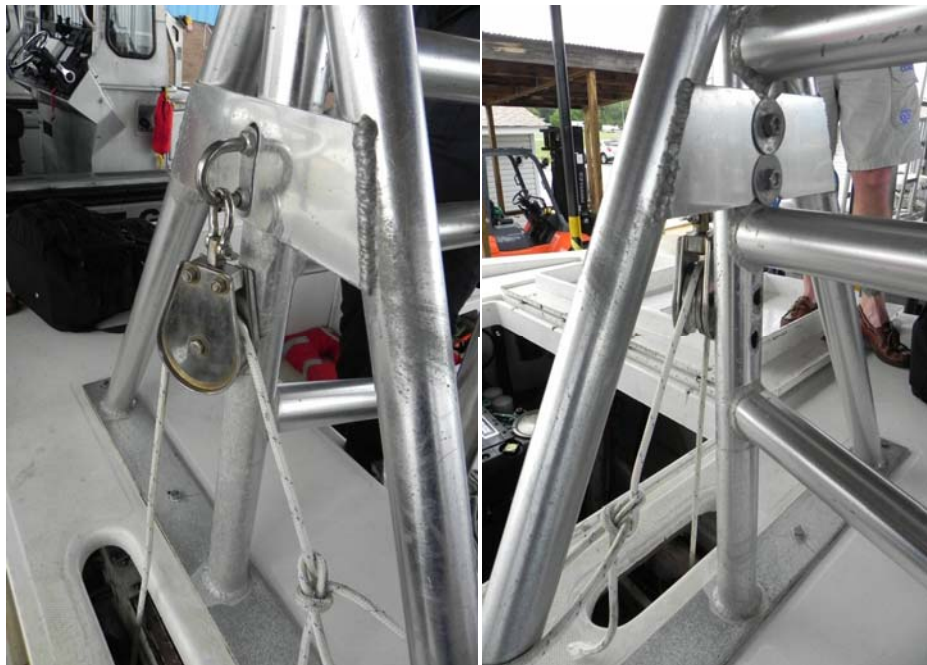
4. *Parasail A-Frame and other equipment.* The WHY KNOT uses an aluminum A-frame system to conduct its parasail operations. The A-frame consists of a pulley that connects the parasail towline from the parasail apparatus through a hole in the deck to the parasail towline drum and winch. When examining the WHY KNOT's A-frame, investigators discovered the pulley's u-bolt nuts were only hand tight and were within a few turns from falling off. The bolts were not fitted with a means to prevent them from backing off, in that they were not fitted with locking washers, a second nut, or of the aviation type nut that provide plastic anti-backing fittings. The investigators surmised that if this condition continued, the pulley would very likely dislodge itself from the A-frame. During their examination of other parasail vessels, they noticed similar findings, particularly in those of the same vessel type and manufacturer, late 1990's Premium parasail vessels.

WHY KNOT's A-Frame. Investigators found the pulley's u-bolt nuts only hand tight and only a few turns from falling off.

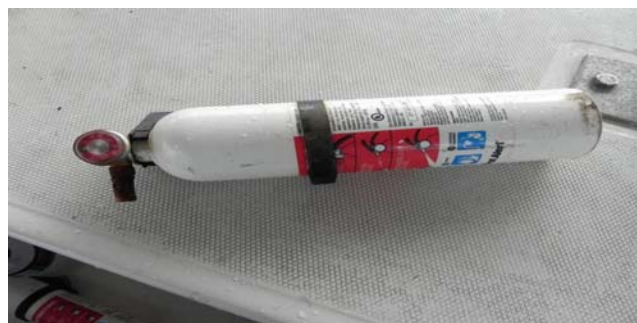
Investigators examined the WHY KNOT's onboard portable fire extinguisher. They found the extinguisher was in a non-serviceable condition as the handle used to discharge the extinguishing agent was broken and missing.

WHY KNOT's onboard portable fire extinguisher.  
Note the operational handle is broken off and missing.
