# UNITED STATES COAST GUARD

REPORT OF INVESTIGATION INTO THE  
CIRCUMSTANCES SURROUNDING

THE SINKING AND TOTAL LOSS OF  
THE ALASKA JURIS (O.N. 569276)

**SINKING AND TOTAL LOSS OF THE COMMERCIAL FISHING VESSEL  
ALASKA JURIS 45 NM NORTHEAST OF KISKA ISLAND, AK  
ON JULY 26, 2016**

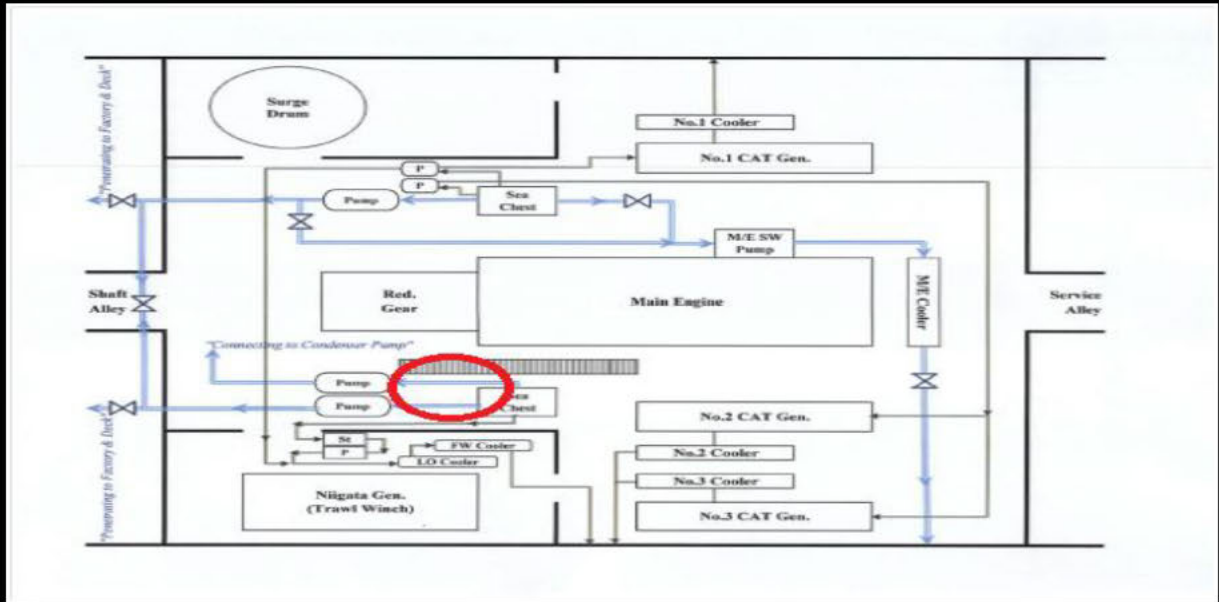
- 4.1.11 At approximately 11:00 am, a piece of piping or piping system component (strainer, valve, or fitting) just aft of starboard sea chest in the engine room failed, allowing seawater to enter the engine room bilge and begin flooding the space.
- 4.1.12 At approximately 11:10 am, Mr. [REDACTED] was conducting a round in the upper engine room (compressor space) and observed steam coming from an area around the main engine exhaust stack. Investigating the steam source in the lower engine room, he discovered approximately one foot of water above the deck plates in the aft section of the starboard engine room near the reduction gear. The deck plates in this area are approximately five feet above the bilge. He also witnessed a sheet of water approximately 4-5 feet wide shooting up from the deck plate level to the engine room overhead and at no time, did he hear any bilge alarms.

Figure 4. B. The above diagram was produced by the Fishing Company of Alaska and indicates the locations of equipment and systems in the ALASKA JURIS's engine room. The red circle indicates the general area where eyewitnesses saw water "billowing" or "boiling" from the engine room bilge.

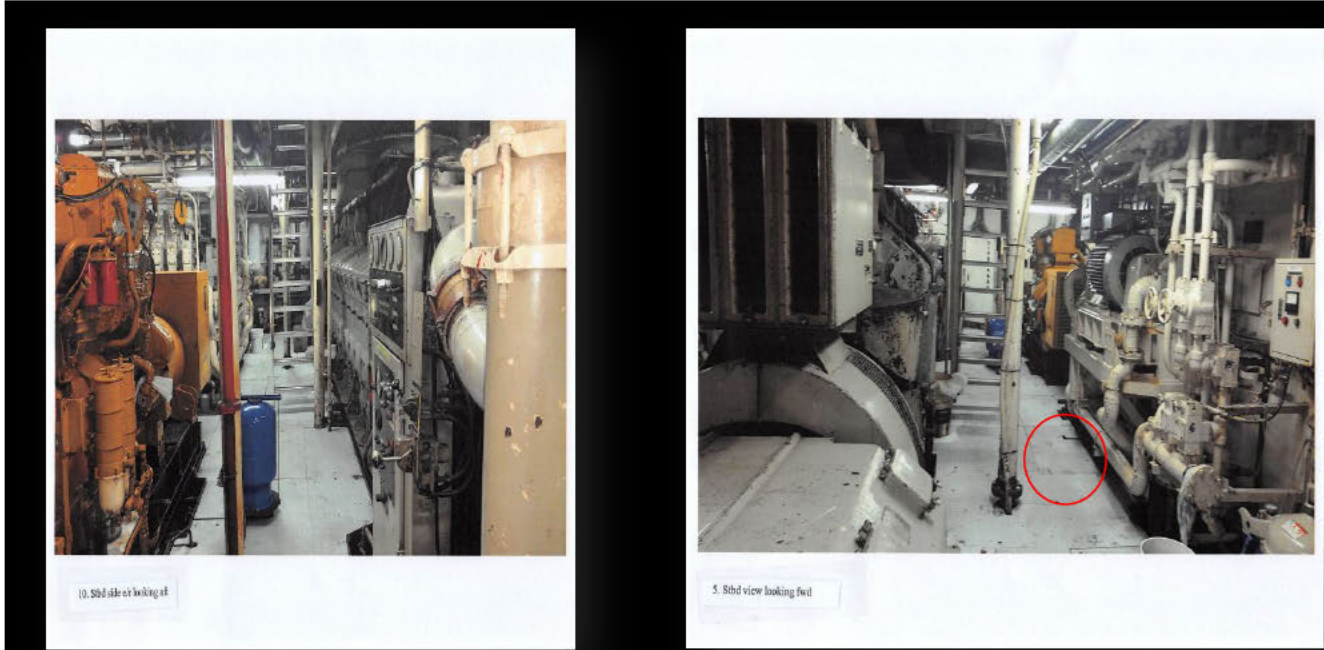
Figure 4. C. The above photos are of the lower engine room of the ALASKA JURIS. The photo on the left is of the starboard side looking aft. The photo on the right is the starboard side lower engine room looking forward. The red circle on the right photo indicates the approximate location where eyewitnesses testified they saw water billowing," or "boiling" from the engine room bilge.

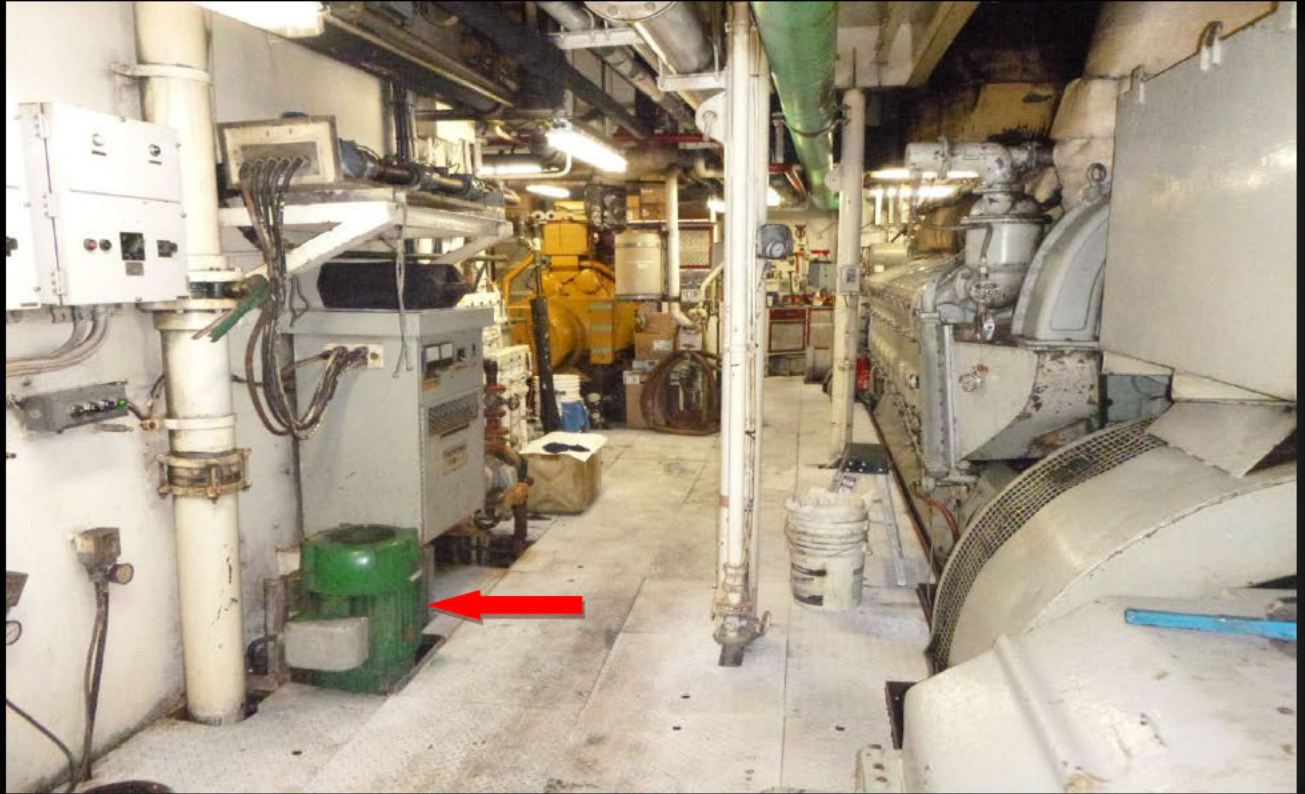
Figure 4.D. The above photo is of the lower engine room port side looking forward. The red arrow is indicating the salt water cooling pump to the main engine and generators.

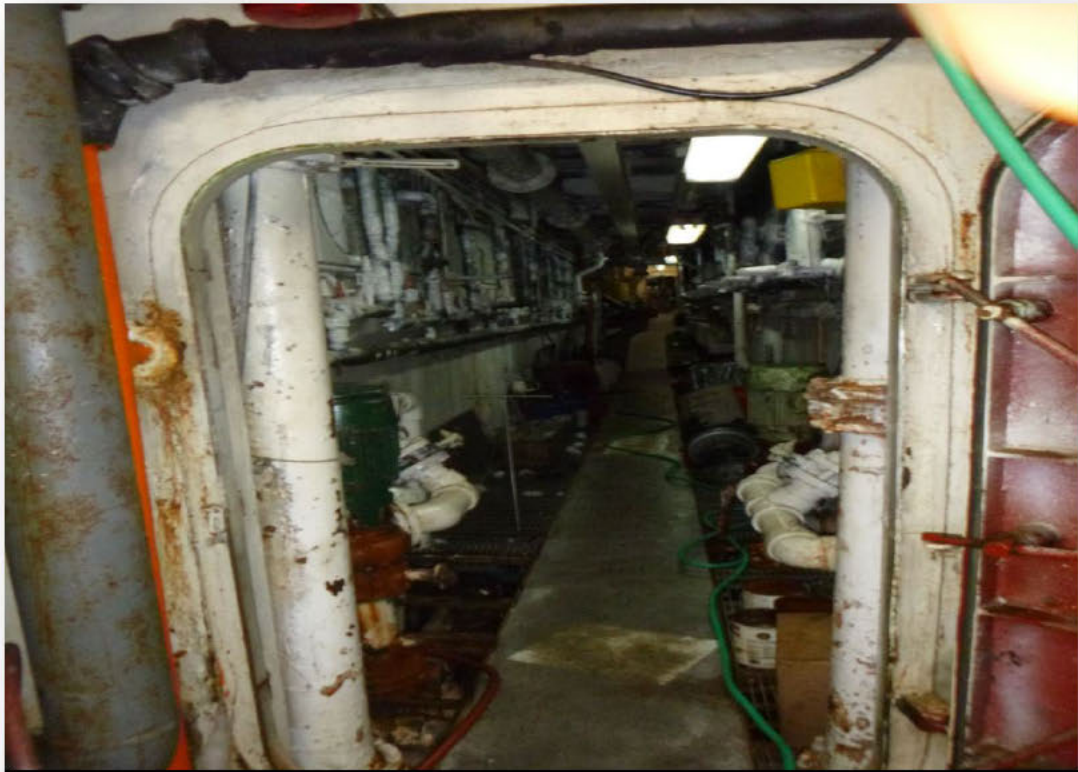
Figure 4.E. The above photo is of the watertight door access to the aft (shaft) alley from the lower engine room located amidships on the ALASKA JURIS. Photo taken on 10/15/2012.

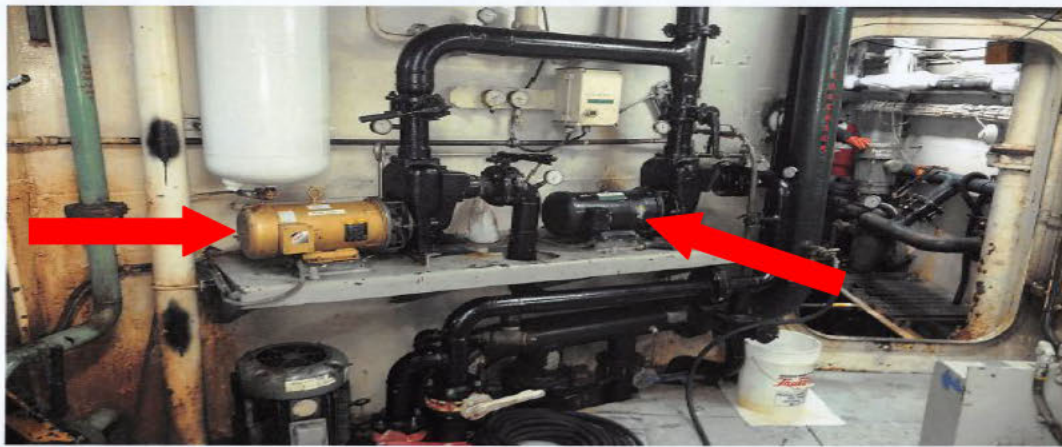
Figure 4.F. The above photo is of the two fixed bilge pumps located on the aft bulkhead of the lower engine room on the ALASKA JURIS. Date photo taken unknown.

- c. Recommendation #3 (7.1.3): Concur. I have directed my staff to collaborate with District 13 and ACSA stakeholders to amend the ACSA program guide and 840 book with a requirement to verify the operation of fixed bilge pump(s) to ensure they are capable of self priming and taking suction from the furthest spaces from where the pumps are installed. I recommend that Commandant, Office of Commercial Vessel Compliance (CG-CVC-3) consider a regulatory change to 46 CFR Part 28.255 to require inspection of fixed bilge pump(s) to ensure they are capable of self priming and taking suction from all spaces for all applicable commercial fishing industry vessels.

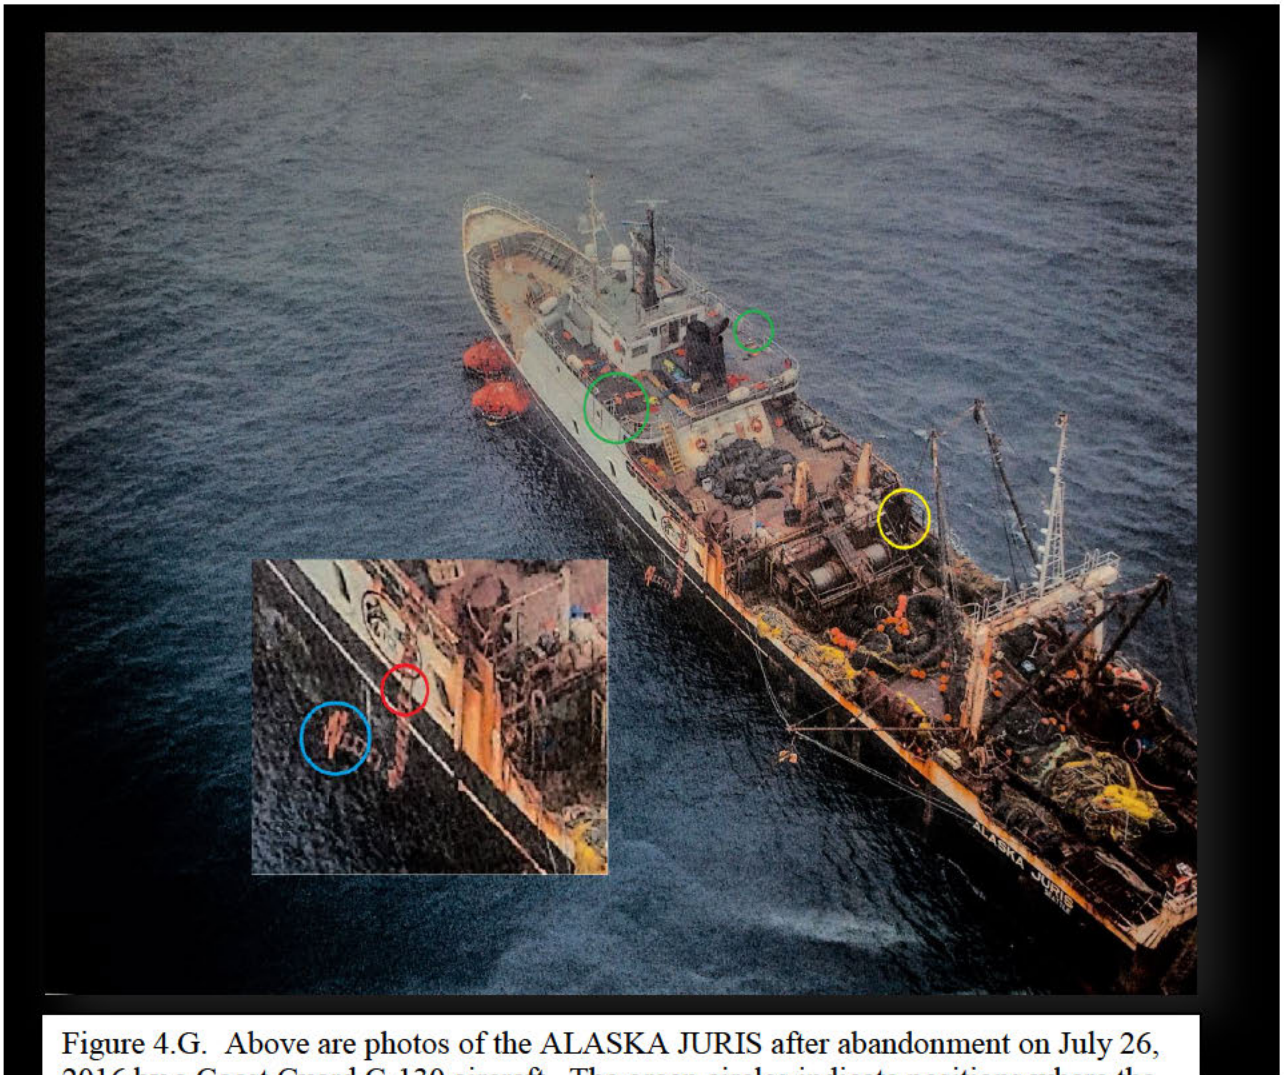
Figure 4.G. Above are photos of the ALASKA JURIS after abandonment on July 26, 2016 by a Coast Guard C-130 aircraft. The green circles indicate positions where the crew mustered and where life rafts were stowed and launched from. The yellow circle indicates the position of the Boatswain's locker where the dewatering pump and hoses were located. The red circle on the inset shows the missing rung on the port Jacob's ladder. The blue circle on the inset shows the Jacob's ladder's spreader bar floating in the water. Photo taken on July 26, 2016.

- 4.1.39 At approximately 11:50 am, the port Jacob's ladder was discovered to be missing a rung.
- 4.1.40 Beginning at approximately 12:00 pm, five crewmembers fell into the water while going down the Jacob's ladders. Two of those crewmembers fell from the port side ladder. On the starboard side, three fell including the first two crewmembers to use the ladder.
- 4.1.41 At approximately 12:10 pm, the crew, with the exception of Captain [REDACTED] and Chief [REDACTED] had entered the three life rafts. Several crewmembers, including the Japanese fish master and Japanese technicians, were not in the life rafts assigned to them. Chief [REDACTED] jumped into the water because of a

- d. Recommendation #4 (7.1.4): Concur. I have directed my staff to collaborate with District 13 and ACSA stakeholders to amend the ACSA program guide and 840 book with a requirement for lowering and inspecting each embarkation ladder at annual ACSA inspections.

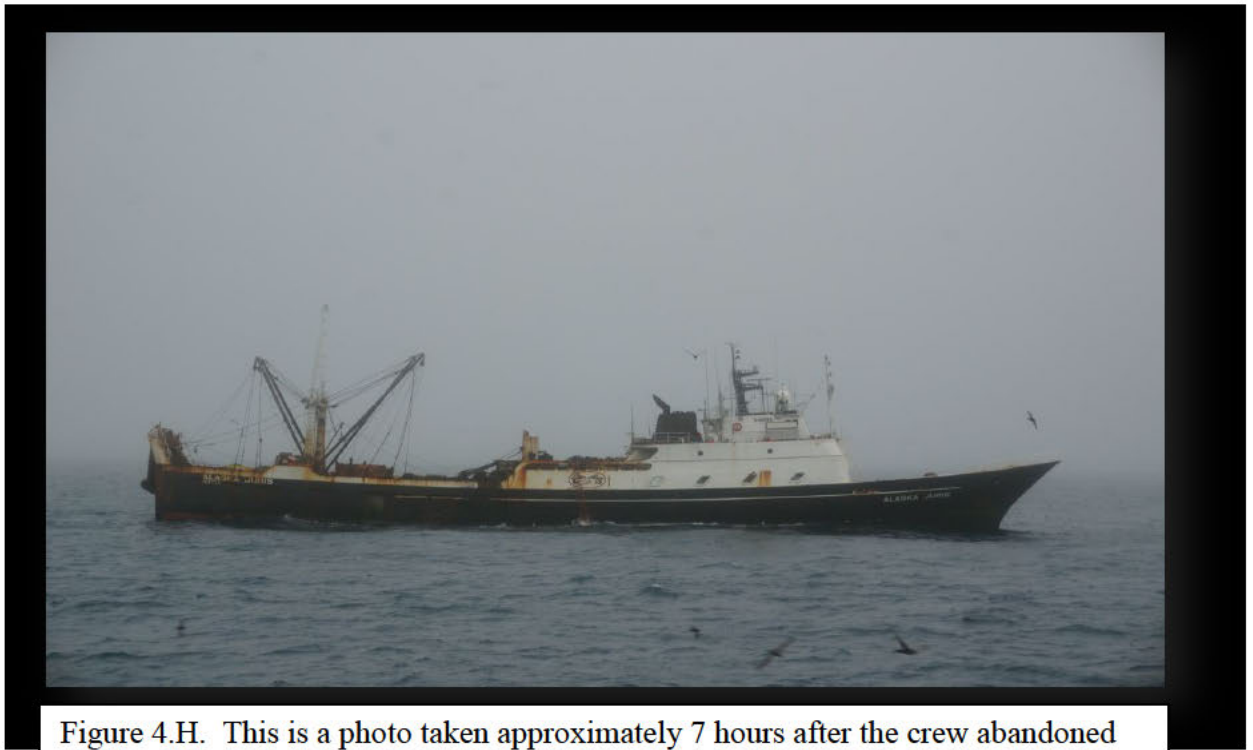
Figure 4.H. This is a photo taken approximately 7 hours after the crew abandoned ship on July 26, 2016

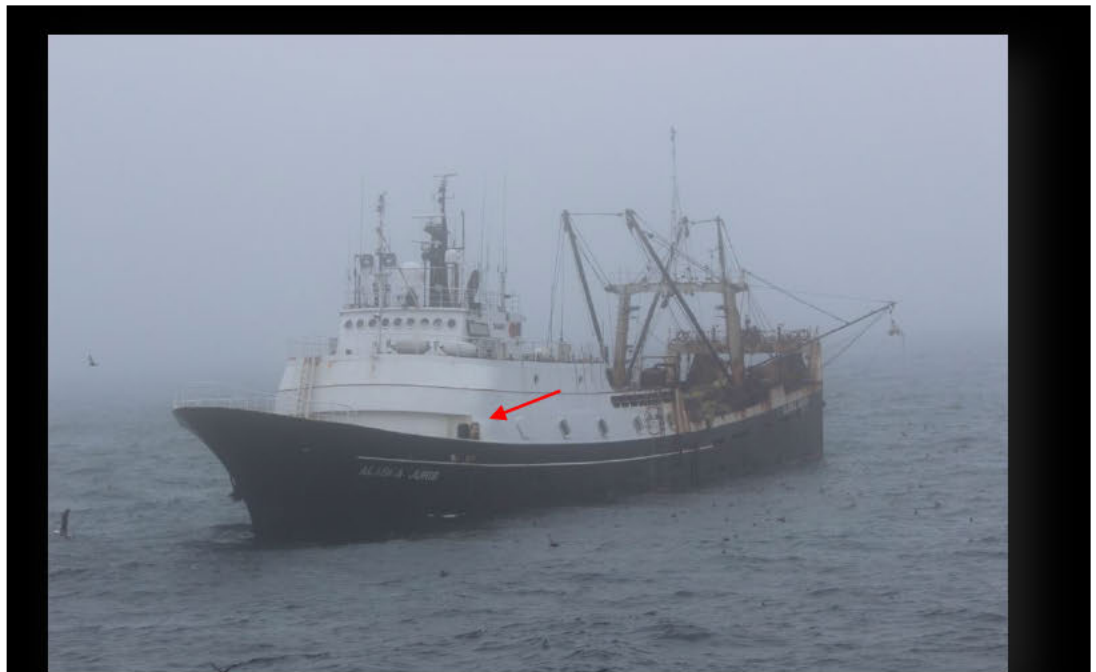
- 4.2.1.7 On 04/01/16, the two ventilation motors providing fixed supply and exhaust ventilation to crew and factory personnel staterooms were not in working order. For ventilation in these spaces crews and factory workers routinely left the watertight doors leading to the main deck and factory space open. These doors were required to be closed while underway in accordance with the ACSA and placards installed on each door.

Figure 4.L. Photo of the ALASKA JURIS with has a red arrow pointing to a watertight door that was routinely left open by crew to provide ventilation to the living quarters in the house. Photo was taken from the SEAFISHER approximately 7 hours after the abandonment on July 26, 2016.

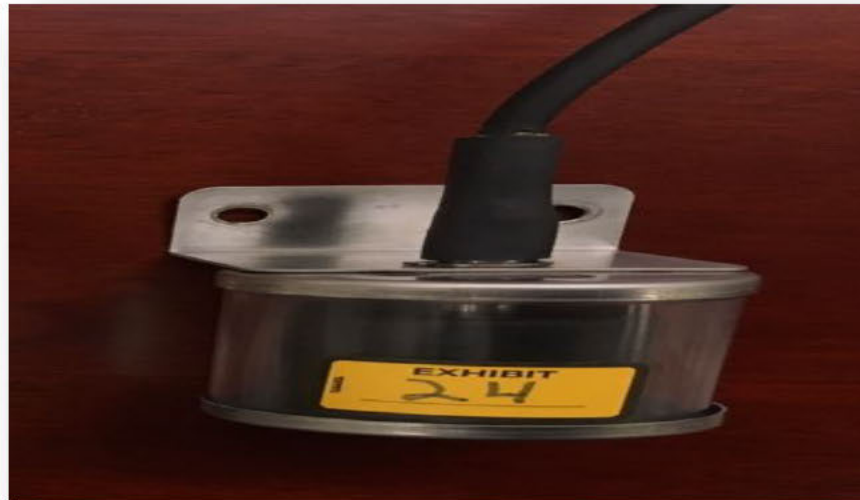
- 4.2.1.9 On 04/01/16, bilge alarm float switches were present in the aft steering space, the aft alley space, two locations in the engine room (aft bilge well and forward bilge near the forward bulkheads), the forward alley space between #2 and #3 port and starboard fish holds, and the bow thruster room. These devices were not tested on a routine basis.

Figure 4.M. Photo of the type of high bilge alarm float switches installed on the ALASKA JURIS.

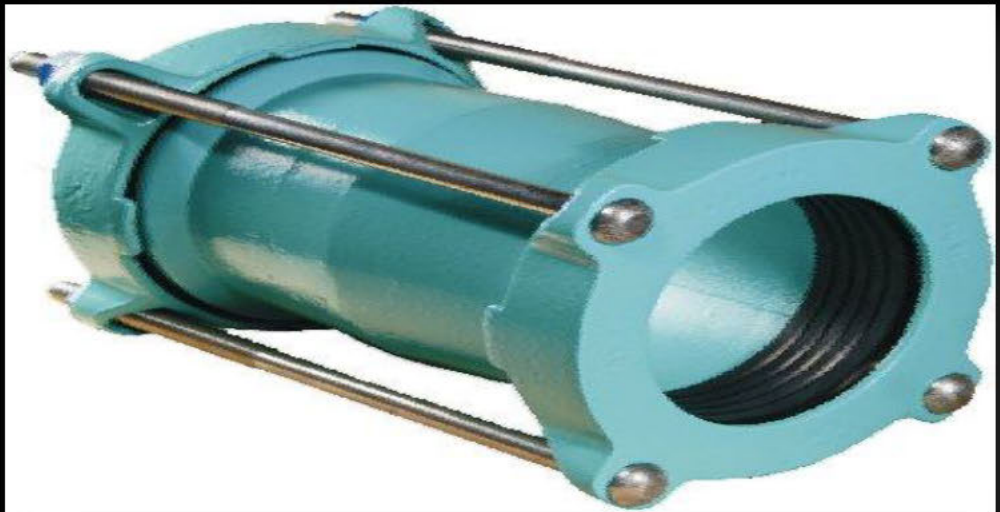
- 4.2.3.6 On 02/23/14, a deficiency check was conducted in Dutch Harbor to clear outstanding deficiencies from the 01/08/14 inspection. One new deficiency was issued to address “several mechanical couplings” found during the inspection of the bilge system.

Figure 4.O. This is an example of what a mechanical coupling on the ALASKA JURIS looked like. Note: Mechanical couplings are used to join pieces of pipe in lieu of welding or bolting flanged joints. Once installed on a pipe, the bolts on the mechanical coupling are tightened and the gasket material on either end of the coupling is compressed onto the pipe to create a seal. They are sometimes used in lieu of repairing wasted pipe or to join misaligned pipe.

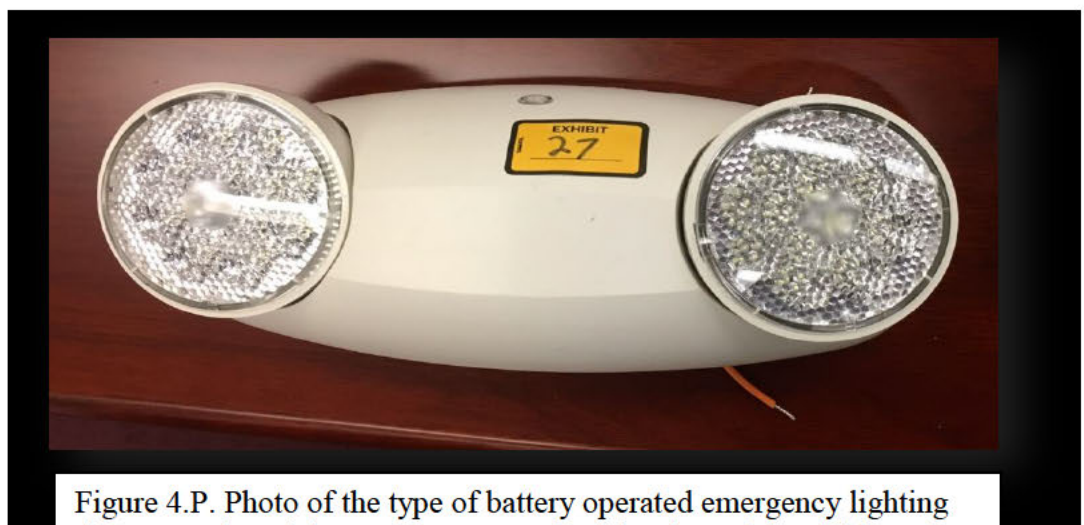
- 4.2.5.5 On 07/25/16, the ALASKA JURIS had battery operated emergency lighting fixtures installed in various locations below decks near exits. The devices would automatically activate when the vessel lost power.
- 4.2.5.6 On 07/25/16, the two electric powered self-priming bilge pumps on the ALASKA JURIS were not operating as designed and needed to be primed manually to gain suction which could take up to five minutes to complete.
- 4.2.5.7 On 07/25/16, Fishing Company of Alaska had no written policies or procedures for the testing and logging of bilge alarms.

- f. Recommendation #6 (7.1.6): Concur. Emergency lighting, although not required in regulation, is currently installed aboard all ACSA vessels. I have directed my staff to collaborate with District 13 and ACSA stakeholders to amend the ACSA program guide and 840 book to establish standards for emergency lighting requirements for egress and adequate reserve power capability no later than the next scheduled ACSA dry dock inspection.

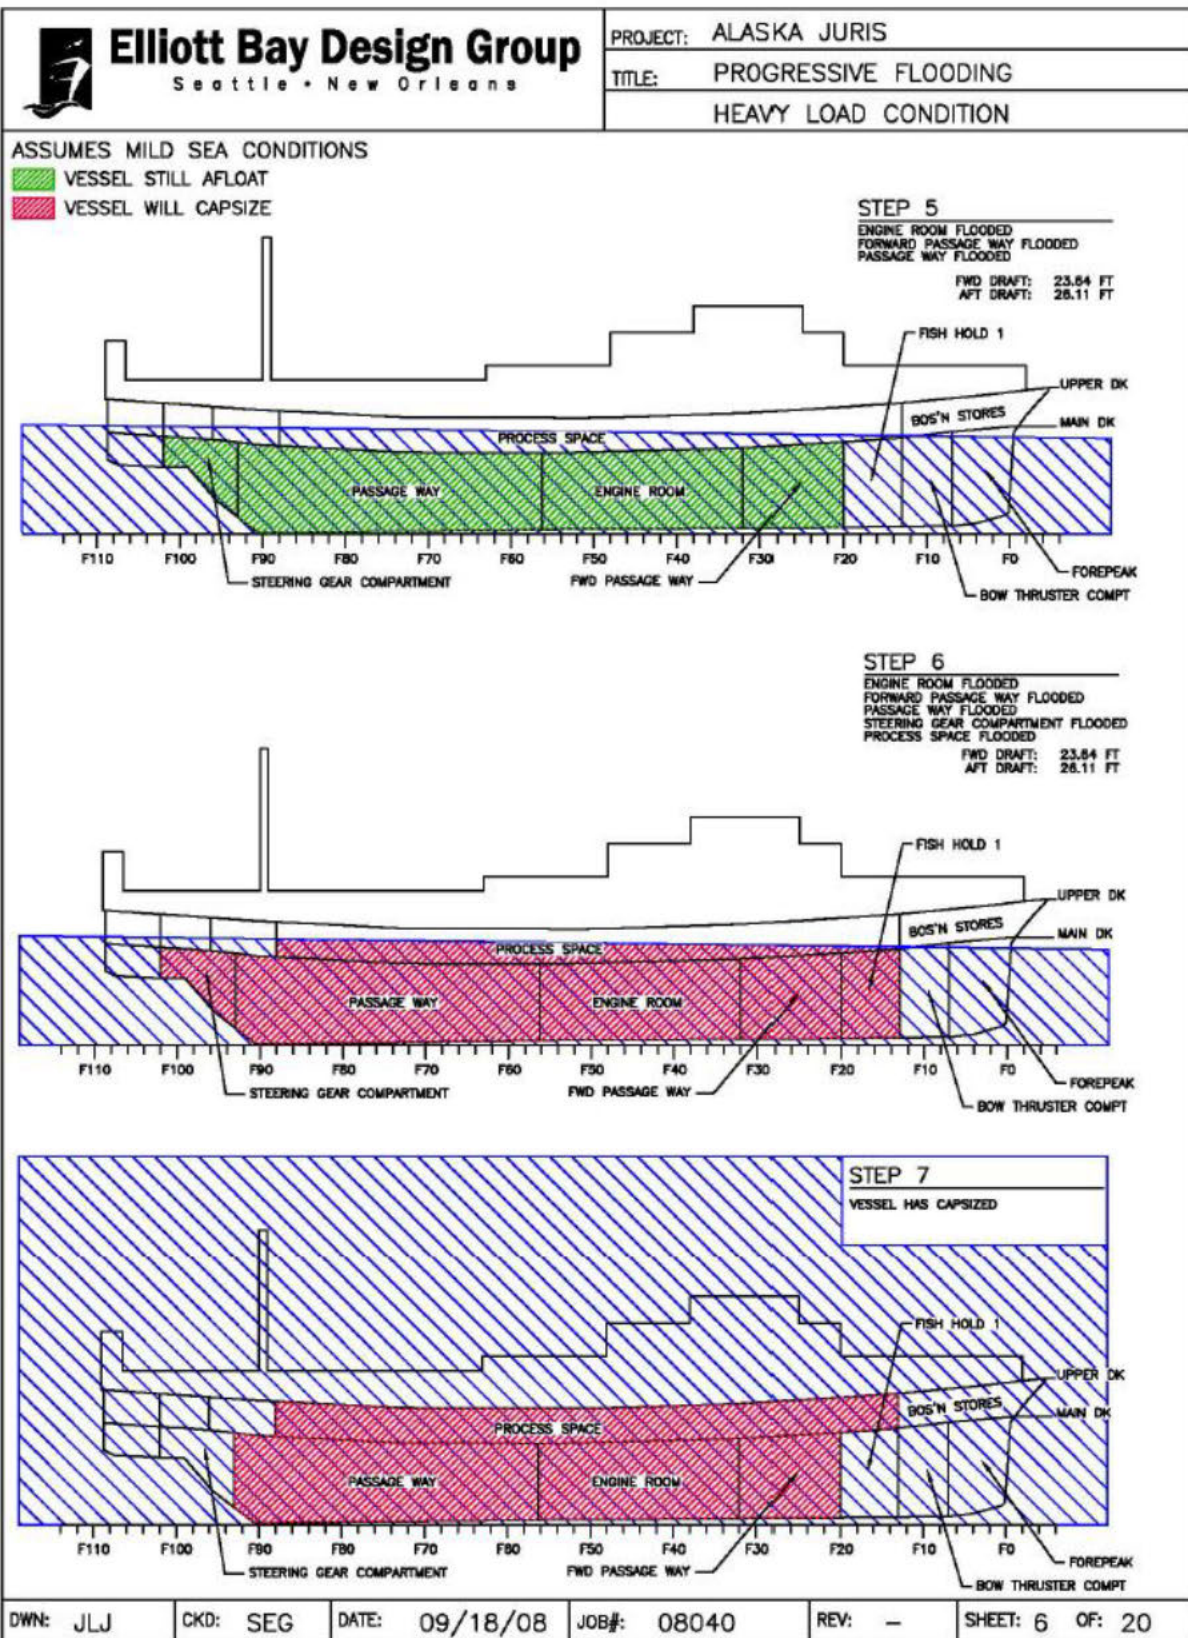
- 5.10.4 **Progressive flooding analysis booklet availability:** After the ALASKA RANGER sinking in 2008, Fishing Company of Alaska commissioned the Elliot Bay Design Group to develop damage trim stability calculations booklets on its remaining vessels, including the ALASKA JURIS. The booklet was called “Progressive Flooding Analysis for the ALASKA JURIS.” This booklet provided easy to understand color coded (red and green) graphics identifying numerous conditions and the resulting impact (remain afloat or capsize) depending on which tanks were compromised or flooded. Captain [REDACTED] testified that he was aware of the book but had never used it. During the hearing, Captain [REDACTED] and Mate [REDACTED] were shown the booklet and both stated that this information would have been very helpful on the day of the sinking.

Figure 5.A. Example of a page from the ALASKA JURIS's Progressive Flooding booklet produced by the Elliot Bay Design Group for the Fishing Company of Alaska.
