United States Coast Guard

Report of Investigation into the Circumstances Surrounding the CARIBBEAN FANTASY Fire, 2 Miles Northwest of San Juan, Puerto Rico; Subsequent Grounding and Evacuation of 511 Persons with 7 Minor Injuries on AUGUST 17, 2016

MISLE Activity Number: 5977513

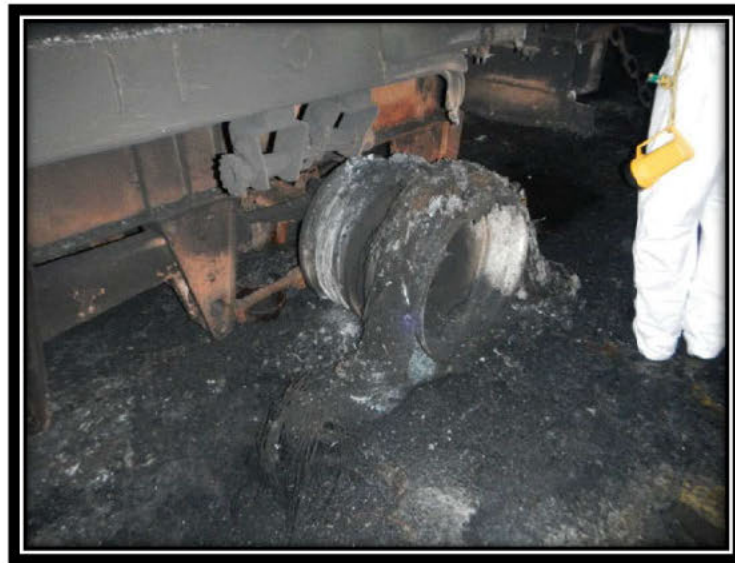
4.1.18. At 0749, the Safety Officer reports an explosion in Garage B. The investigation later confirmed that the sounds of explosion were the tires from the container trailers directly over the engine room busting and igniting. The Master requested the Drencher for Garage B, the Chief Engineer confirmed the Drencher was already running.

Figure 4; Post Casualty photo of container trailer wheels in Garage B directly over engine room (Secondary fire and source of explosions heard and reported by crew)

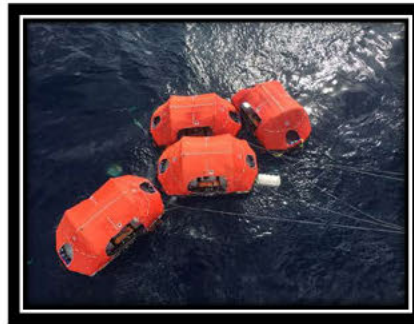
4.1.25. At 0803, Master requested Coast Guard to help gathering rafts and bring them to the port side MES platform. The Staff Captain reported smoke on the port side that was blowing onto the port MES, and the slide angle was too steep, near vertical, for people to slide down. The Coast Guard rescue boat also recommended the CARIBBEAN FANTASY use the starboard MES.

Figure 5; Photo of empty inflated liferafts not at the end of MES slide during the evacuation.

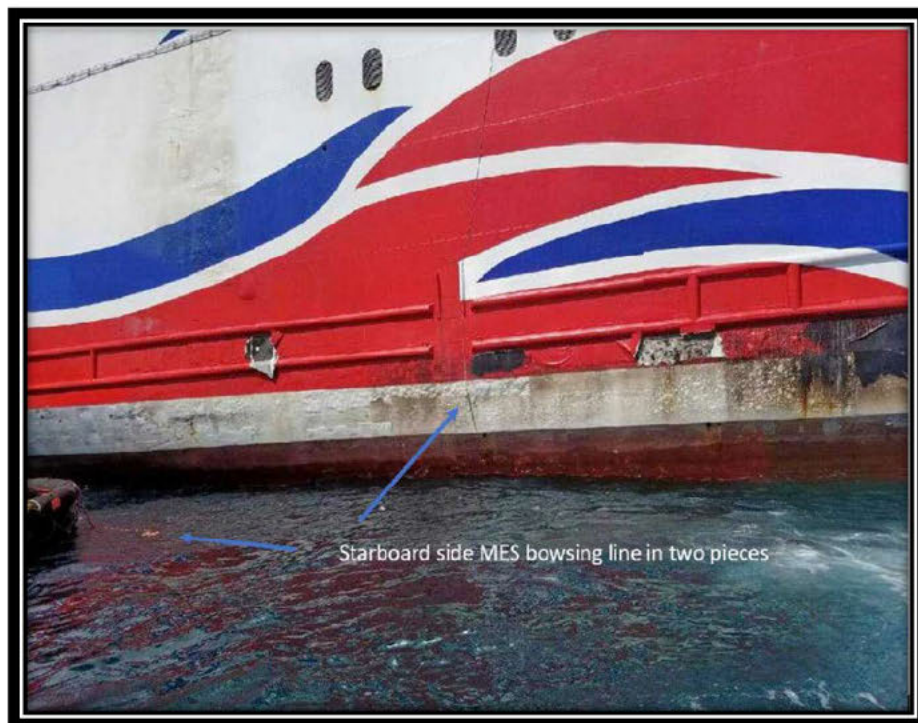
- 4.1.31. At 0810, the vessel again sounded one long blast on ship's whistle, the vessel's signal for abandon ship.
- 4.1.32. At 0812, The Deck Cadet ordered starboard MES crew to release starboard liferafts.
- 4.1.33. At 0814, the Chief Engineer arrived on the bridge and briefed the master that everything in the engine room was secured, but could not verify that the fire was out.
- 4.1.34. At 0815, the Master ordered the crew to prepare Lifeboat #3 and sent the Third Officer to command the Lifeboat because the Second Officer was staying on the bridge for command and control.
- 4.1.35. At 0817, there was a power interruption as the ship transitioned from electrical generators to the emergency diesel generator.
- 4.1.36. At 0818, the Staff Captain reported that starboard MES bowing line was broken and that the port MES was not able to be used.

Figure 6; Post Casualty photo of Marine Evacuation System bowing line in two pieces.

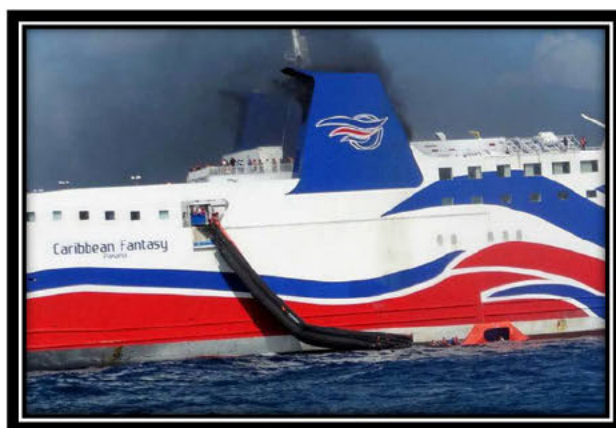
4.1.46. At 0847, the Master ordered Lifeboat #3 to launch, and again requested to send crew down the MES slide. The Staff Captain responded that he would send people down but it was not safe because of the steep angle.

Figure 8; Photo of the STBD Marine Evacuation System orientation during the evacuation.

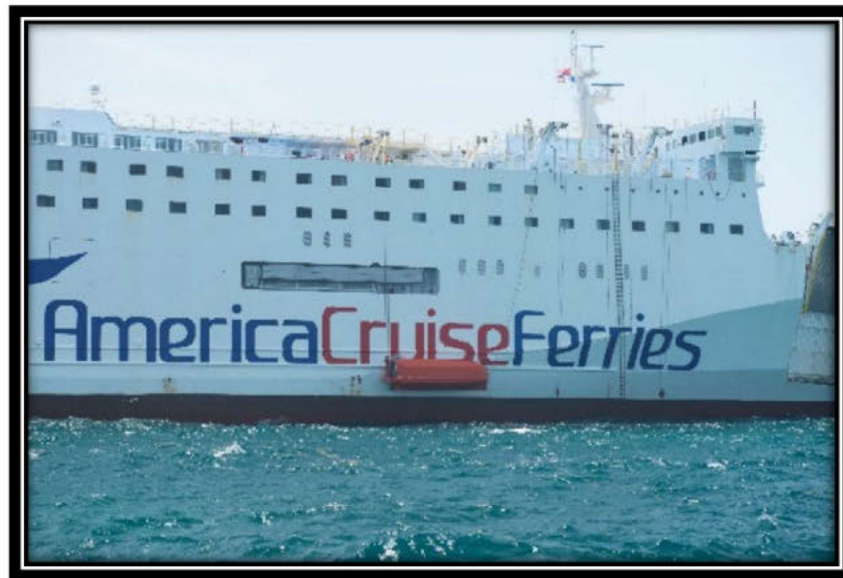
Figure 9; Post Casualty photo of Lifeboat 3 hanging above water.

4.1.55. At 0916, After failing to release the hooks on Lifeboat #3 for 29 minutes the CARIBBEAN FANTASY attempted to hoist the lifeboat back up, the winch tripped, leaving Lifeboat #3 suspended 10 feet above the water, with approximately 100 passengers inside. The CARIBBEAN FANTASY requested assistance to remove the passengers and crew suspended in Lifeboat #3.

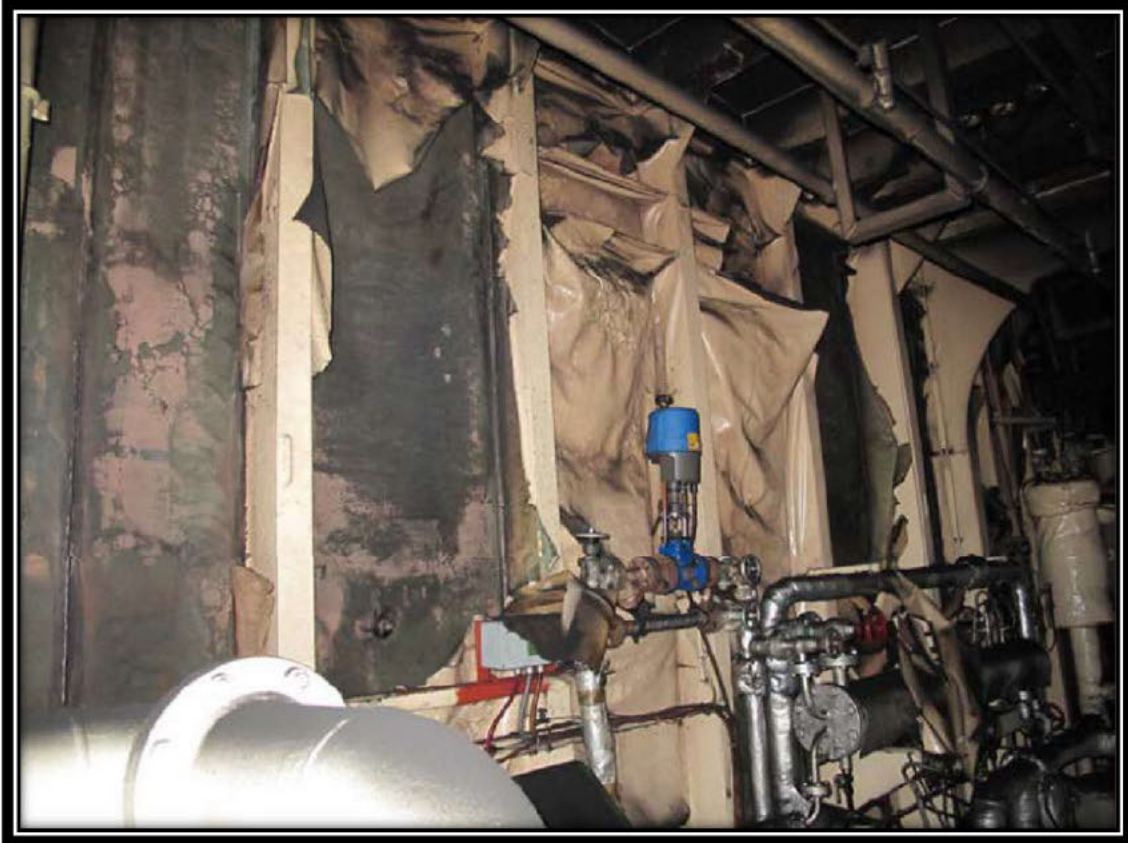
4.2.2. The CARIBBEAN FANTASY was divided into five main vertical zones (MVZs) that provided both watertight integrity and thermal/fire containment. The ship also had two main horizontal zones (MHZs) subdividing the garage decks with A-60 boundaries.

Figure 13; Post casualty Photo of bulkhead between main engine room & auxiliary engine room (auxiliary engine room side)

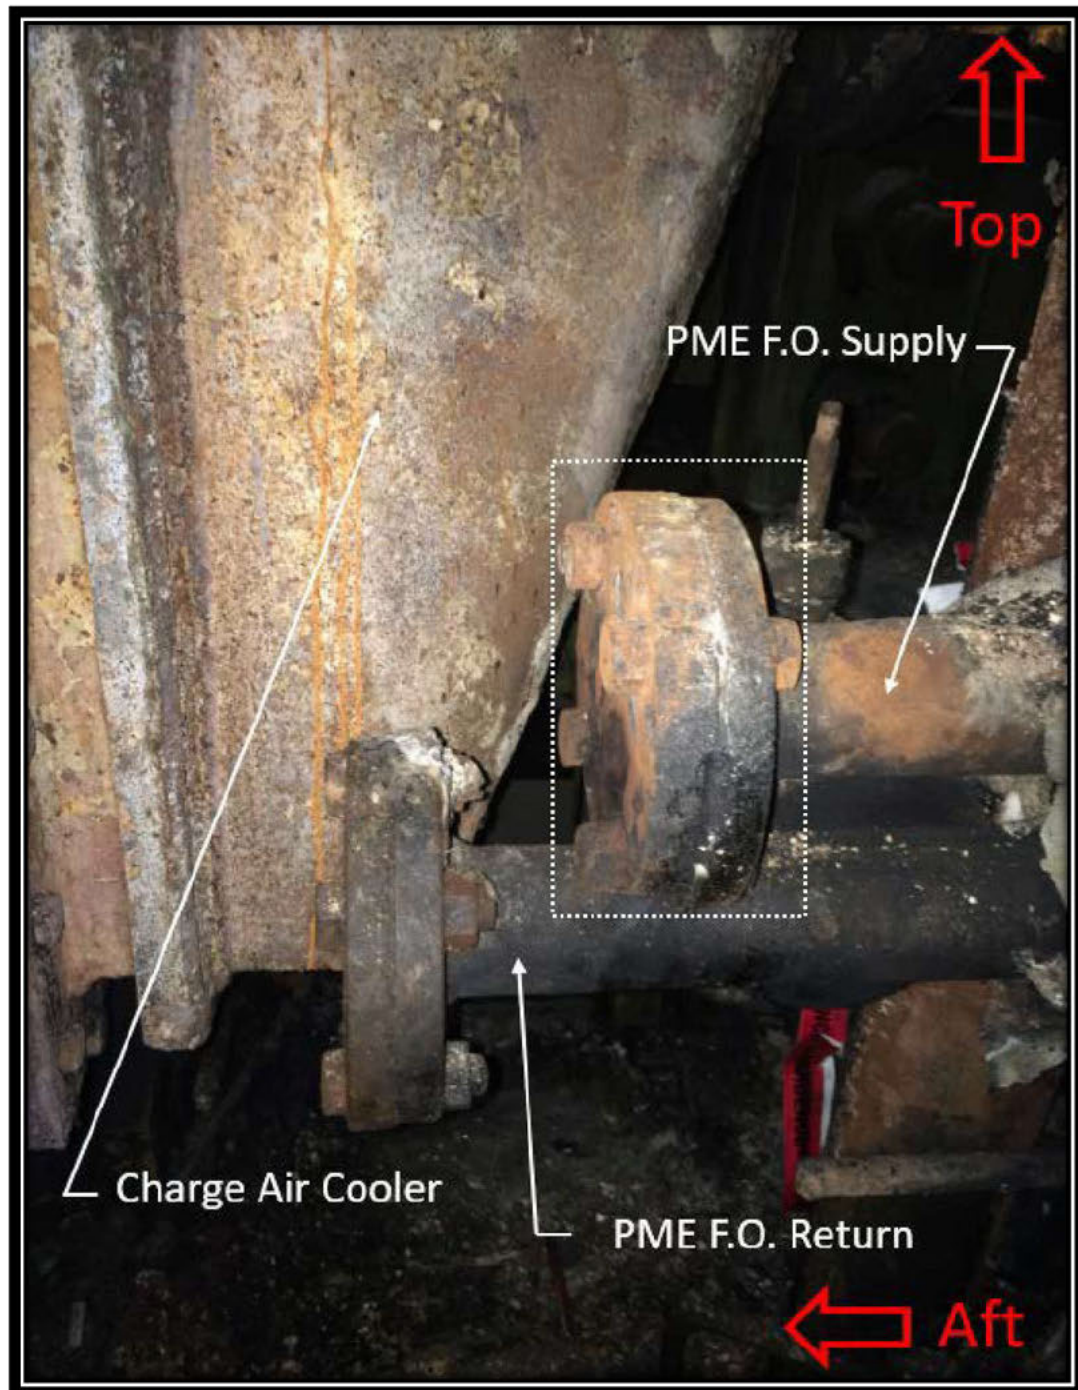
4.2.3. The port engine fuel supply line blanking plate was found to be fabricated from a piece of steel previously used in a different application. It appeared to be torch cut and not a symmetrical circle. It contained 12 holes, however, only 4 holes were used to secure the blank end to the flange.

Figure 14; Photo post casualty of Port Main Engine Fuel Oil Supply blank end (source of fuel leak).

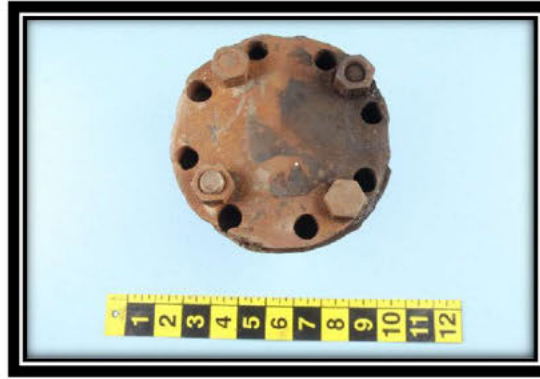
Figure 15; Post Casualty photo of Fuel supply line blank end examined in NTSB materials lab. (blank end view)

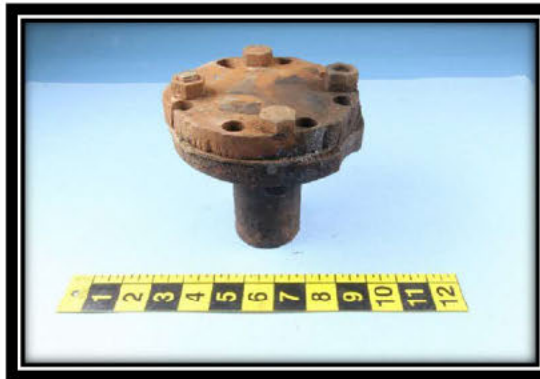
Figure 16; Post Casualty photo of Fuel supply line flange and blank end in NTSB materials lab. (profile)

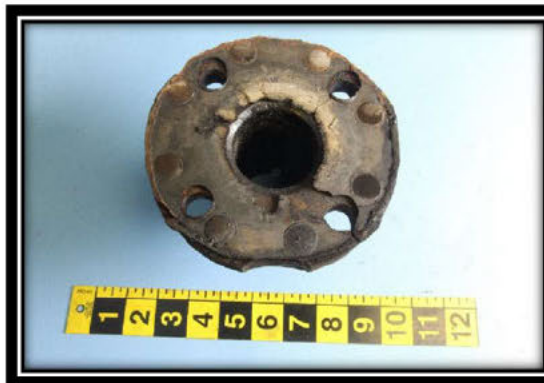
4.2.4. The port engine fuel supply line gasket used at the site of the fuel leak was tested by the NTSB materials laboratory and found to be silicone rubber. Silicone rubber is considered an unsuitable gasket material for use in fuel systems because exposure to fuel degrades the silicone rubber. The engine manufacture recommended that the gasket material be nitrile rubber filled with aramid yarn, mineral wool, and other inorganic fillers.

Figure 17; Post Casualty photo of Fuel supply line gasket in NTSB materials lab. (Between flange & blank end)

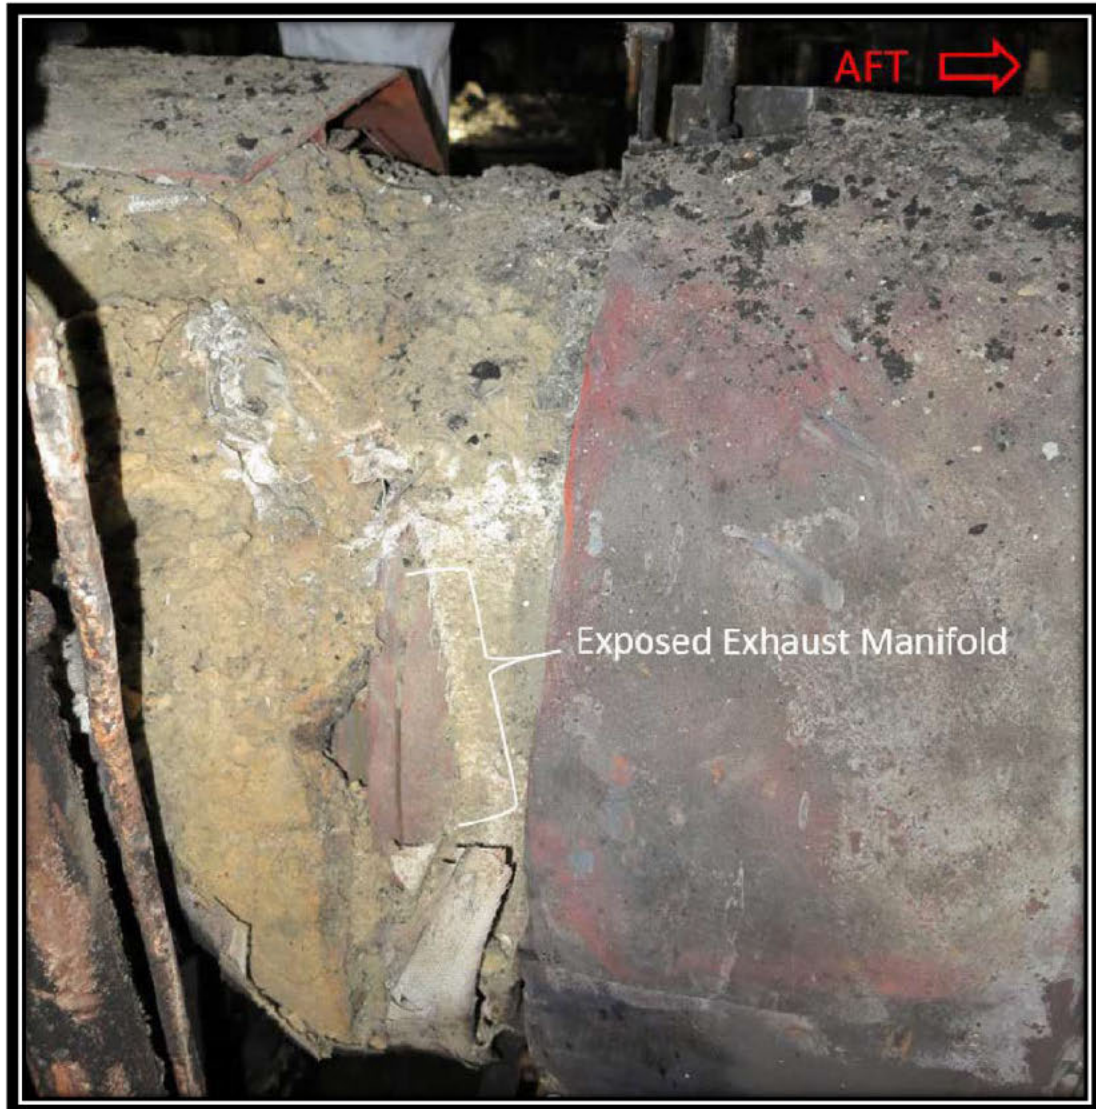
4.2.5. During the post-casualty inspection of the engine room, investigators discovered several areas of inadequate installation of anti-splash/anti spray tape on the Port and Starboard Main Engine fuel oil piping flanges and connections per the manufactures recommendations. Only one layer of tape was fitted around the fuel oil flanges and connections. Several areas had exhaust pipe insulation that was degraded, exposing the hot exhaust pipe manifold. During normal operation the exhaust pipe manifold is between 750-850 degrees F. The fuel oil at the time of the casualty had an ignition temperature of 495 degrees F.

Figure 18; Post Casualty photo of STRB Main Engine with damaged thermal protection.

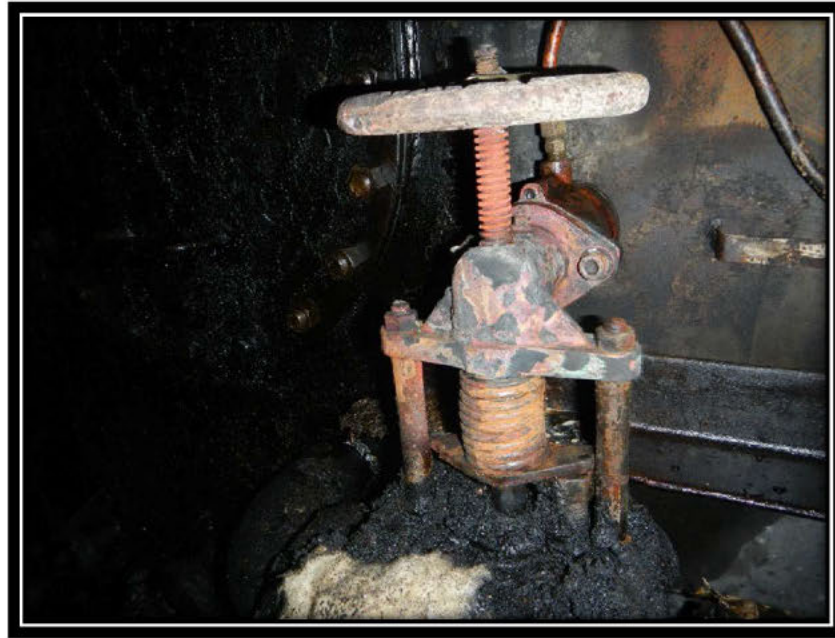
4.2.9. After the accident, investigators found all eight fuel and lube oil quick closing valves were intentionally blocked open with inserted bolts. It was impossible to isolate

the fuel oil and lube oil supply to the main engine room via remote activation. The port lube oil supply valve was tested by removing the bolt holding the valve open and the valve closed properly.

Figure 19; Post Casualty photo of Lube Oil Storage tank quick cut-off valve blocked open with bolt

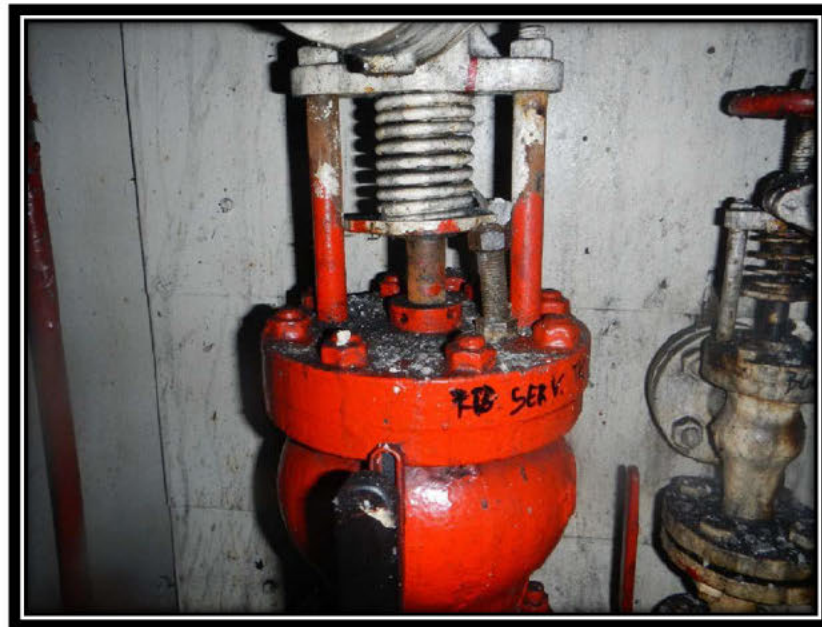
Figure 20; Post Casualty photo of Fuel Oil Service tank blocked open with bolt.

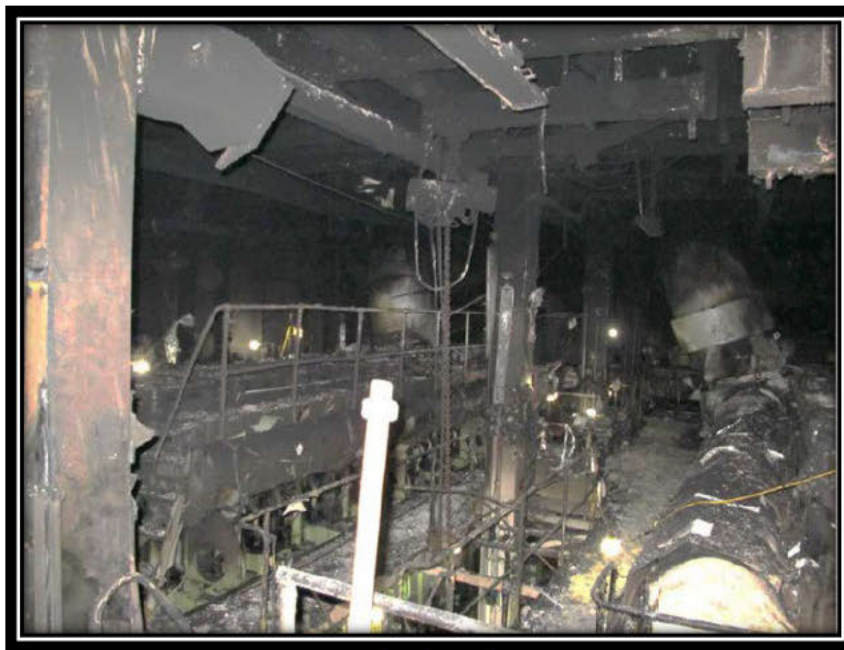
6.1.3.1. A causal factor for the fire spreading to Garage B was the continuous supply of uncontrolled fire in the space below, the intense heat, and amount of time the fire remained out of control. This causal factor was determined post casualty by investigators finding the insulating material between the main engine space and Garage B deck fully consumed. In addition, investigators found combustible cargo fully and partially consumed in Garage B directly over the main engine space.

Figure 22; Post Casualty photo of main engine room upper.
