REPORT OF INVESTIGATION
INTO THE
COMMERCIAL FISHING VESSEL (CFV)
COASTAL REIGN
Capsizing & Loss of Life

20 February 2021 16:37:00 PST

MISLE Activity Number: 7145693
MISLE Case Number: 1250976

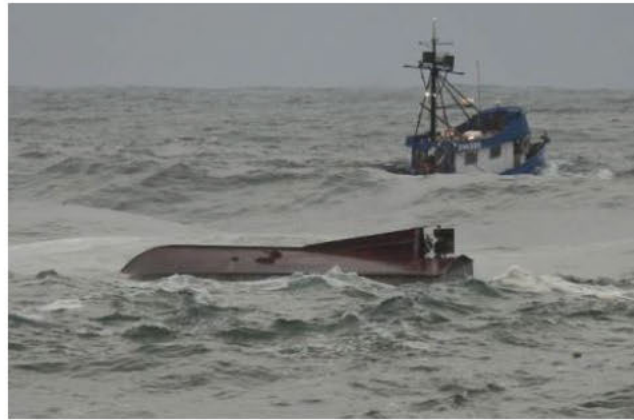
4.3.2 Post casualty photos of the hull revealed no visible defect or holes to indicate a grounding. The rudder of the vessel was standard, though small, and unable to effect quick turns in rougher water.

Photo of the COASTAL REIGN capsized at the end of the submerged South Jetty. 20 Feb 2021

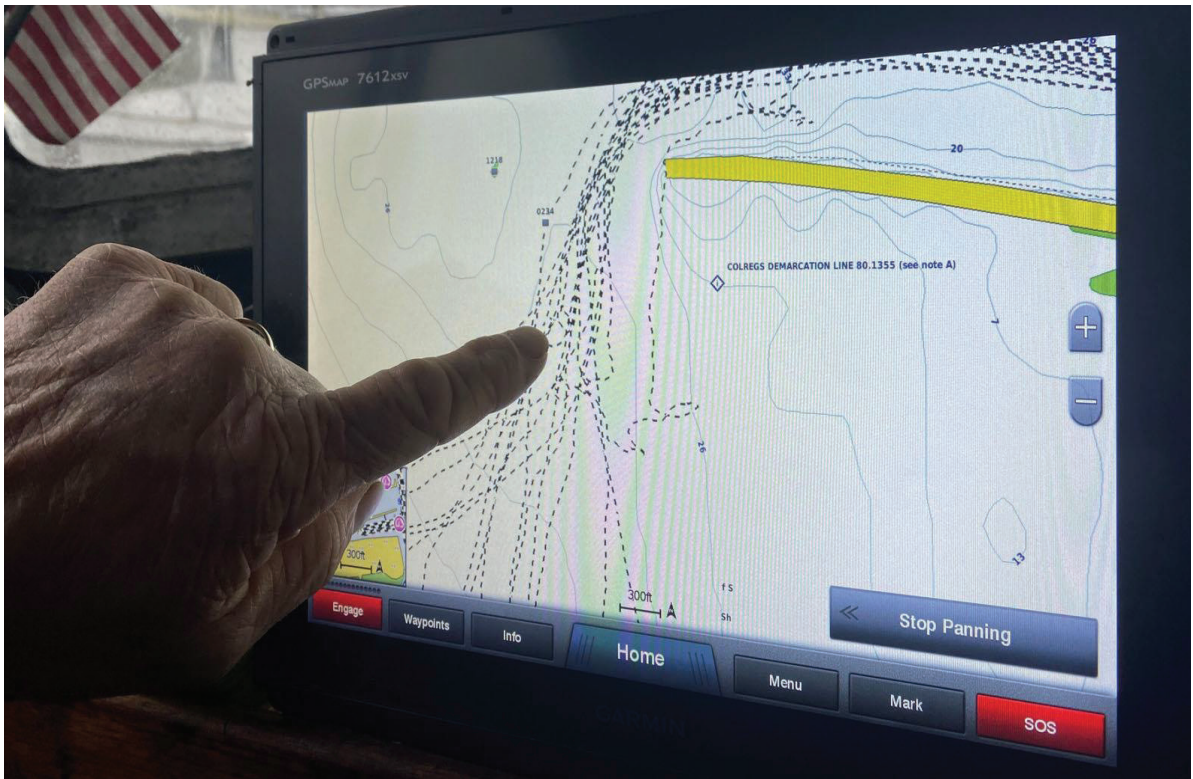
Photo of the CFV LADY LEE track lines through the South Hole. Note: chart shows full extent of the south jetty to the 'as built' length. The submerged area of the jetty colored solid as if fully configured. The electronic chart with the full length of the jetty highlighted would ensure that vessels maintain a safe distance from the submerged portion of the structure. Here, [REDACTED] is pointing to the exact location where the CFV LADY LEE set up for its approach.

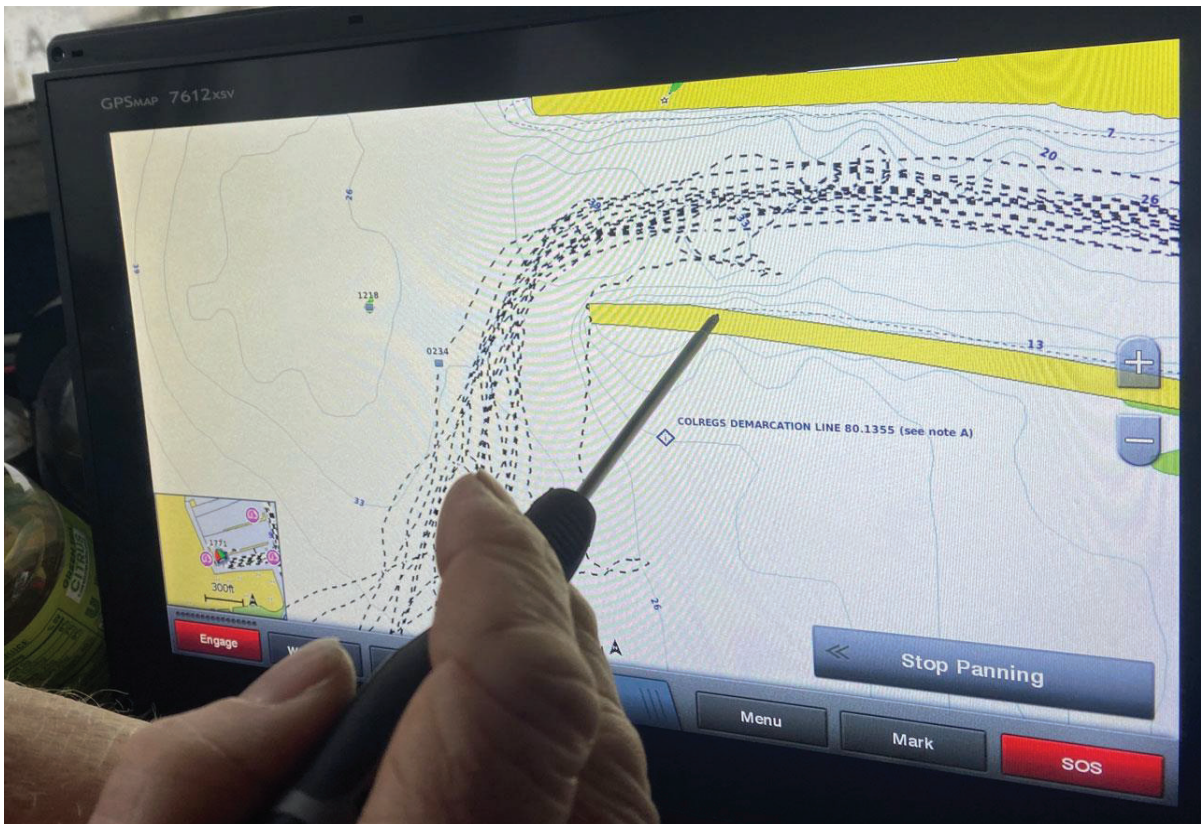
The approximate end of the submerged jetty, showing that the electronic chart portrays an image of the as-built jetty.

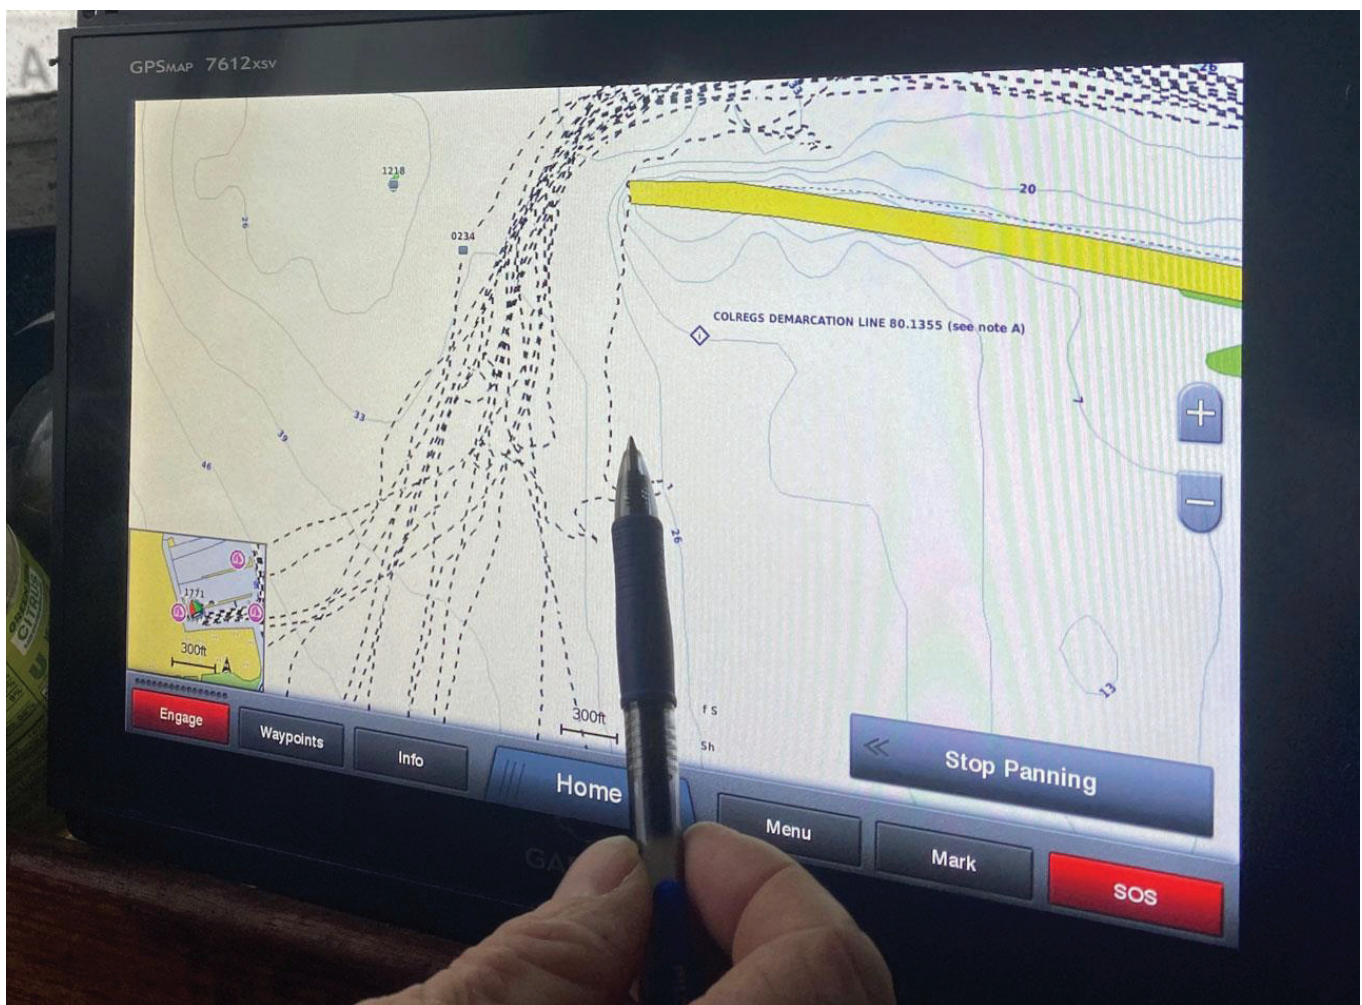
4.4.1.7 Despite its poor starting point to the south of the jetty, the CFV COASTAL REIGN appeared to have chosen a good wave set in which to cross. However, unpredictable waves 'jump up' at the submerged jetty because it is so shallow. He was unable to contact the CFV COASTAL REIGN via radio to make them aware of their position as he did not have a radio on the flying bridge. However, he could hear his radio below and the CFV PETRA MARIE stating to the CFV COASTAL REIGN that, "You're in too far! You're in too far! Turn out, turn out, turn out!"

Owner/operator of CFV LADY LEE pointing to the location where the CFV COASTAL REIGN was set up prior to beginning its approach from the south, approximately 600 feet east of the CFV LADY LEE's starting position.

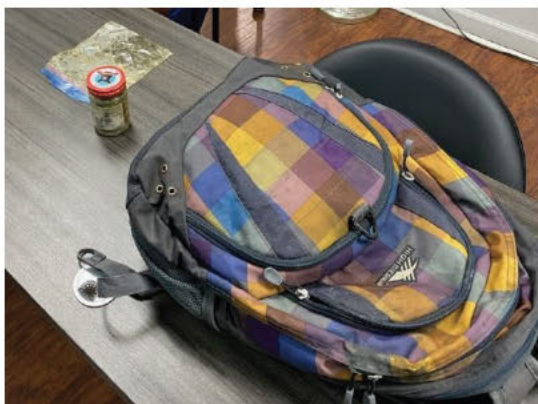
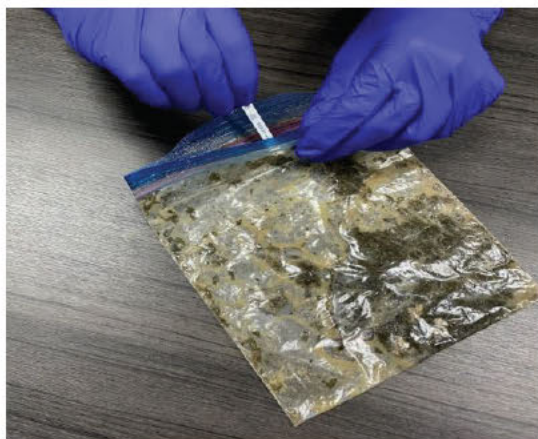
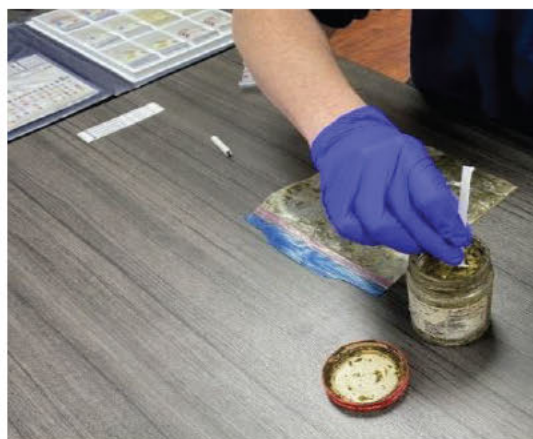
Left: Backpack found on the beach with the CFV COASTAL REIGN wreckage. Confirmed to be Mr. Zach Zappone's property. Note: plastic bag and glass jar containing green leafy organic material.

Below left and below right: Station personnel retrieve a sample from the plastic bag and glass jar described by Mr. [REDACTED]

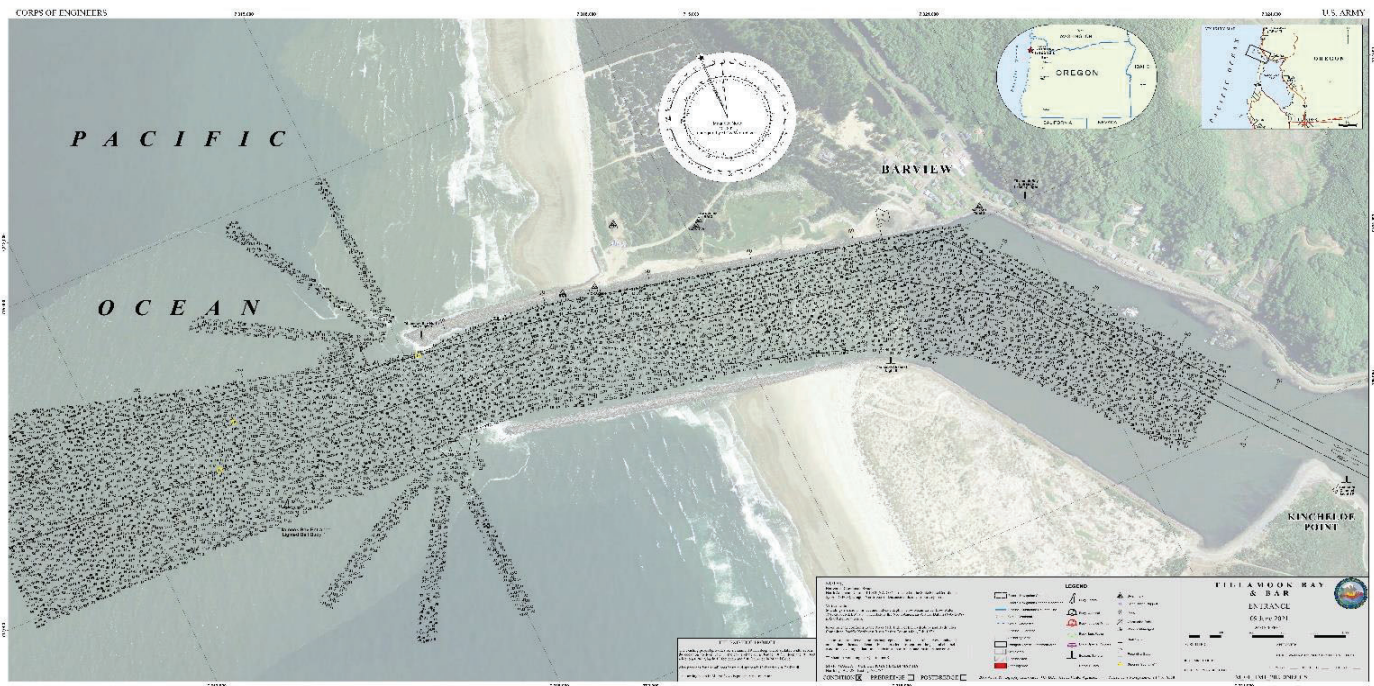
4.7.1.8 The Tillamook jetty system project was proposed in such a way to have near-even jetty tips that would cause the inflow and outflow of water to serve as a means of pushing sediment from Tillamook Bay out to sea, thereby creating and maintaining a channel through the bar. The uneven jetty system has created persistent and often unpredictable shoaling. The USACE does not have a dredging program for the Tillamook entrance. According to the USACE, the Tillamook entrance is already self-dredging and has been since construction.

ACOE Aerial photo of area above, with current depth data, June 2019.
