UNITED STATES COAST GUARD

**REPORT OF THE INVESTIGATION
INTO THE
SINKING OF THE COMMERCIAL FISHING VESSEL
EMMY ROSE (O.N. 909149), APPROXIMATELY 27
NAUTICAL MILES NORTHEAST OF PROVINCETOWN,
MA, RESULTING IN THE LOSS OF FOUR LIVES ON
NOVEMBER 23, 2020**

MISLEACTIVITY NUMBER: 7100250

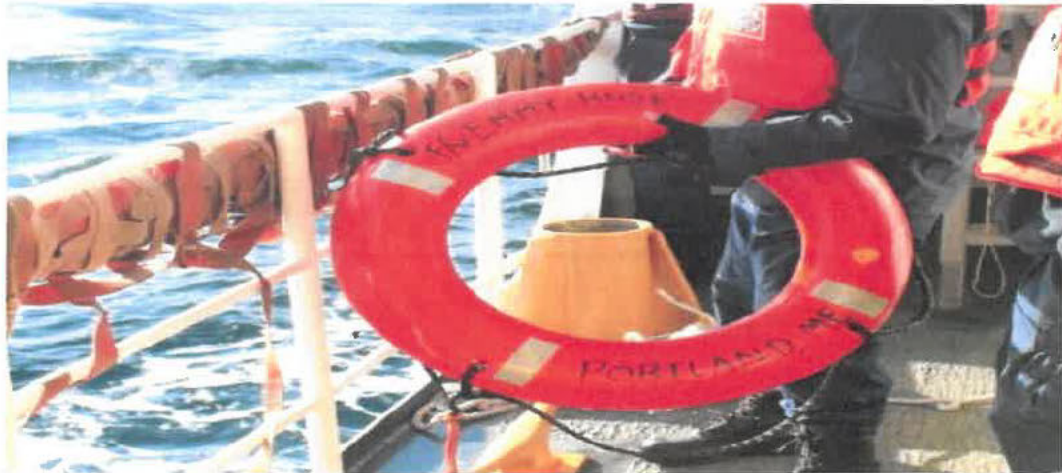
- 4.1.24. At 0912, the CGC VIGOROUS crew recovered a life ring and two wooden fish hold covers belonging to the EMMY ROSE in position 42° 10' 4.2" N, 069° 28' 60" W.

Figure 5: EMMY ROSE life ring recovered by the U.S. Coast Guard.

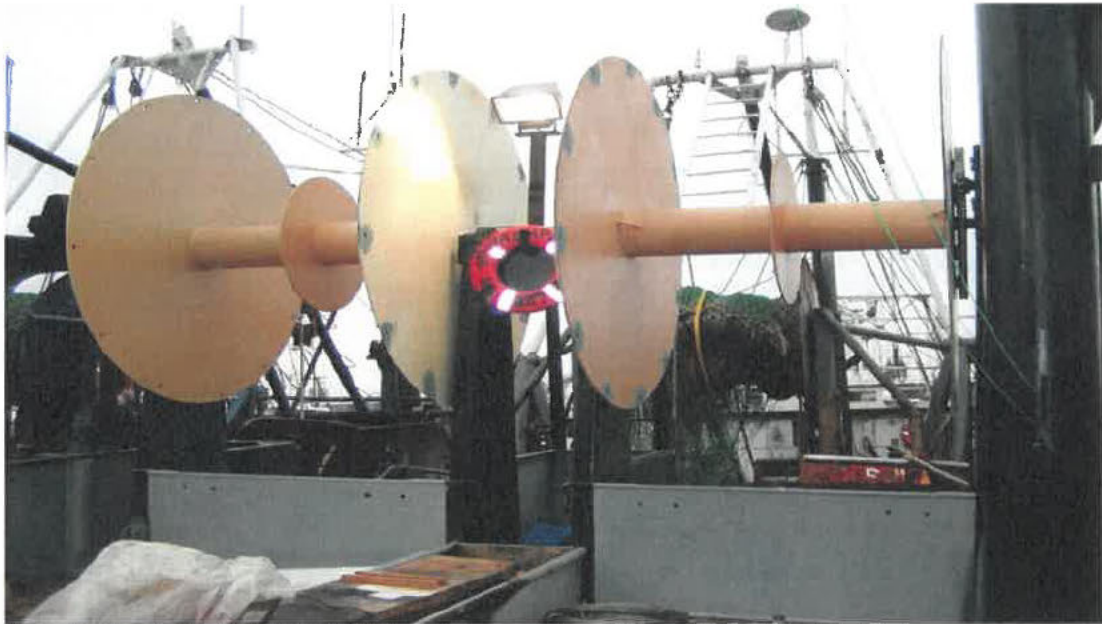
4.4.2. In January 2001 the vessel was sold to Sasha Lee, Inc., homeport was changed to New Bedford, MA and the vessel was renamed the SASHA LEE. With the change in location and fishery, the vessel was then modified to accommodate the regional fishery. Two 7-foot in diameter steel net drums and mounting were added to the stern of the vessel, amongst other various mechanical additions. The port and starboard walkways were closed off and the bulwarks were extended to provide protection from the elements for the crew on the aft deck.

Figure 8: Net reels added to the SASHA LEE in 2001. Image courtesy of Thomas M. Farrell Naval Architects.

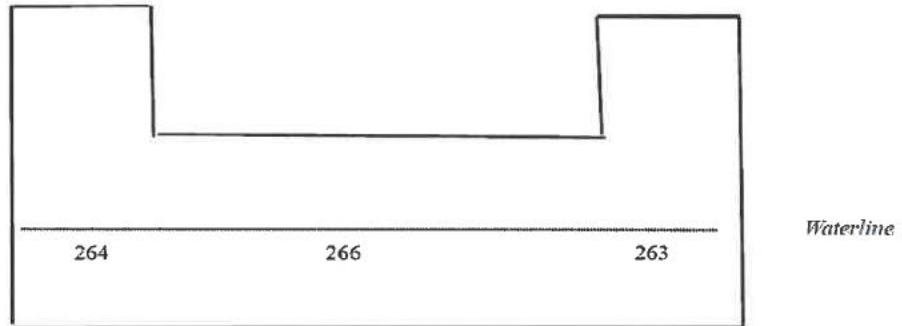
Transom

Figure 10. Stern ultrasonic test readings taken during evaluation, Aug 2019. Image courtesy of Marine Safety Consultants.

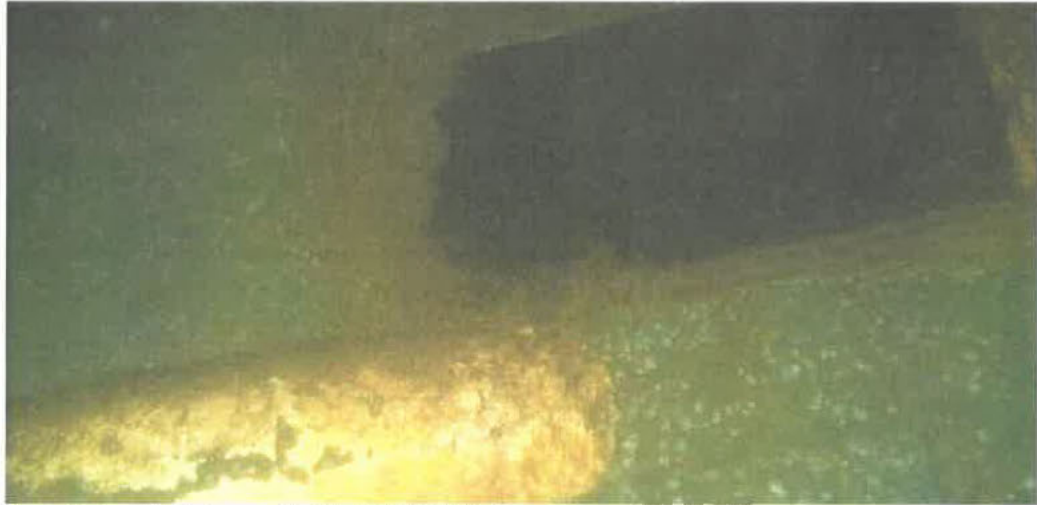
Figure 49: Port side freeing port #1 of the EMMY ROSE. Image courtesy of WHOI, 2021.

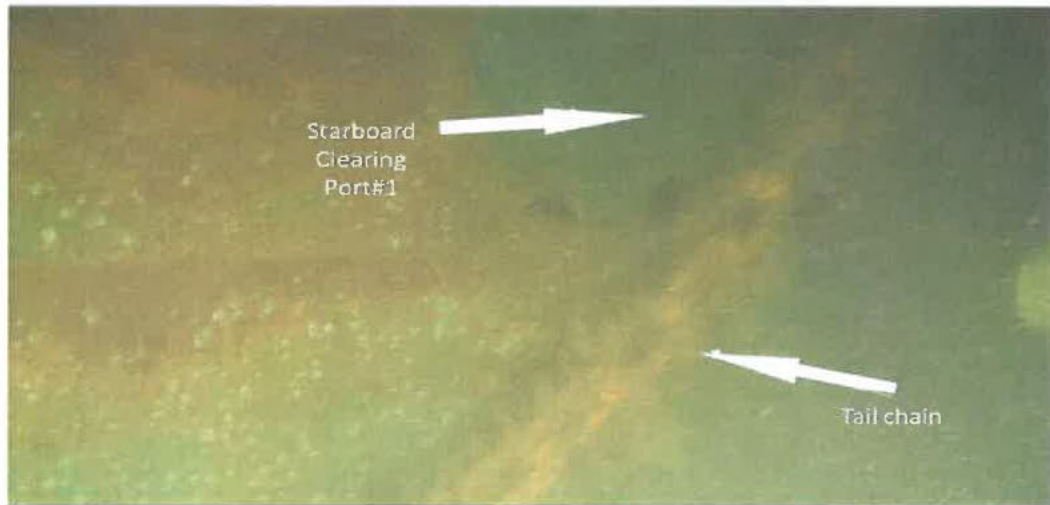
Figure 52: Starboard side clearing (freeing) port #1, tail chain visible. Image courtesy of WHOI, 2021.

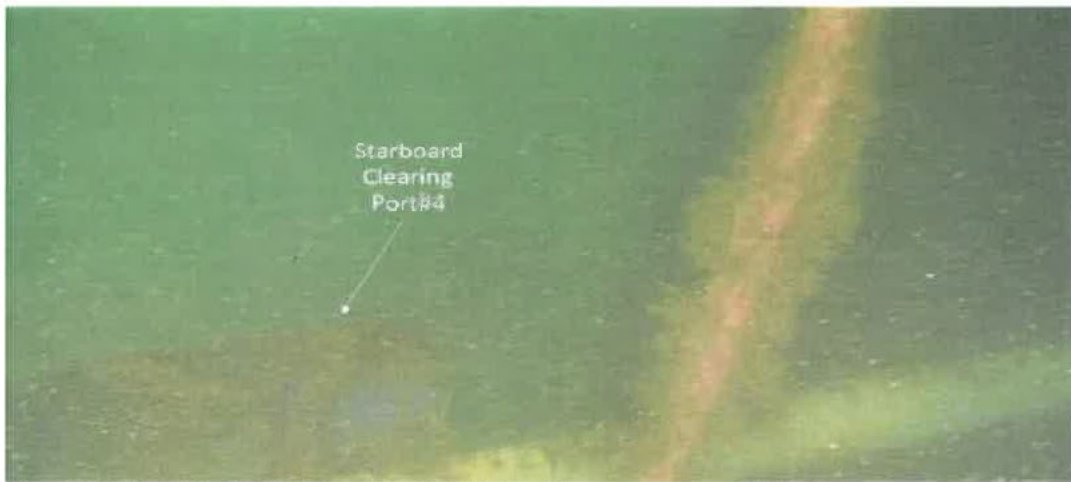
Figure 57: Starboard clearing (freeing) port #4 of the EMMY ROSE. Image courtesy of WHOI, 2021.

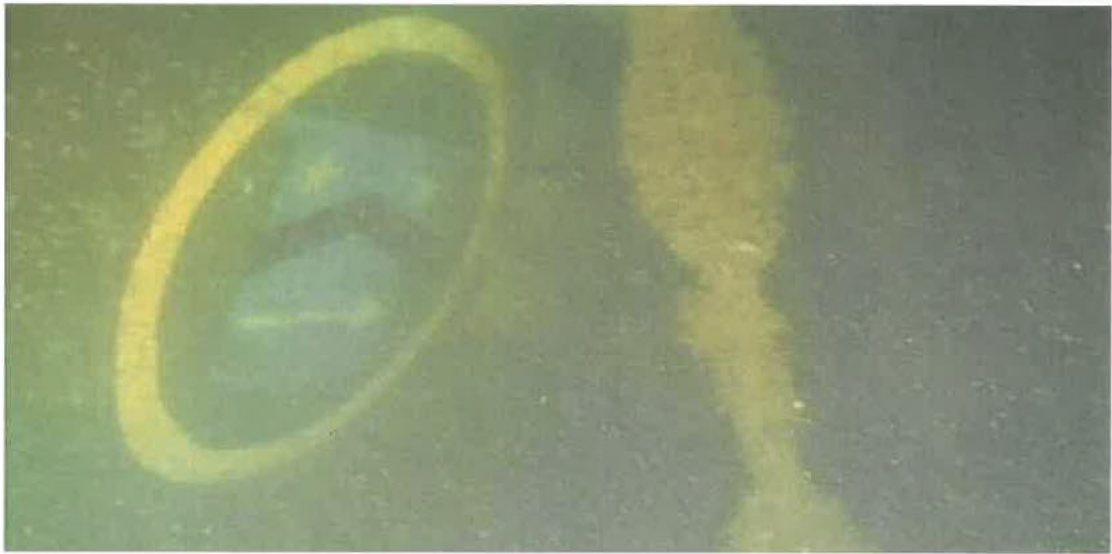
Figure 64: Port side bow with chain hanging over crest of the EMMY ROSE. Image courtesy of WHOI, 2021.

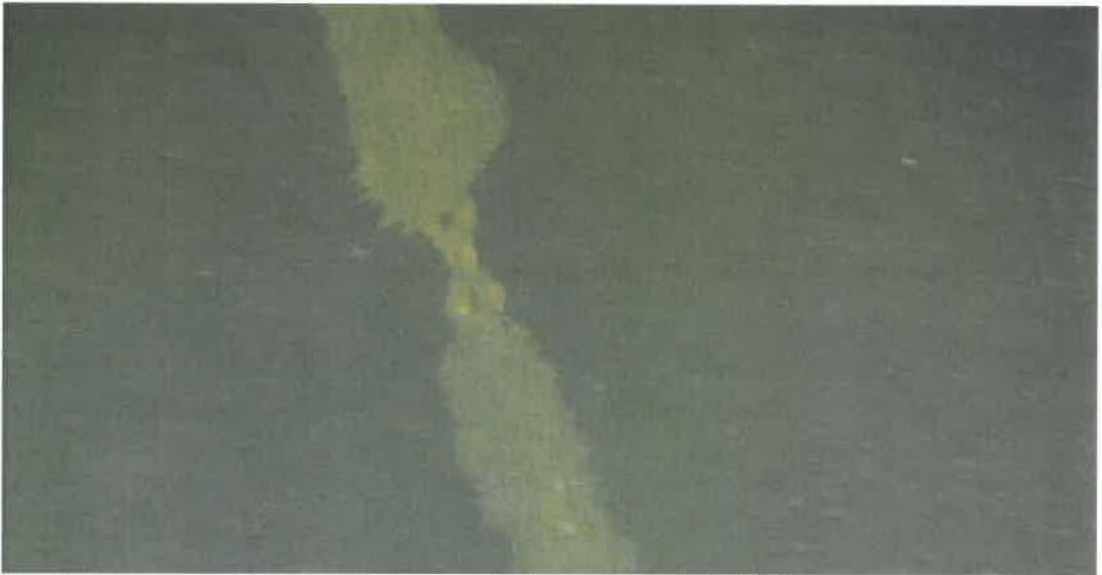
Figure 66: Port paravanes chain leading directly to the seafloor. Image courtesy of WHOI, 2021.
